# FAULT DIAGNOSIS OF PHOTOVOLTAIC MODULES BY MONITORING THE I-V CHARACTERISTICS AND PROCESSING THERMAL IMAGES

**Abstract:** This paper diagnoses faults on photovoltaic (PV) modules before and after the commissioning of the “Zvizdan” photovoltaic power plant, aiming to ensure reliable and safe operation of the plant and reduce technical losses to optimize the production of PV modules. All PV modules are inspected with thermal camera, with a focus on safety and reliability before commissioning, and on minimizing production losses after commissioning. Then, the I V curve parameters of modules showing faults in thermal images are measured and compared with manufacturer’s data. Results of this research provide deeper insights into the efficiency reduction of PV modules caused by various faults and they question a need for module replacement due to economic losses and protection of the system from extreme events such as fires.

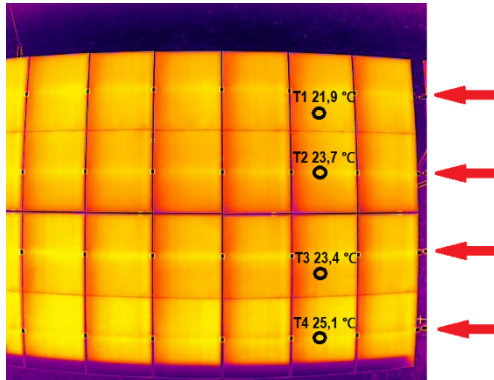
Figure 1.a shows a thermal image of functional PV modules, without any hot-spot areas. On all modules, including the ones shown, two horizontal parallel lines can be observed. Analysis of thermal images revealed a temperature rise of 2°C to 3°C compared to the rest

of the module, which does not qualify as hot spot areas. The cause of this temperature rise is slight shading from the underside of the module, which occurs due to the proximity of the substructure on which the bifacial PV modules are placed, initially designed for monofacial modules. Two modules were selected as reference modules for measuring the I V characteristic and its main parameters, one from the upper string and one from the lower string. Figure 1.b shows the I V characteristic of the PV module from the lower string.

Figure 1.a: Thermal image of functional PV modules

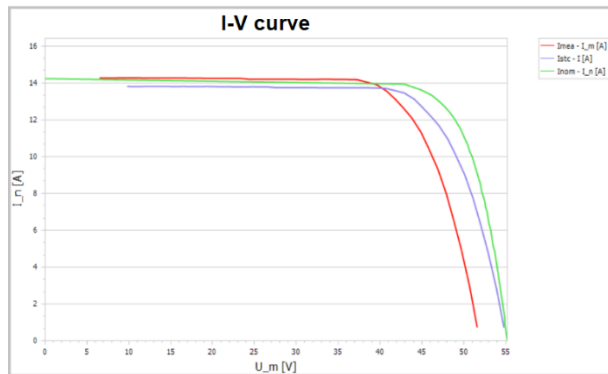
Figure 1.b: I-V curve of functional PV modules

In the I V characteristic, three graphs are visible (Figure 1.b). The red graph represents the actual measured I V characteristic. It directly depends on the current measurement conditions (cell temperature, irradiance, etc.). In order to compare the characteristics of different modules, it is necessary to standardize them to the same measurement conditions. Since this is not possible, the measured characteristic of all modules is recalculated to STC conditions for each measurement, enabling a comparative analysis of the modules (blue graph). The STC measurement conditions are an irradiance of 1000 W/m<sup>2</sup> and a cell temperature of 25 °C. The green graph represents the nominal characteristic, with its main parameters taken from the manufacturer's datasheet, a summary of which is provided in Table I.

The measurement results show a power loss increase of 2% to 5% for the lower row of PV modules (Table II). The reason for this could be lower irradiance on the underside of the modules, greater susceptibility to contamination, reduced cooling, and shading from the adjacent row of PV modules. Therefore, a combiner box containing all functional modules was selected, and the results of the power loss are shown in Table III. The same table also shows the varying power loss across all modules.

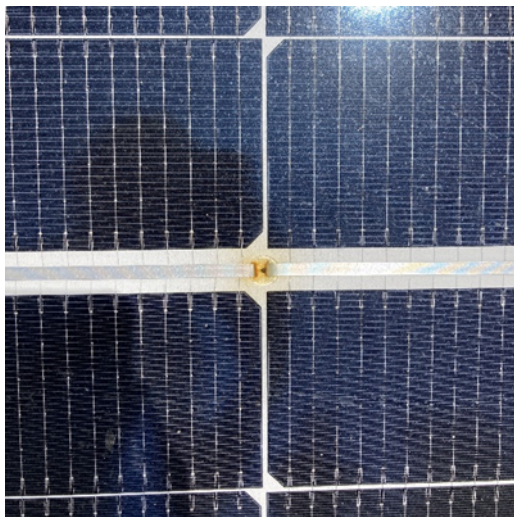
The tested PV modules contain three bypass diodes, all located in a single junction box. Overheating of the junction box is most commonly caused by inadequate design, manufacturing defects, wiring issues, such as poor connections, or mechanical stress during transport. Inadequate design or improper sealing of the junction box allows moisture ingress, which causes corrosion of the internal connections (Figure 2). This results in wiring failure, leading to internal arcing.

Figure 2: Corrosion at the installation site of the junction box

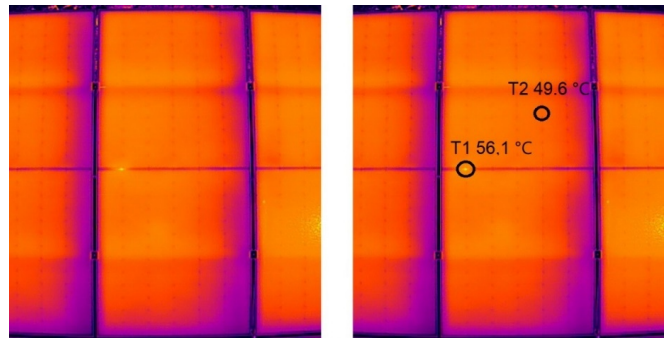
Figure 3: Thermal image of junction box fault

Excessive heating of the junction box leads to energy loss due to resistance within the bypass diode (conversion to thermal energy), which can reduce the module's efficiency or even cause failure. Therefore, this type of issue requires regular monitoring. Figure 3 shows one of the observed cases, where, despite temperature variations, there is no impact on the rest of the module or production efficiency, making this example not concerning at this stage. The cold periodic (purple) areas are caused by shading and the drone's angle.

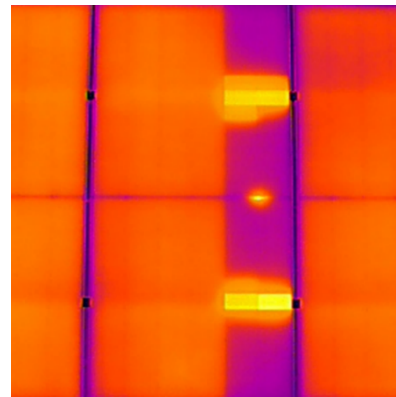
In addition to the junction box fault described in Chapter 1.2, this type of issue also involves faults in the interconnection of PV cells. Interconnection failure can be caused by cell cracking during the manufacturing process, particularly during the stringing process, electrochemical corrosion, a defect in a single cell causing the series string to be interrupted, or a short circuit in the cell string caused by a failure in the junction box. Any fault in the PV cells or contact lines results in thermal expansion and contraction, as well as mechanical stress, leading to a loss in output power. The power loss increases linearly over time. In addition to the decrease in efficiency, this type of

Figure 4.a: Thermal image of cell string and junction box failures

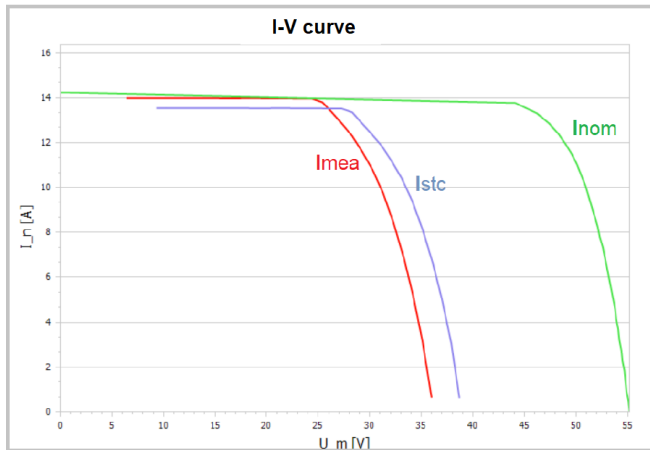
Figure 4.b: I V characteristic for cell string and junction box failures

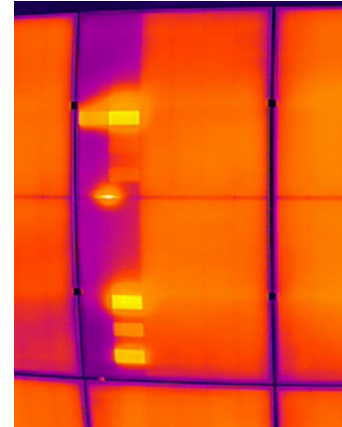
In addition to cell string and junction box failures, cracking of the glass on the PV module has also been found in this type of issue. It is clear that the cracking of the PV module is not a manufacturing defect and is one of the main external causes of module failure. The effects of glass breakage result in module overheating, electrical safety issues, and performance degradation during long-term operation, as moisture can enter through the cracks, leading to corrosion (delamination - see Chapter 1.6). The mismatch in cell currents causes visible distortion in the I V characteristic (Figure 5.b).

Figure 5.a: Thermal image of combined external and internal failures

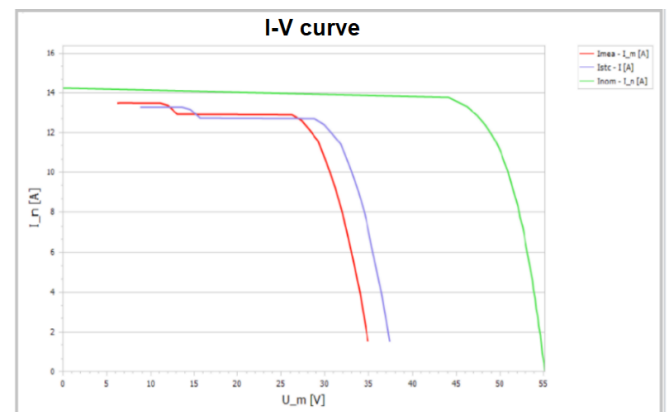
Figure 5.b: I V characteristic for combined external and internal failures

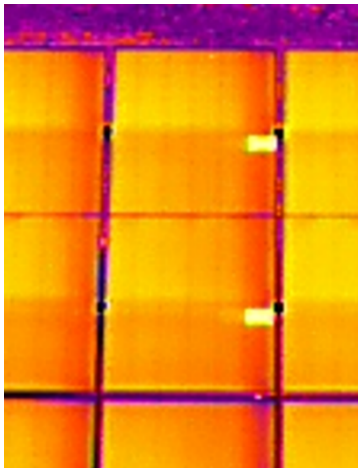
PVPP are framed and no visible glass cracking was observed, thermal images revealed hot spots near the clamps on some modules (Figures 6.a and 7.a). As a result, a torque tightening check was performed on the identified modules using a torque wrench. The specified torque for tightening the clamp bolts on the PV module frame during installation is 8 Nm. When the required torque is reached with the torque wrench, the operator hears a “click”. If a click is heard during the first tightening without the bolt moving, it indicates that the application is already too tight. The testing was carried out on a sample from a single string, resulting in a torque range of 13 Nm to 20 Nm, which concludes that the tightening torque was increased across the entire plant, and in some modules to the extent that it could cause hot spots. Two examples are attached below, the first from the upper string, the second from the lower string.

Figure 6.a: Hot spots caused by clamps on the upper PV module

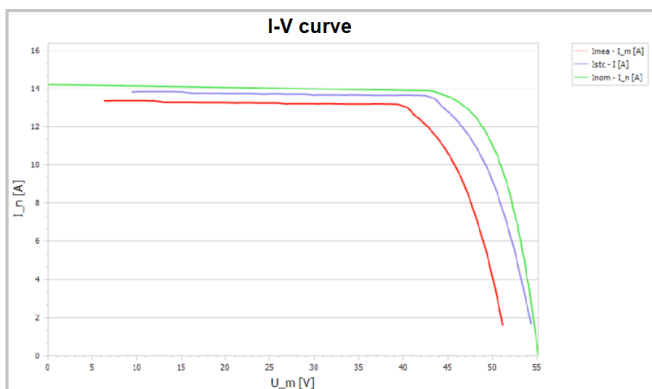
Figure 6.b: I V characteristics of the upper PV module with clamp induced hot spots

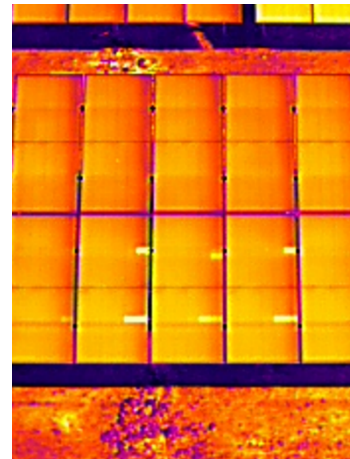
Figure 7.a: Hot spots caused by clamps on lower PV modules

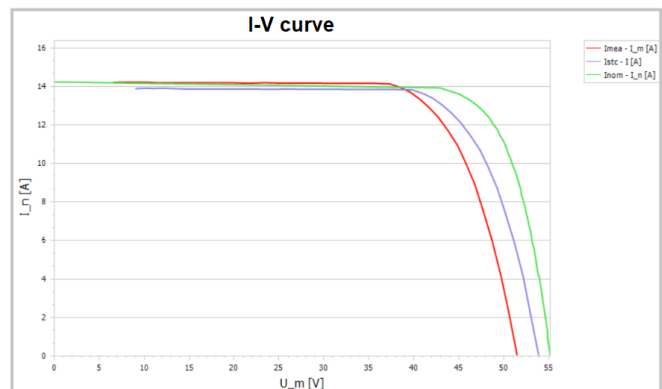
Figure 7.b: I V characteristics of the lower PV module with clamp induced hot spots

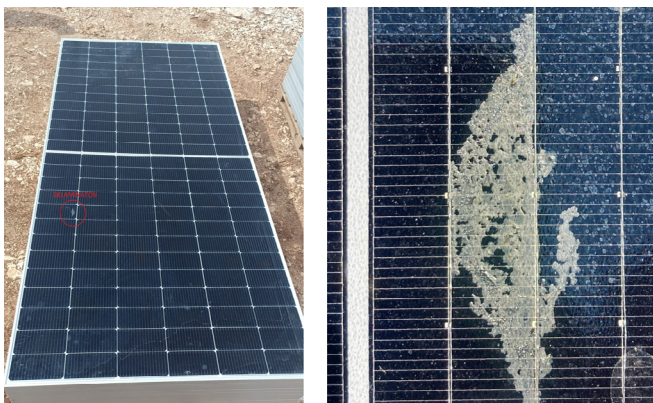
Delamination of PV modules is a phenomenon in which the layers of the module, i.e., the glass, silicon cells and encapsulant, separate from one another. The effect of delamination occurs due to environmental factors, primarily humidity, moisture and temperature variations. Theoretically, 90% of modules are prone to delamination. Delamination does not lead to module failure but results in optical reflection, which causes subsequent power loss, while also posing a safety concern. The efficiency of PV modules degrades at a very slow rate, approximately 0.5% per year. This suggests that such issues are more common after a longer period of time [1]. The observed example of delamination at the “Zvizdan” PVPP (Figure 8) cannot yet be detected with a thermal camera at this stage and has no impact on the module’s performance.

Figure 8: Example of delamination in the PVPP “Zvizdan”
