# IN SITU VERIFICATION OF TENDONS OF FIRST SEGMENTAL POST-TENSIONED ROAD BRIDGES

## Abstract

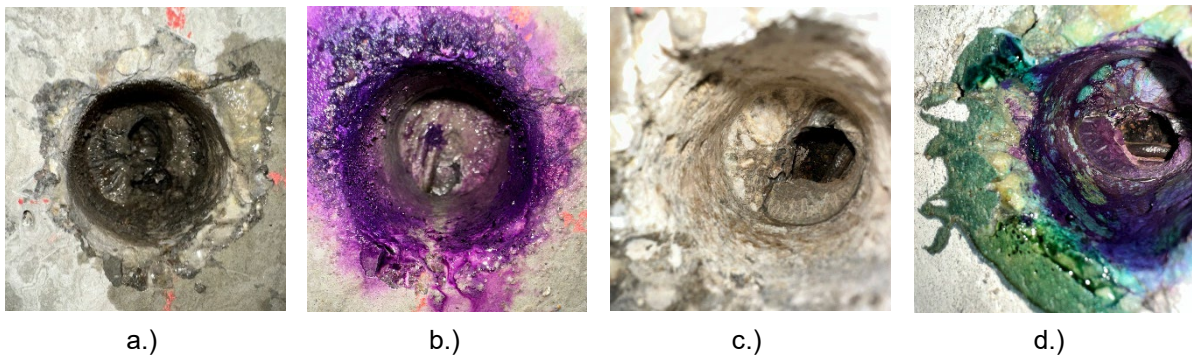
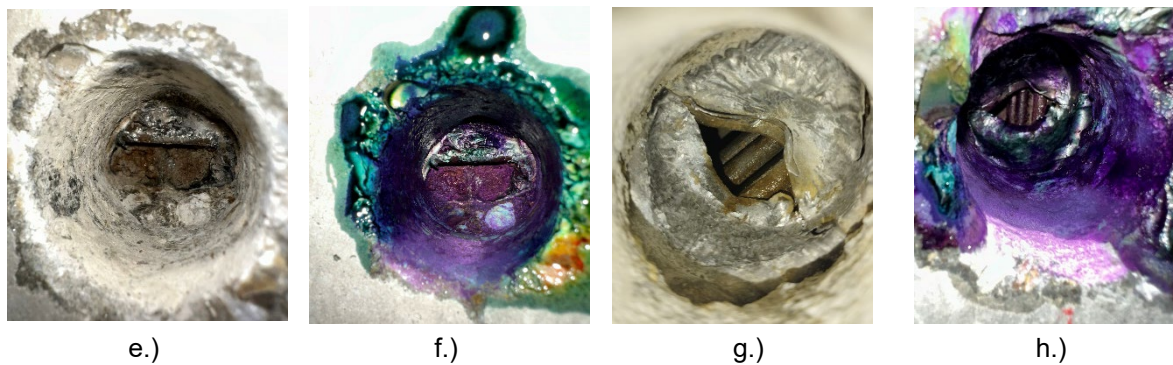
The diagnostic survey was conducted on individual bridge spans with the aim of performing at least five cores in each span. Figure 14 displays the overall number of cores in individual bridges. The examples of the revealed ducts can be seen in Figure 15. Specifically, Figure 15a presents a duct with the presence of water. Interestingly, the prestressing wires were not corroded. It can be attributed to the fact, that the water was present in only one duct and could leak during recent pavement reconstruction. Photographs on the right side represent the cores after application of phenolphthalein indicator solution. All performed cores were in alkaline environments. In Figure 15c and Figure 15e, partially injected ducts are displayed. Moreover, corroded wires in not injected duct can be seen in Figure 15g. In the investigation, the state of tendons in the area adjacent to gaps between the individual segments was studied too. This is important because this location can be prone to water voids which could result in corrosion which could spread along the insufficiently injected tendon.

Fig. 15: Examples of revealed prestressing steel: a.) presence of water (Bridge “B”); c.) partially injected duct (Bridge “D”); e.) partially injected duct (Bridge “D”); g.) corroded wires (Bridge “B”); b.; d.; f.; h.) cores after application of indicator solution.

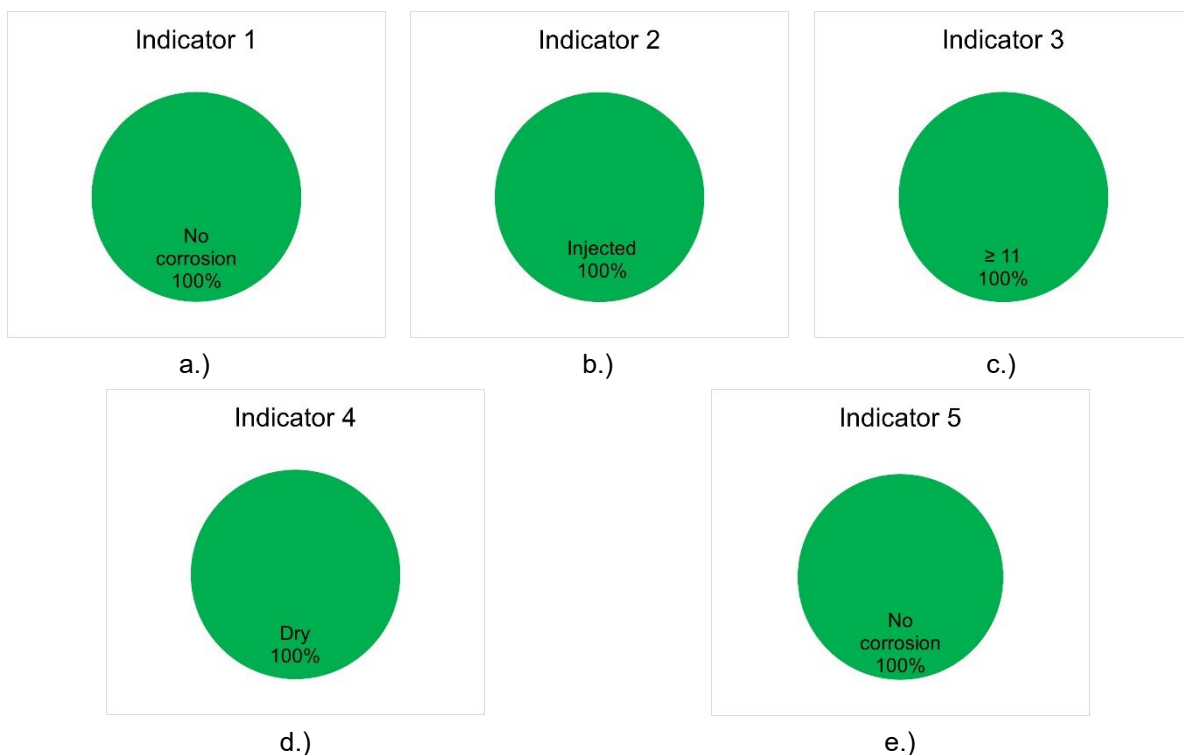
Figure 16 displays the evaluation of performed cores in Bridge “A”. Overall, nine cores were drilled in the single-span bridge. All cores were in a good state – the presence of injection and no signs of corrosion. Consequently, the prestressing of this bridge was in good condition. The alkalinity of the concrete met the required criteria in all cases.

Fig. 16: Bridge “A” – evaluation: a.) Indicator 1; b.) Indicator 2; c.) Indicator 3; d.) Indicator 4; e.) Indicator 5.

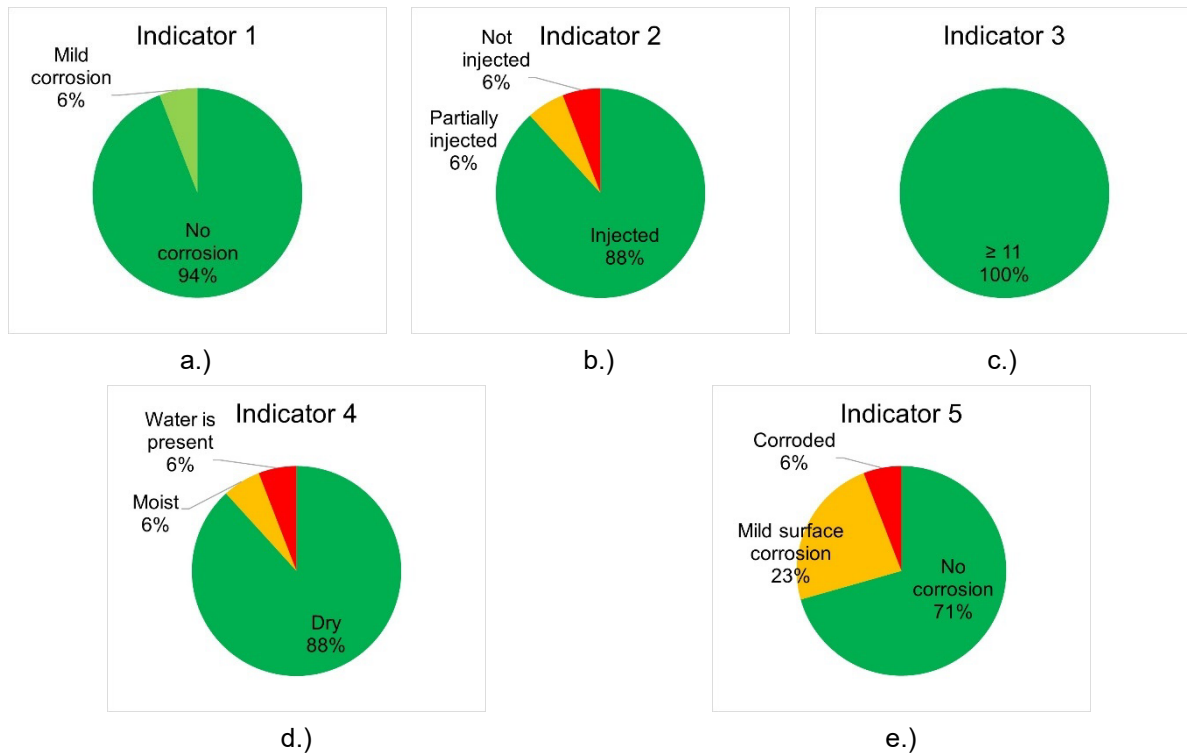
Figure 17 presents the results from the exposure of tendons in Bridge “B”. Overall, seventeen cores were drilled in the three-span bridge. Specifically, five cores in 1<sup>st</sup> span, six cores in 2<sup>nd</sup> span, and six cores in 3<sup>rd</sup> span. The majority of the revealed tendons were in a good state. However, in one tendon in 3<sup>rd</sup> span, the water was present. Probably because of recent pavement reconstruction and the longitudinal slope of the bridge that enabled water to accumulate in lower parts. This tendon was anchored in the top flange of the I-girder right under the pavement. Almost 90 % of revealed tendons

were fully injected. Additionally, circa 30 % of the diagnosed tendons contained wires with signs of corrosion. To sum up, the prestressing of this bridge was in sufficient condition without affecting the overall performance of the structure. However, attention is required regarding the possible presence of the water in not-injected tendons. The alkalinity of the concrete was sufficient in all drilled cores.

Fig. 17: Bridge "B" – evaluation: a.) Indicator 1; b.) Indicator 2; c.) Indicator 3; d.) Indicator 4; e.) Indicator 5.

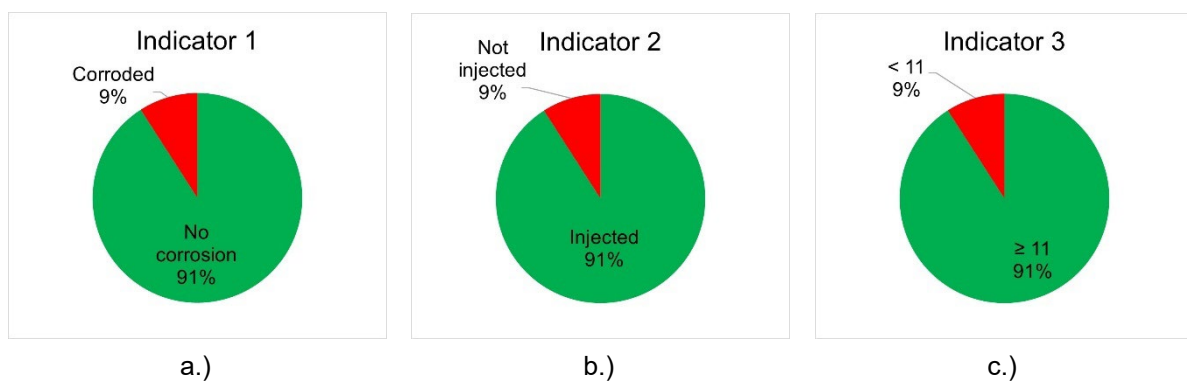
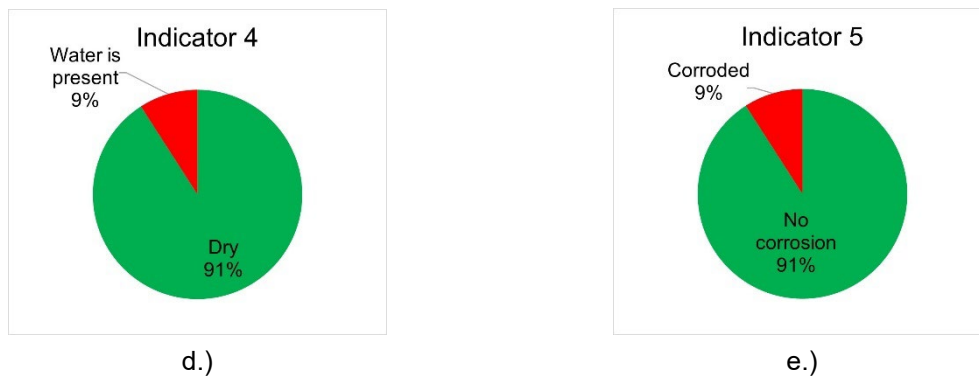
The evaluation of data collected in Bridge "C" is summarised in Figure 18. To sum up, two-span Bridge "C" was subjected to overall eleven prestressing steel exposures. In particular, in 1<sup>st</sup> span five exposures were performed and in 2<sup>nd</sup> span six exposures respectively. In 2<sup>nd</sup> span, tendons of edge girders were visible without any intervention - a detached concrete cover. Except for this tendon, all other diagnosed tendons were in good condition with the present injection. To sum up, a damaged edge girder requires action to avoid spreading corrosion to other girders. The problematic edge girder can be seen in Figure 19. The alkalinity of the concrete did not meet the required criteria only in the case of edge girder.

Fig. 18: Bridge “C” – evaluation: a.) Indicator 1; b.) Indicator 2; c.) Indicator 3; d.) Indicator 4; e.) Indicator 5.

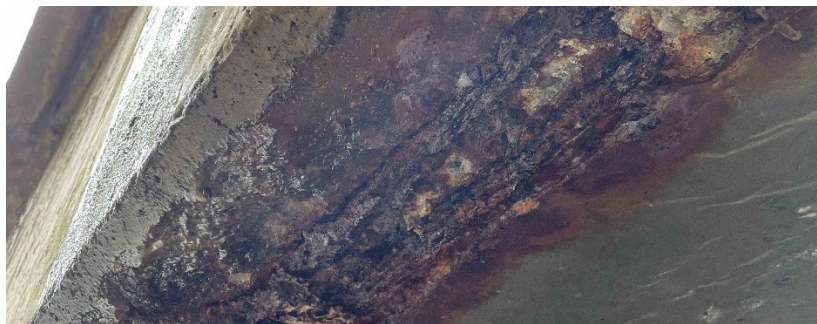
Fig. 19: Bridge “C” – edge girder with visible corroded tendons.

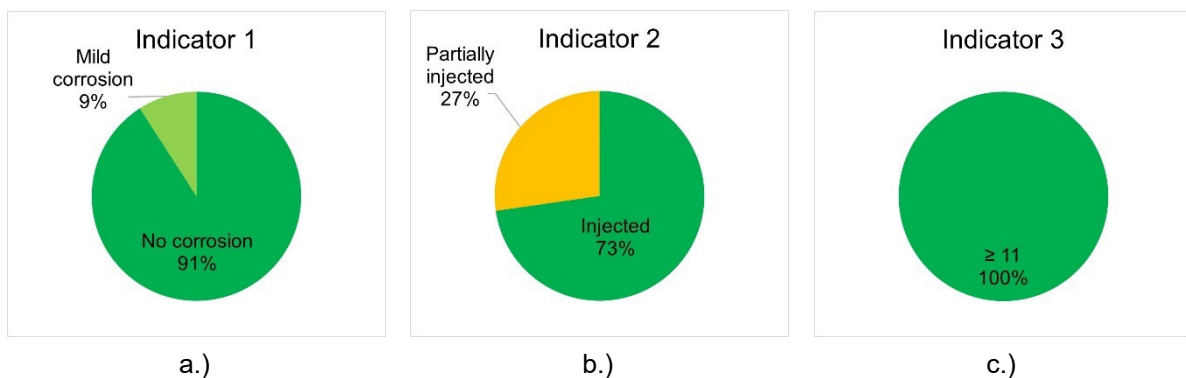
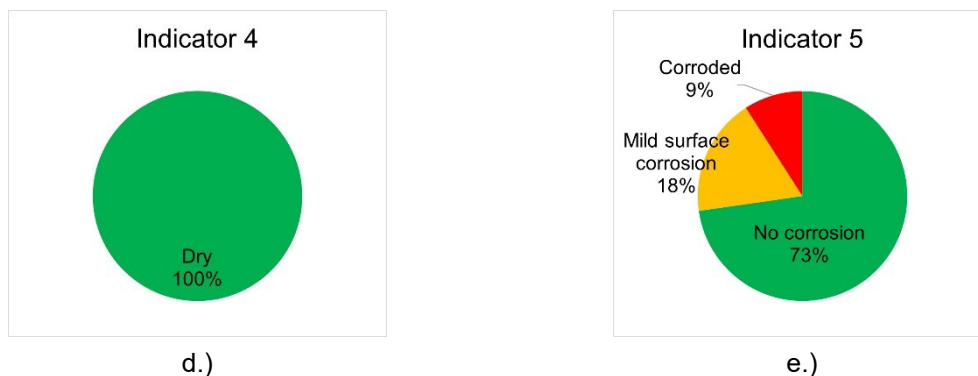
Figure 20 summarises the results of the Bridge “D” prestressing diagnostics. In the case of this two-span bridge overall eleven drilled cores were performed – five in 1<sup>st</sup> span and six in 2<sup>nd</sup> span respectively. More than two-thirds of the revealed tendons were fully injected. The rest of them were only partially injected. Almost 30 % of diagnosed tendons consisted of corroded wires or wires with mild surface corrosion. Importantly, water was not detected in the tendons. Finally, the overall prestressing of the bridge should not be significantly affected. The alkalinity of the concrete was sufficient in all cases.

Fig. 20: Bridge “D” – evaluation: a.) Indicator 1; b.) Indicator 2; c.) Indicator 3; d.) Indicator 4; e.) Indicator 5.
