# NON-DESTRUCTIVE TESTING OF A HISTORICAL VAULT USING GROUND PENETRATING RADAR METHOD

## Abstract

The article presents the results of research conducted in the Main Building of the Gdańsk University of Technology, which was destroyed in the World War II, reconstructed and included in the Register of Historic Buildings several decades ago. The study was carried out on the ceiling above the second floor, in the central part of the building at the 3rd level, in the hall in front of the Main Hall. The primary objective was to identify the geometry of the vault and assess the feasibility of detecting its internal structure using the non-destructive ground penetrating radar (GPR) method. A GPR system with a 2 GHz antenna was used for the study. Selected echograms (B-scans) in both scanning directions and tomographic maps at different depths were presented. The results indicate the presence of steel load-bearing beams in both directions, as well as a steel grid in the central part of the ceiling, while also mapping the boundaries of the vaulted structure. This research is particularly important due to the limited availability of technical documentation for the analysed area. The finding

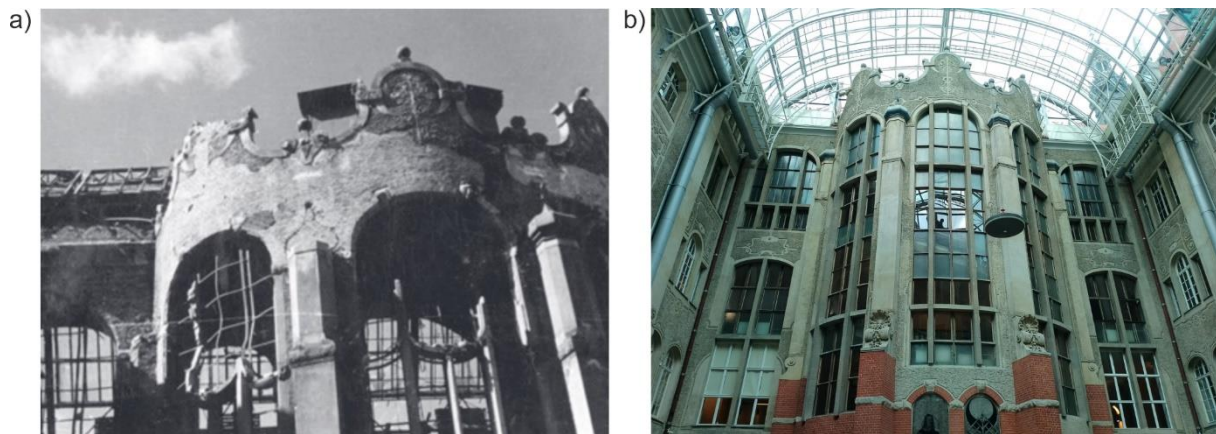
Fig. 1: Main Building of the Gdańsk University of Technology (link: <https://ochronazabytkow.gda.pl/rejestr-zabytkow/rejestr-zabytkow-nieruchomych/>): a) destroyed staircase in World War II [28], b) present-day view of the staircase.

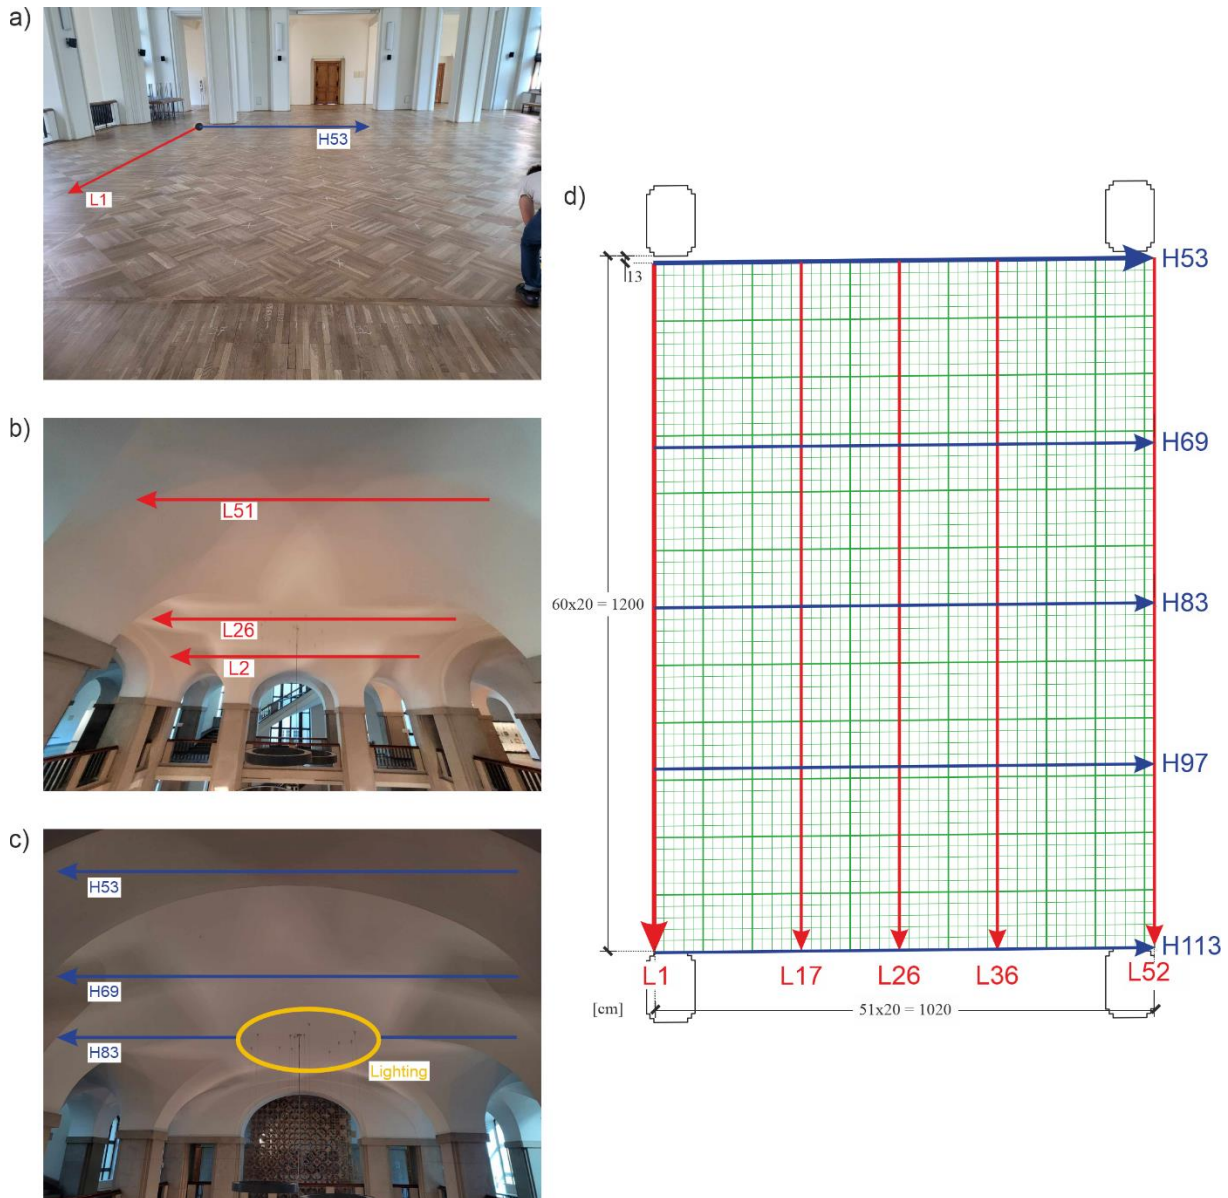
Fig. 3: Measurement area #A: a) ceiling location, b) view of the ceiling from below – selected longitudinal profiles with a visible arched ceiling, c) view of the ceiling from below – selected transverse profiles with a visible arched ceiling and marking lighting, d) marking in the 3. floor plan.

The initial inspection of the ceiling from below, i.e., from the 2nd level, clearly indicates the presence of anomalies in the form of variations along the length of the edges of the cross-ribbed vaults. Furthermore, several metal rods support suspended lighting fixtures at the centre of the ceiling (Fig. 3), which will also manifest as anomalies due to the magnetic properties of steel.

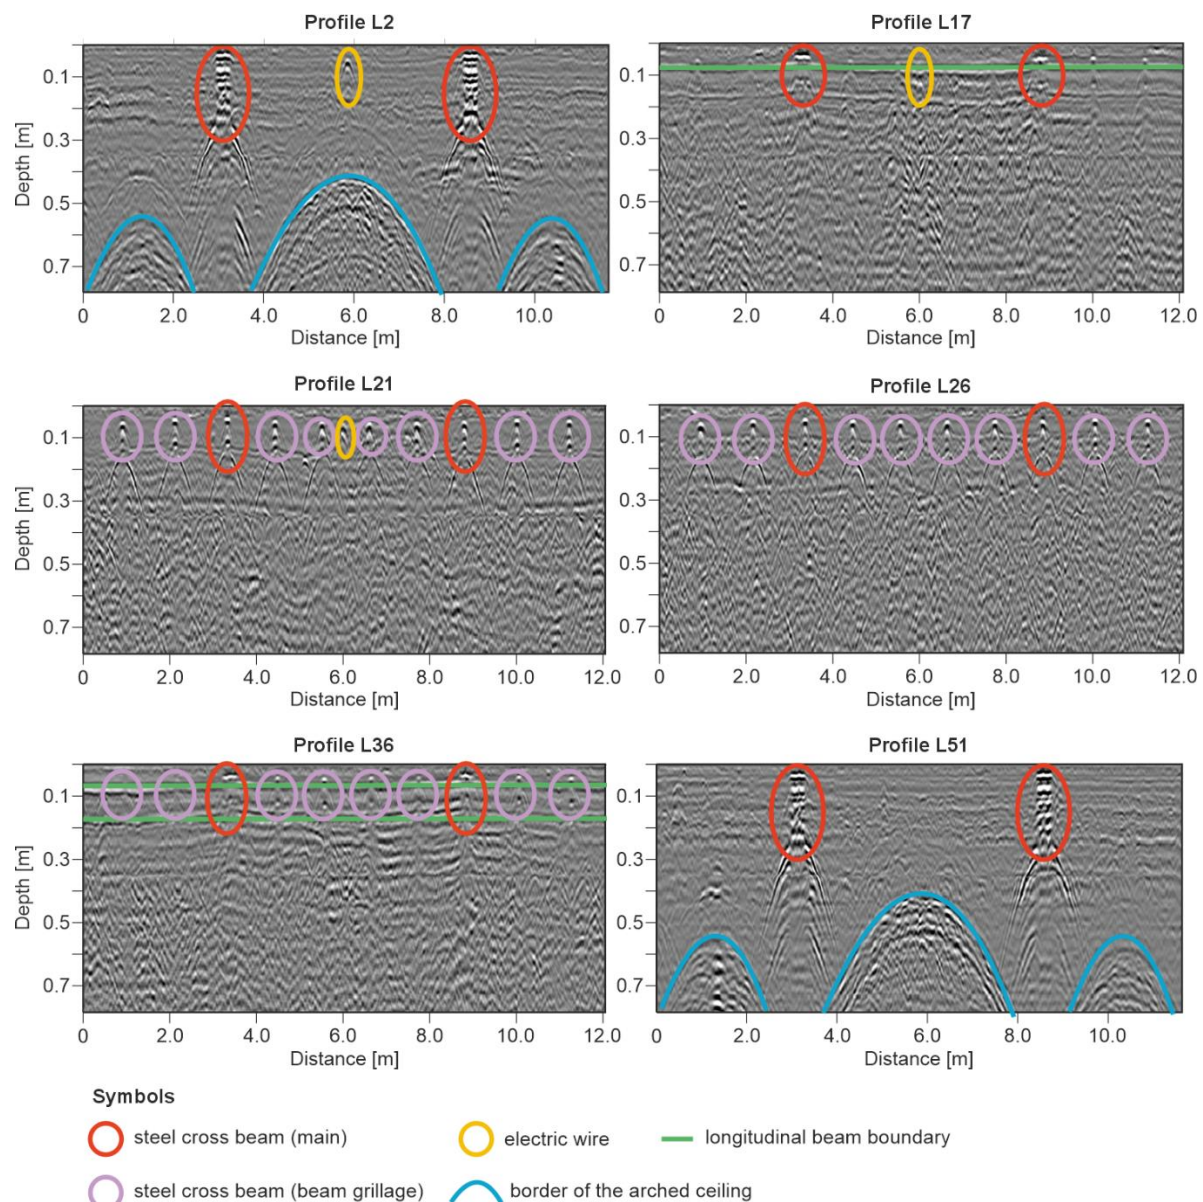
Fig. 4: Analysis of the selected radargrams in the longitudinal direction (explanation in the text).

Figure 4 presents echograms for three selected longitudinal profiles: L2, L17, L21, L26, L36 and L51. In profile L2, characteristic subsurface disturbances are visible at approximately 3.00 m and 8.50 m along the length. Both disturbances exhibit hyperbolic reflections at a depth of approximately 25 cm, indicating the presence of longitudinal inclusions. These are most likely the steel load-bearing beams of the ceiling, positioned above the vaulted sections and aligned with the column axes. Additionally, the boundary between the arched ceiling segments can be observed: smaller arches symmetrically positioned on both sides of the profile, with a lower boundary extending to approximately 2.80 m and an arch rise at a depth of around 0.6 m, and a larger central arch extending from approximately 3.80 m to 8.00 m, with an arch rise at a depth of about 45 cm. The gaps between the arches, where no anomalies are detected, correspond to the locations of the columns and, consequently, to the presumed locations of the steel beams. The lower surface of the ceiling is well-maintained, suggesting that a reinforcing steel mesh was installed during renovation work. This is supported by subsurface disturbances observed beneath the arch edges on the radargram. There is also a single hyperbolic anomaly at approximately 5.80 m along the profile and at a depth of 5 cm. This anomaly appears in the same location across all profiles from L1 to L26, covering half of the surveyed area. It can be inferred that this corresponds to an electrical conduit for the suspended lighting system beneath the ceiling. Anomalies corresponding to the presence of steel girders are also observed in profile L17, the locations of which are entirely consistent with those in profile L2. However, in this measurement path, the arch geometry is no longer visible. Instead, linear inclusions appear at depths of 8 cm and 20 cm along the entire profile, indicating the presence of a continuous disturbance along this path. A similar situation is observed in profile 36, which is symmetrical to the centreline. This suggests the presence of two beams running parallel to the longitudinal measurement paths, likely serving as girders. Radargram 26, representing the

measurement path crossing the centre of the investigated area, indicates the presence of a beam grid in the middle of the ceiling. This is evidenced by disturbances appearing at approximately 1.00 m intervals, beginning at radargram 18 (at a distance of 3.40 m from the starting point), corresponding to ten steel beams. The locations of these disturbances coincide with the previously observed two repeating beams. In the scans where these ten anomalies are visible, the vaulted segments are no longer present, suggesting that the grid of beams has a structural reinforcement function.

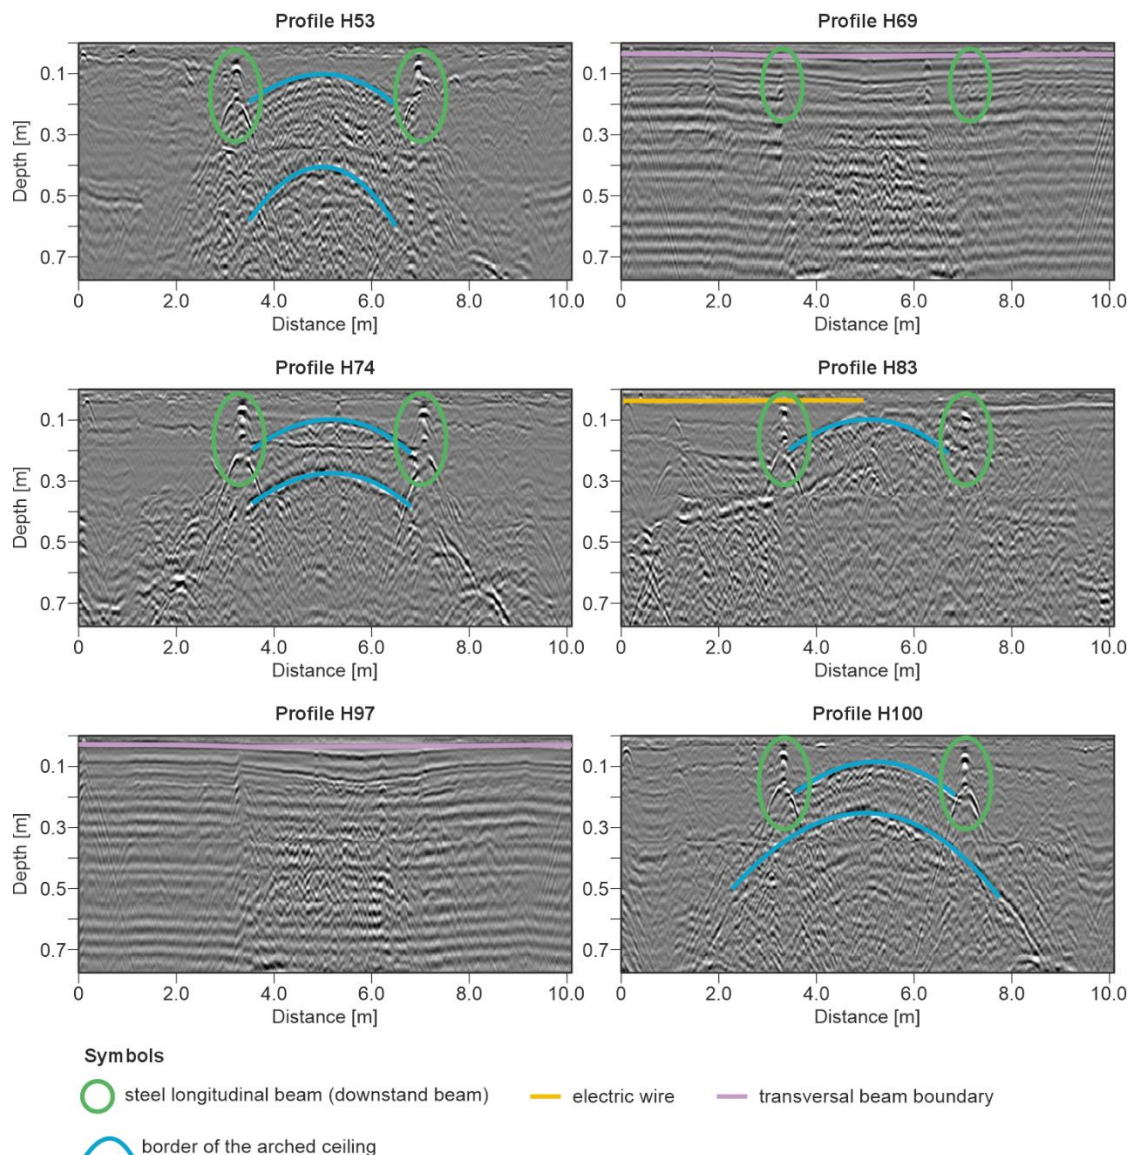
Fig. 5: Analysis of the selected radargrams in the transverse direction (explanation in the text).

Fig. 5 presents echograms recorded for selected transverse measurement paths. In echograms H53 (first transverse scan) and H83 (scan through the centre of the measurement area), as well as in most of the scans, disturbances in the form of two hyperbolas are visible at approximately 3.40 m and 7.20 m. Their locations correspond to the longitudinal profiles L17 and L36, where linear inclusions were identified. This indicates the presence of two main beams running in the longitudinal direction (previously mentioned girders). Both hyperbolas appear at a depth of approximately 20 cm, probably corresponding to the beam edges, which also aligns with the linear inclusions observed in profiles L17 and L36. At shallower depths, strong disturbances caused by the presence of steel are visible. The echograms clearly show the arched boundary of the ceiling between the disturbances corresponding to the steel girders. Furthermore, both the upper and lower boundaries of the arch can be distinguished (e.g., profiles H74, H100), probably indicating the presence of brick infill between the beams (similar to a Klein ceiling). The difference between the edges of these arches at their extremes is approximately 15 cm. Radargram 69 corresponds to a measurement path located along one of the two main transverse beams. This is evidenced by the presence of linear inclusions along the entire profile, as well as the distance of this path from the starting point (3.20 m) which approximately corresponds to the hyperbolas observed in the longitudinal profiles. A similar situation is observed in echogram H97, which corresponds to a profile symmetrical to H69. In addition, linear inclusions can be observed in selected transverse

measurement paths in the central parts of the echograms (between the main hyperbolas). These paths coincide with the transverse beams of the grid structure in the central part of the ceiling.

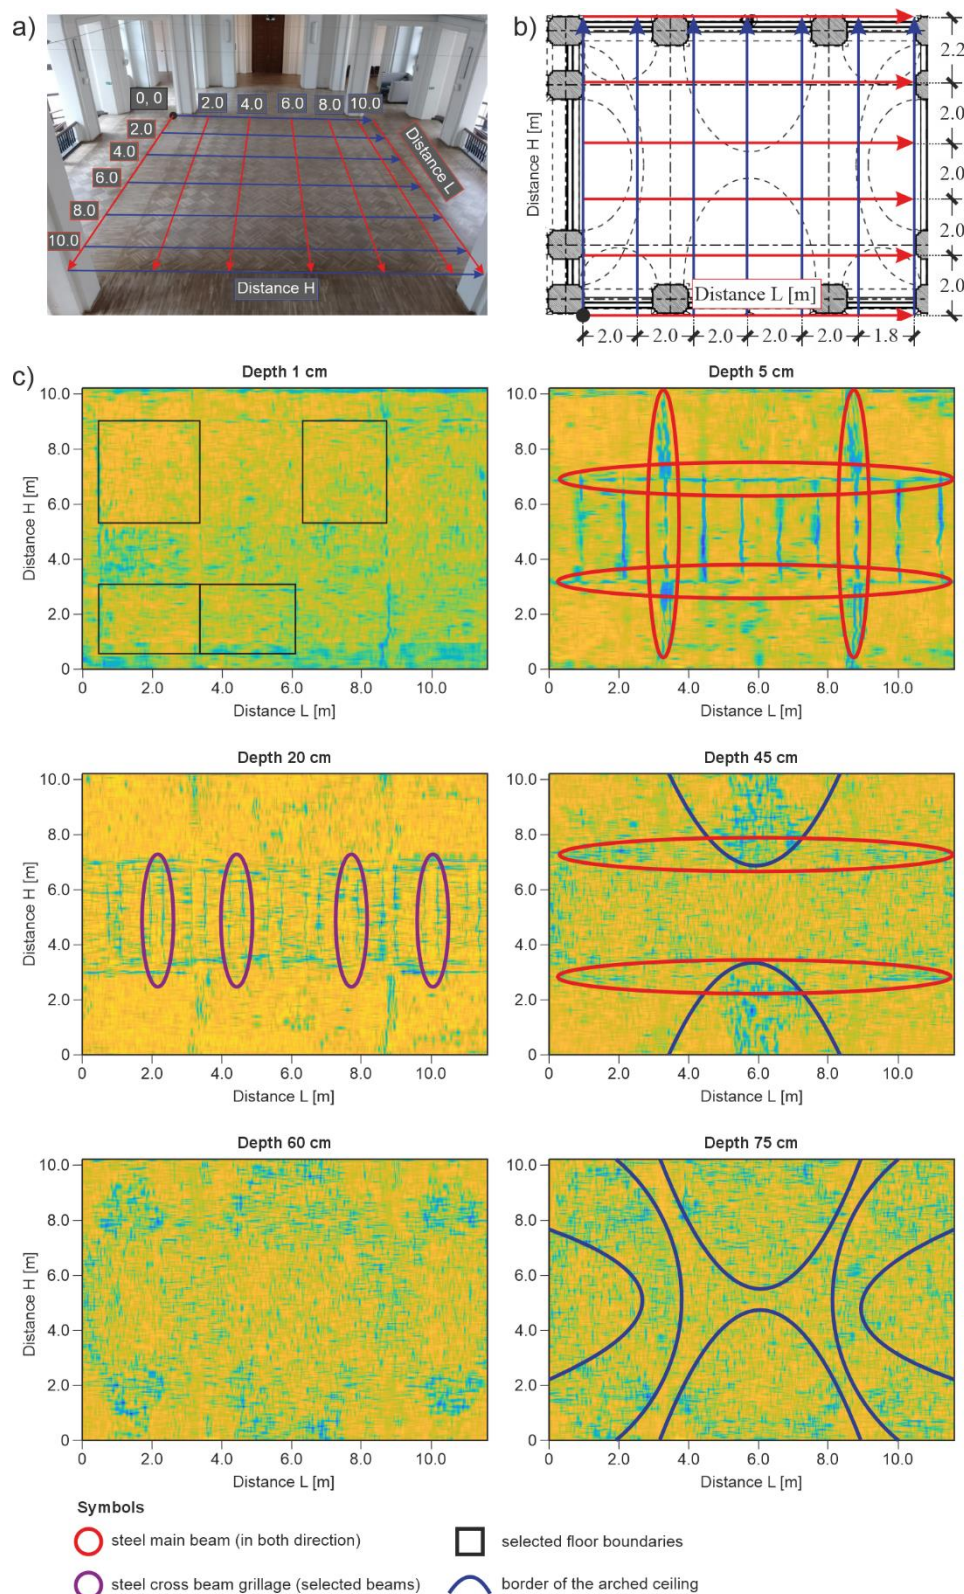
Fig. 6: Examples of tomographic maps obtained from measurements (c) (explanation in the text) with a measurement area marked in the top view (a) and on the 2<sup>nd</sup> floor plan (b).

Fig. 6 presents tomographic images for selected depths. At a depth of 1 cm, just below the floor, rectangular shapes are visible, which may correspond to the boundaries of the floor layers. At greater depths, up to 35 cm and in some cases up to 45 cm, the grid structure of the beams can be clearly seen: two longitudinal beams, two main transverse beams and additional transverse steel beams in the central part of the floor supported by the beams. At a depth of 20 cm, the beam edges are visible, corresponding to the hyperbolic reflections observed in the longitudinal scans. At a depth of 40 cm, the boundaries of the ceiling become visible, beginning in the central part of the structure where the largest vault is located. At the maximum depth of 75 cm, the full geometry of the arched ceiling is shown in both directions, together with the positions of the columns from the 2nd level, the space between the smaller arches and the largest arch in the longitudinal direction.
