Reopening of the Footbridge in Bratislava Exposed to Fire

Journal of the Faculty of Civil Engineering | University of Žilina

Bridge failures due to fire are very rare, and they are mostly caused by traffic accidents involving a tanker truck under or on the bridge. The article deals with a fire of the high voltage electric line attached to the main girders of the approach footbridge to the Harbour Bridge over the Danube that damaged some parts of the structure. Detailed diagnostic survey confirmed that fire adversely affected the mechanical properties of the concrete in the girder's webs and in the top reinforced concrete slab of the last span. Because their effect on the structural behaviour of the girders was very difficult to assess, the re-opening of the footbridge was conditioned by the favourable results of the load test. Due to restricted access to the cars on the footbridge, the structure was loaded with a set of water tanks that were filled with water pumped from the Danube River. Comparison of the deformations obtained on a damaged girder and a reference girder confirmed by fire caused defects when vertical displacement was 17.5% greater than in the reference girder; how

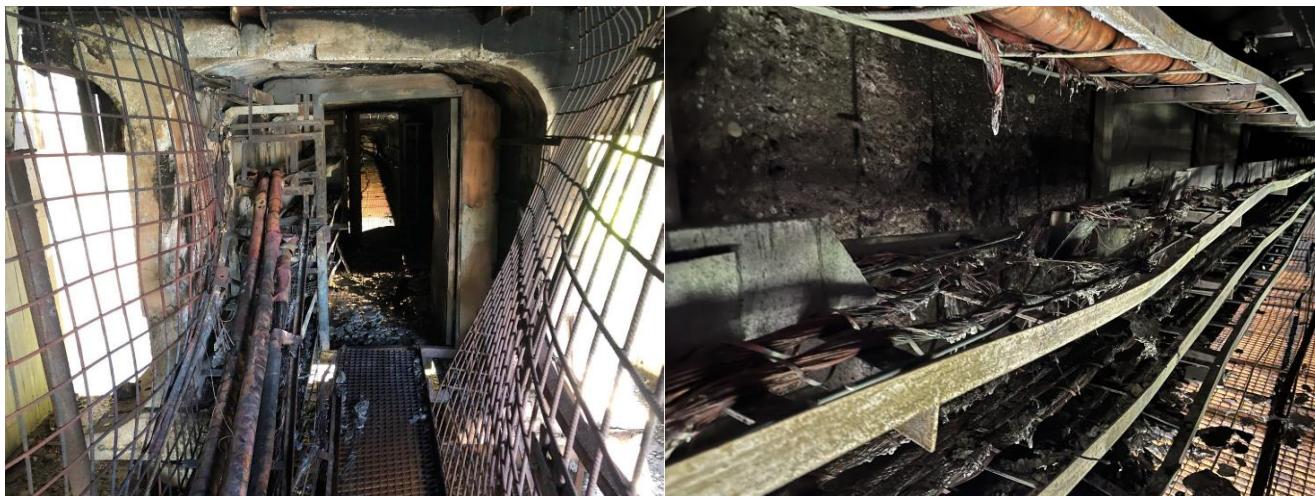
On April 21st 2022 at 10:30, set to fire high voltage electrical lines attached to the girders of the approach footbridge to the Harbour bridge in Bratislava. The electrical cable lines of 110 kV and 3x22 kV were placed inside the box cell of the footbridge structure, see Figure 1. The high temperature caused some structural damage to the structure, e.g. concrete spalling, changes in material properties of the concrete and probably in several inclined tendons passing through the girder's web.

Figure 1: View at the entrance to the chamber of the footbridge and inside the chamber after the fire of the electrical cables

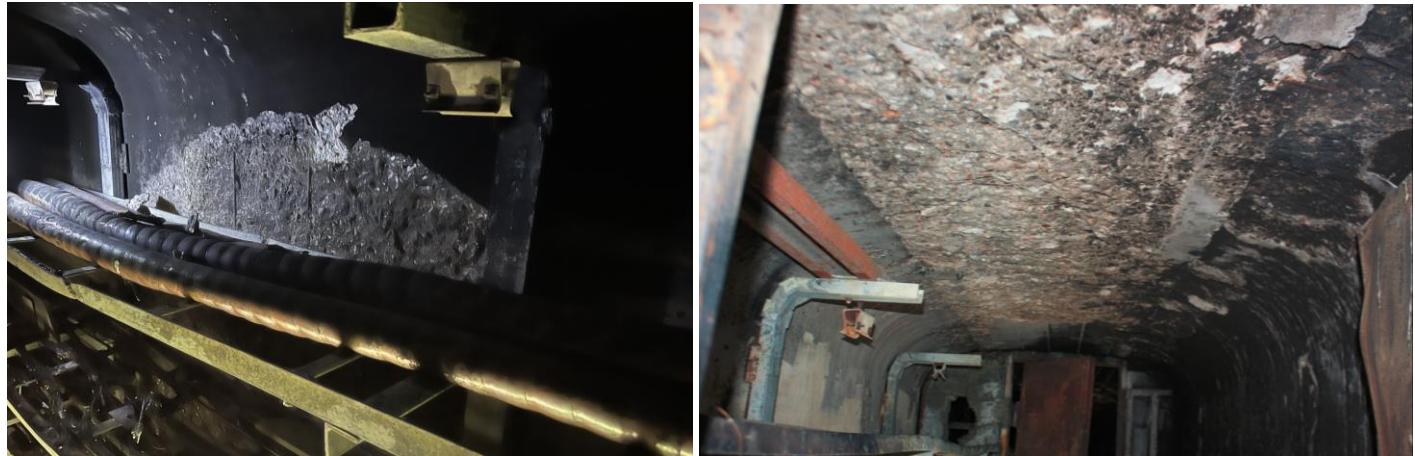
The highest heat of the fire was situated inside the box cell of the last span of the footbridge, approximately 5 m from the joint between the Harbour bridge and the footbridge, affecting steel elements of the Harbour bridge footway, the expansion joint, bearings and concrete elements of the footbridge. The fire caused concrete spalling on the inside surface of the girder's webs and top flanges, see Figure 4 and black discolouration from soot along the whole last span and half of the neighbouring spans. The greatest damages were recorded on the top RC slab with falling chunks of concrete and a spalling concrete cover layer, which let uncovered some reinforcing bars.

Figure 4: Spalling of the concrete inside footbridge box cell web on the left, RC slab right

The extent of the damage to the most severely attacked concrete surface of the web reached a depth of up to 30 mm. Despite this, the inclined ducts were not uncovered and remain in a 35 mm-thick dense concrete layer. We expect that several inclined tendons could be affected by the fire. However, no signs of shear cracks were found. In the case of the bottom flange, where most of the tendons are concentrated, the thickness of the concrete sparse layer was up to 2 mm. Therefore, we did not expect serious problems with the safety and durability of the structure, only a decrease in stiffness. To confirm our assumption, a load test was proposed to the municipal transportation authority.

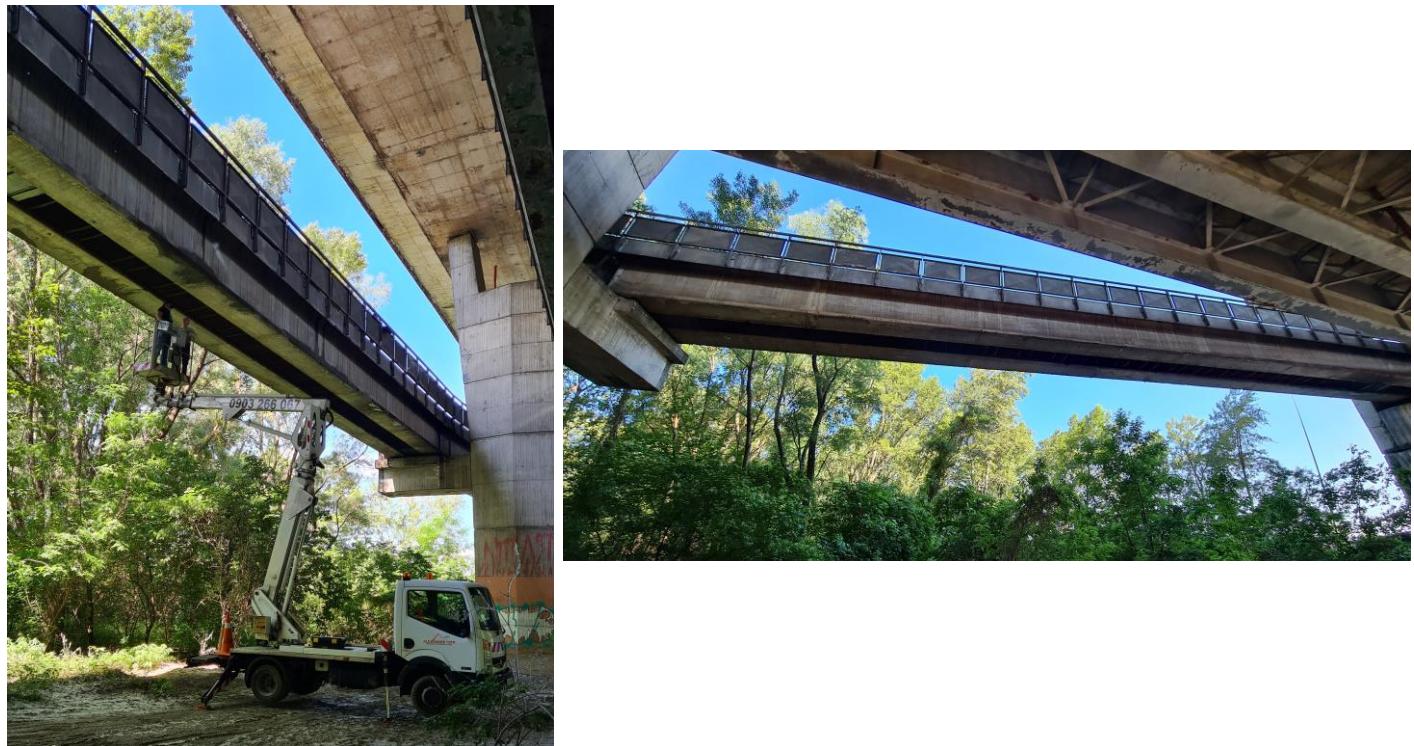
The measured deflections f_{mes} were always lower compared to the predicted values f_{pred} . However, the ratio $f_{\text{mes}}/f_{\text{pred}}$ was quite different for the damaged and reference span. The reference span was stiffer than the girder's FEM model by 24.6 % and 26.7% respectively while the damaged span was also stiffer, but only by 11% and 15.5%. It means that the deflections due to testing load in the damaged span were higher by 17.5% and 15.3% in comparison with the reference span. This indicates adverse effect of the fire on the structural behaviour of the damaged beams. Together with span loading, a detailed inspection of the girder's bottom flanges and webs was carried out at maximum testing load, see Figure 8. Both joints that are located only one meter from the centre of the span, and the web surfaces were visually checked for possible joint opening or cracking. No sign of the joint opening or cracking was recorded.

Figure 8: Photo of the damaged span during and after inspection

Non-destructive measurement of concrete strengths confirmed an adverse effect of the fire on the concrete properties. Particularly, in the parts that were directly exposed to the fire. Also, load test confirmed some impact of the fire on the structural behaviour of damaged girders when the ratio of measured and predicted deflections was higher by 17.5% at mid span section compared to the reference girders. However, the ratio $f_{\text{mes}}/f_{\text{pred}}$ obtained for the damaged span was still lower than one when even the footway surfacing was counted to the flexural stiffness of the structure. Detailed visual inspection under maximum testing load has not revealed any joint opening or cracking in the area of maximum bending and in the areas with the greatest impact of the fire on the structure (webs). Based on these results, it was recommended to reopen the footbridge to the public in June 2022.
