# Monitoring of Crack Flank Movement in a Steel Orthotropic Deck

Rudolf ÁROCH<sup>1,\*</sup>, Tomáš KLAS<sup>1</sup>, Ján BRODNIANSKY<sup>1</sup>

<sup>1</sup> Department of Steel and Timber Structures, Faculty of Civil Engineering, Slovak University of Technology, Radlinského 11, Bratislava, Slovakia.

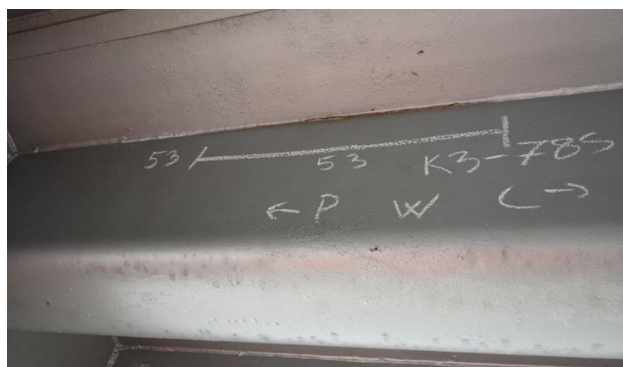
**Figure 2:** Crack in the weld between the longitudinal stiffener and the deck plate

The longitudinal stiffener is connected to the deck plate by single-sided fillet welds with a leg length of 5 mm. From today's standpoint, this weld is undersized. The stiffener plate edge is not parallel to the deck plate, and the gap between the two plates frequently exceeds 0.5 mm. The fillet weld penetration is only up to 2 mm, producing a pronouncedly

asymmetrical profile. Cracks develop beneath the wheel paths of heavy vehicles (in stiffener 2, see **Chyba! Nenašiel sa žiaden zdroj odkazov.**) and appear at random locations along the stiffener span.

Conventional repair practices involve removing the damaged welds and replacing them with new ones, often accompanied by a change in weld type (for example, replacing fillet welds with butt welds).

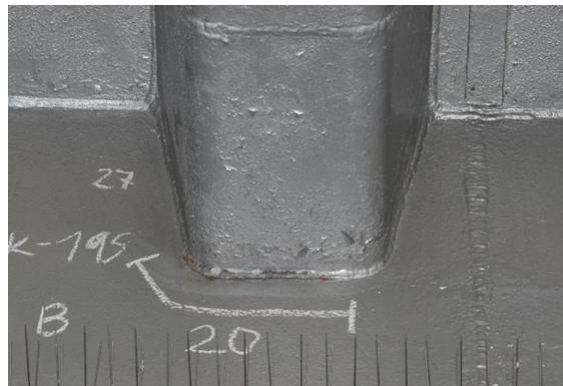
**Figure 3:** Crack in the weld between the longitudinal stiffener and the crossbeam

Throughout the bridge, longitudinal stiffeners are discontinuous at the crossbeam locations, where the crossbeam web interrupts the stiffeners. The stiffeners are welded directly to the crossbeam web using half-V butt welds reinforced by fillet welds. Significant misalignment between stiffeners on opposite sides of the crossbeam web is common, in some cases reaching several centimetres – well beyond the  $\pm 2$  mm tolerance required by current standards. Cracks typically initiate at the rounded ends of the stiffeners and propagate through either the flange or web welds.

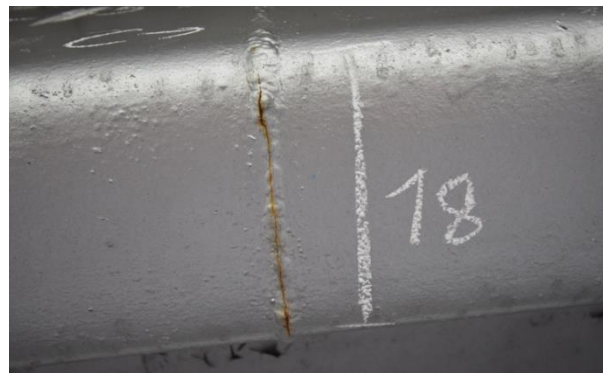
**Figure 4:** Crack in the weld at the longitudinal stiffener splice

The longitudinal stiffener splice is formed with a butt weld on a permanent root backing strip. Its location is suboptimal, placed at midspan – where bending moments are greatest – rather than at a point of zero moment. Misalignment frequently exceeds 1.0 mm. The specified gap between weld preparation edges, 3.0 mm, is significantly below the recommended range of 8-12 mm (FprCEN/TS 1993-1-901:2025). When the gap is less than 4 mm, the detail category decreases from 100 to 36 (FprEN 1993-1-9:2024). In addition, the tack welds of the backing strip are intermittent fillet welds placed outside the butt weld profile rather than within the butt joint itself (FprCEN/TS 1993-1-901:2025).

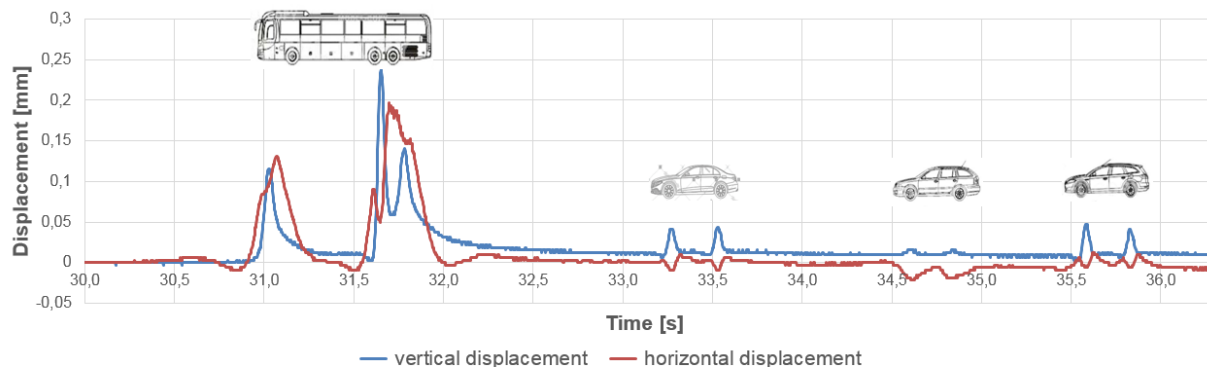
**Figure 6:** Measured displacement of crack flanks - Case 1, Scenario 1

The maximum vertical relative movement was 0.241 mm (bus) versus 0.047 mm (cars), indicating that passenger cars generated approximately five times less vertical movement. The maximum horizontal relative movement was 0.194 mm (bus) versus 0.022 mm (cars), with cars producing about nine times less horizontal displacement. Traffic in the inner lane had negligible effect on this crack, located in the cantilever portion of the orthotropic deck.

In cases where cracks extended over the full stiffener span (~3 m), the highest measured displacements were unexpectedly located at the quarter span rather than at midspan, in some cases up to ten times greater than expected. This suggests partial restraint of the crack flanks, which is likely to be released during repair grinding, potentially increasing crack flank movement significantly.

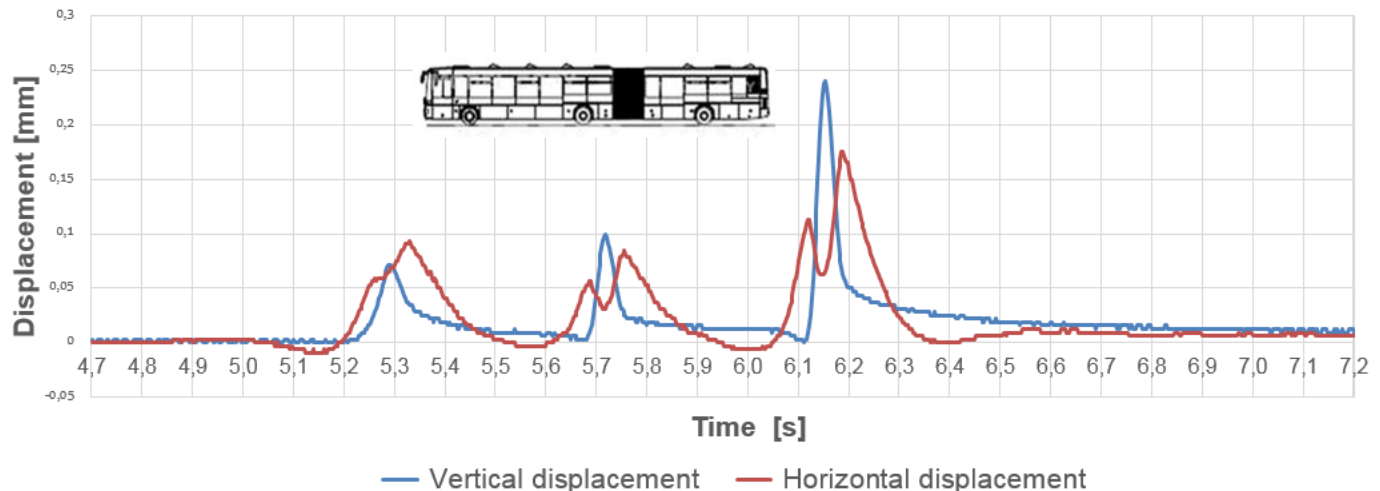
**Figure 8:** Measured displacement of crack flanks - Case 1, Scenario 2

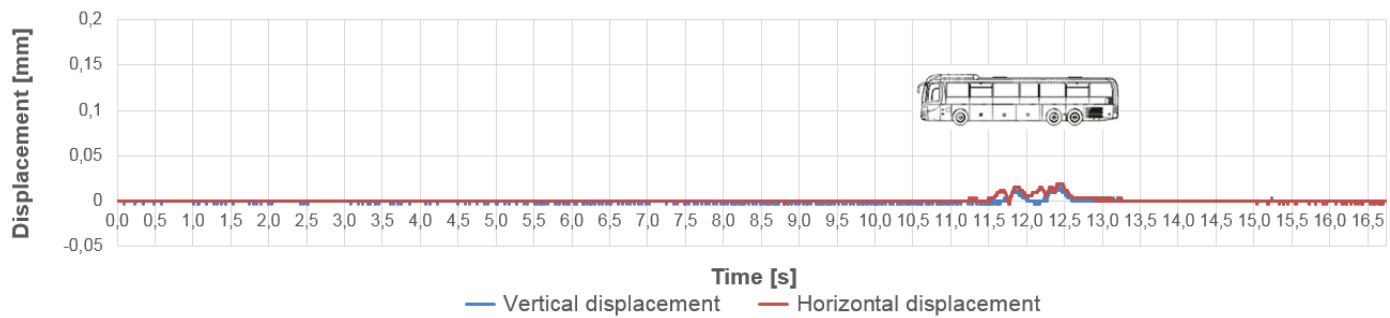
**Figure 9:** Measured displacement of crack flanks - Case 2, Scenario 3

The maximum measured relative movement (0.016 mm vertical, 0.019 mm horizontal) was approximately one-tenth of that observed in Case 1. This lower displacement is attributed to the shorter crack length (19 cm). Passenger cars produced negligible displacement, and inner-lane traffic had no significant influence on this cantilever-located crack.

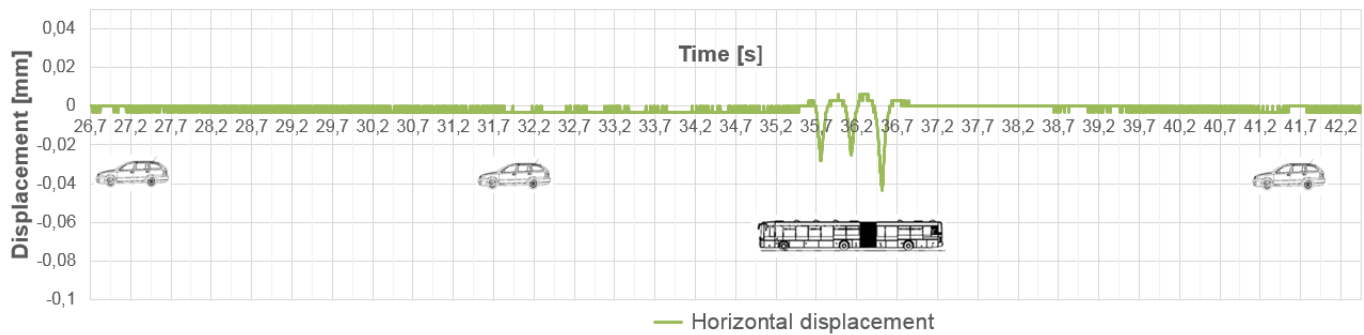
**Figure 11:** Measured displacement of crack flanks - Case 3, Scenario 4

The maximum horizontal relative displacement was 0.044 mm (bus), with passenger cars producing negligible movement. Inner-lane traffic again had no measurable influence on this crack, located in the cantilever portion of the deck.
