## APPLICATION OF SELECTED METHODS IN PROCESS IMPROVEMENT

DOI: 10.2478/czoto-2024-0047

**Keywords:** CSC belts; complaints; 8D report; improvement; action plan

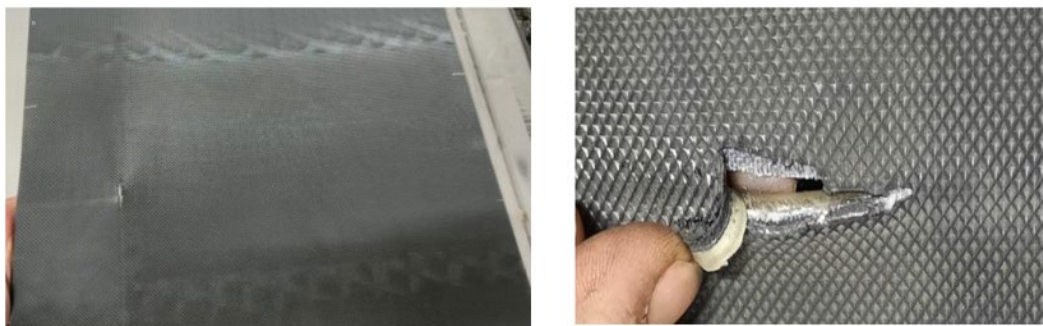
The subject of this paper is the identification and correction of a problem that first appeared in the organization in March 2022, and that was damaged sorting belts (Fig. 2).

Fig. 2. Visible crack at the joint and complete loosening of the joint tooth at the point of profile welding (Binčík, 2022)

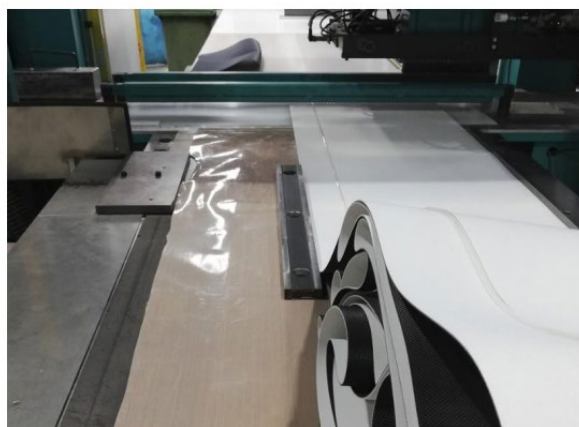
Initially, the workplace produced 80 strips per shift (Fig. 3). After applying the changes, the output increased to 250 pieces per shift. One of the significant changes to the equipment was to rotate the material when chopping with the polyester side with the rolled profile facing downwards, due to the reduction of the coefficient of friction and improved handling (Fig. 4).

Fig. 3. The original placement of the material when cutting out the joints before the changes were introduced (Binčík, 2022)

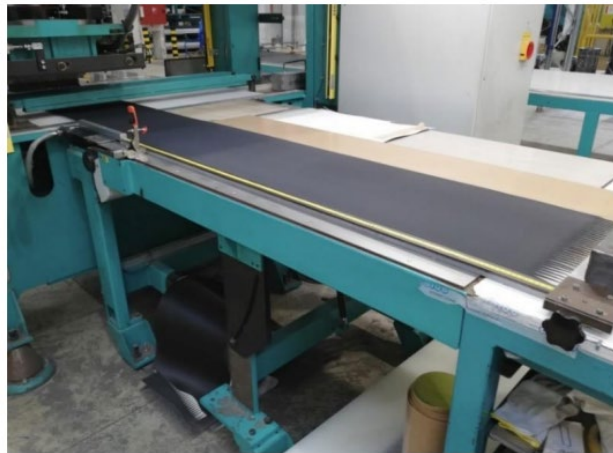
Fig. 4. New placement of material when cutting out joints after the introduced changes (Binčík, 2022)

The change in the die-cutting side of the joint introduced in 2020 has been identified as one of the most significant causes affecting the quality of the tooth joint design. The change in the manufacturing process had a significant impact on the efficiency and ergonomics of the work. The output increased from 80 pieces per shift to 250 pieces after the implemented change.

- The use of a non-slip material to ensure a lower coefficient of friction between the material and the table.
- Purchase and install an air system that would provide smooth and easy movement over the table surface and vacuum fixation of the web during the joint punching process. The company uses a similar system on the ZSG 3000.
- Installation of a conveyor belt made of S8-0 RTP A90 material, which includes replaceable and adaptable rollers in case of belt damage.

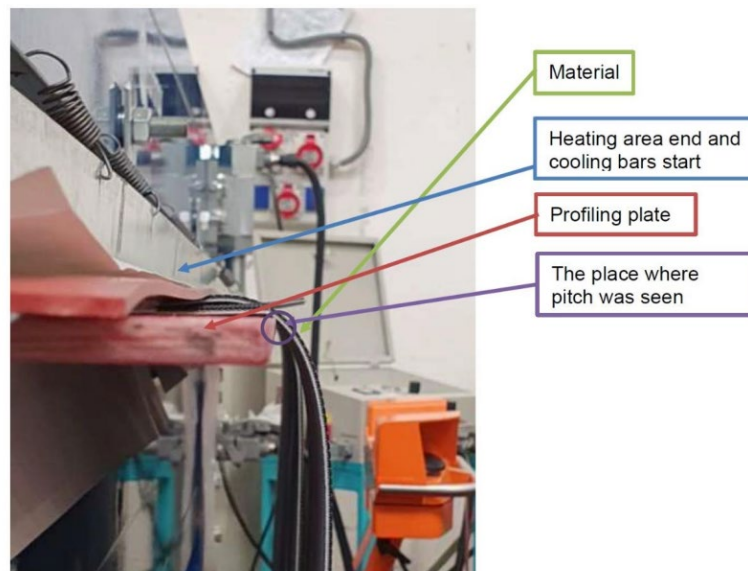
The change in the width of the press plates was implemented due to previous issues reported from a subcontractor in 2020. There were unevenness in the profile at the joint that was caused by the combination of temperature, pressure and narrow press plates during the pressing operation. This defect did not appear when wider press plates were used. In Fig. 5, we can see the deposition of the material in the press. The original pressing platen width was 300 mm, the new pressing platen is 400 mm wide.

Fig. 5. Placing the material in the press (Binčík, 2022)

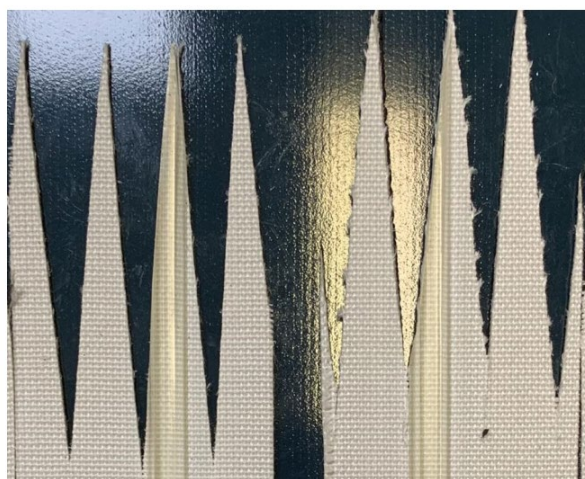
In the process of analysis, it was found that the joint did not lie flat under the punching head when the teeth were punched out. The material was tilted at the point of the profile welding. During the internal analysis at the Forbo Malacky plant, differences were observed in the quality of the cut on the material punched with the profile part upwards and the standard placement of the material. When the joint was punched in the standard way, one tooth curved regularly in the same place. It was assumed that the PU material from the profile would flow through the gap in the tooth tip into the top PVC layer. In this case, the PU material was intended to act as a separator between the layers. After a period of use, abrasion of the PU material and the formation of a crack was expected to occur.

In Fig. 6, we can see a comparison of the quality of the joints after the profile side upwards and the profile side downwards were cut out. The chamfer can be seen on the tooth with the profile. The cut is not clean and when overlapping both sides of the joint, a minor unevenness could be seen at the profile welding point.

Fig. 6. Cutting out the teeth with the left side of the profile facing upwards. Right profile side downwards (Binčík, 2022)

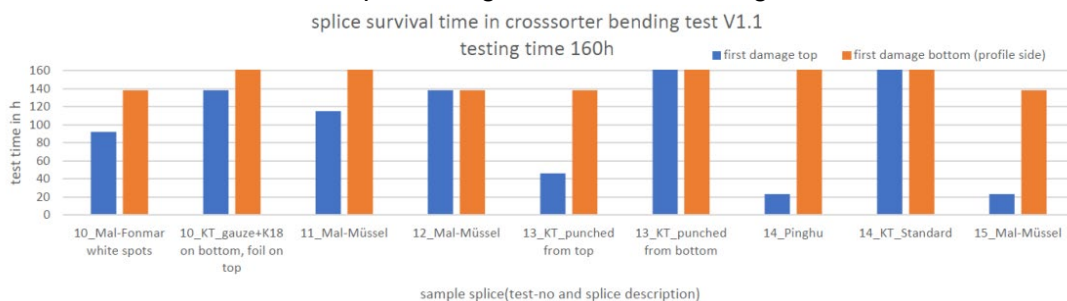
Fig. 8. Results of testing of individual samples at test stations (Binčík, 2022)

Only the specimen that was cut with the profile side up and the standard test specimen survived without damage.

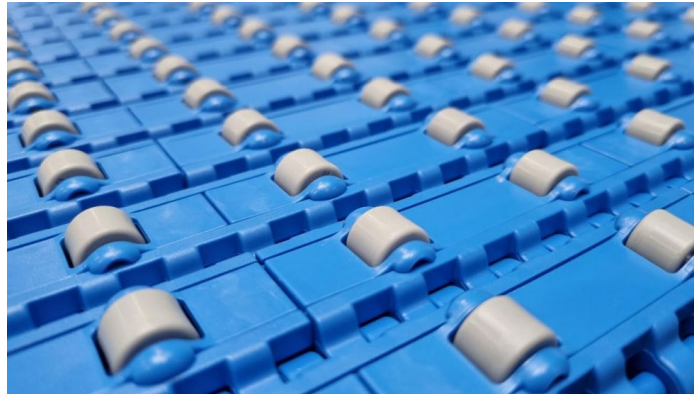
Fig. 9. Surface structure of modular conveyor belt S8-0 RTP A90 (Binčík, 2022)

In selecting the most appropriate alternative regarding the change in material position during the tooth extraction process, the team made decisions based on the speed of applying the changes and the purchase price. The use of materials with a low coefficient of surface friction was not successful. None of the material types tested achieved optimal handling results. The team decided to pursue the option of using a modular roller belt composed of S8-0 RTP A90 material, which is adaptable to the dimensions of the handling area (Fig. 9). The technical manager defined a test specimen on which the sliding properties were tested. The testing of the belt was evaluated as successful and the next

steps in the modular belt implementation process were taken. Firstly, an internal purchase order was created in which the dimensions and technical requirements for the belts were defined. Production of the belts was completed within 24 hours of the order being established. Upon completion, the belts were installed on the handling area of the Rodder & Piller facility. The cost of producing the belts was EUR 798,66.

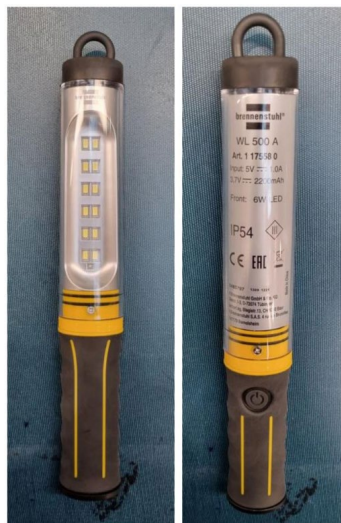
Fig. 10. LED work light Brennenstuhl WL 500 A (Binčík, 2022)

The change of the connection type could not be achieved as it was not agreed by the customer. From the customer's side, new tests would have had to be carried out in R&D and the approval process would have been unnecessary and lengthy, according to the team. As there had been no similar problems in the past with joints of the same type, the customer did not see the need for a technological change in the joint. However, the point is part of the action plan in case the problem with opening of the joints recurs. The last suggestion was the implementation of a joint inspection point using work lighting, due to the detection of non-conforming parts during the CSC belt inspection process. A Brennenstuhl WL 500 AAKU work light was purchased for the quality control department, along with protective masks, with a dark filter to prevent possible eye damage (Fig. 10).

The process engineer in collaboration with the quality manager integrated this step into the existing SOP and issued a new revision of the document. The checkpoint was also

added to the updated version of the checklist. Quality control personnel were trained on the safe use of the Brennenstuhl WL 500 A LED work light for inspection).

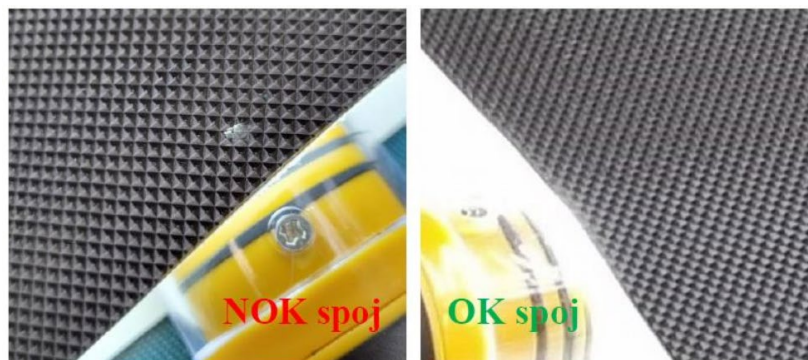
Fig. 11. The part of the SOP defining a link fault (Binčík, 2022)
