# Investigation of a steam pipeline leaking in a nuclear powerplant

*The article deals with the real defect, a crack that occurred on a part of the steam pipeline of the separator and the steam superheater of the turbo-generator in the V2 nuclear power plant (NPP) in Jaslovské Bohunice. The damage was caused by the mechanism of erosion-corrosion, which led to a reduction of the pipe wall with the critical thickness. The main cause of the failure was identified to be the usage of unsuitable steel, instead of the required steel EN 10028-2, during the reconstruction of the pipeline.*

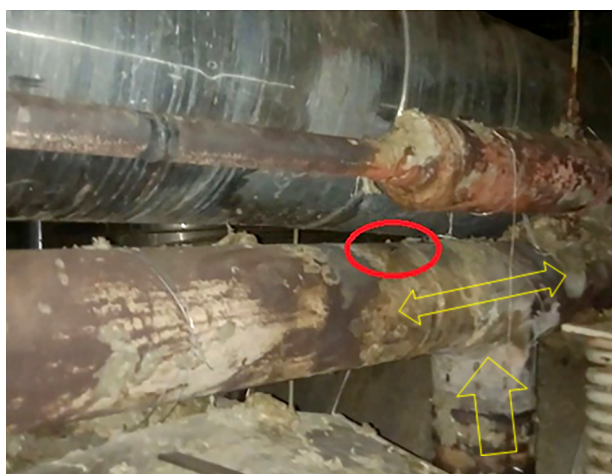
The corrosion and erosion stability of operating components is one of the most important presumptions for the long-term and safe operation of all nuclear facilities, and this also applies to steam pipelines. The article presents the results of the material properties evaluation and the chemical composition of the damaged part of the steam pipeline, where the leak was detected. The damaged pipe was originally a part of the T-piece marked as 56T (Figure 1, yellow arrows show steam flow in the pipes).

Fig. 1. Leaking on steam-pipe – red ellipse

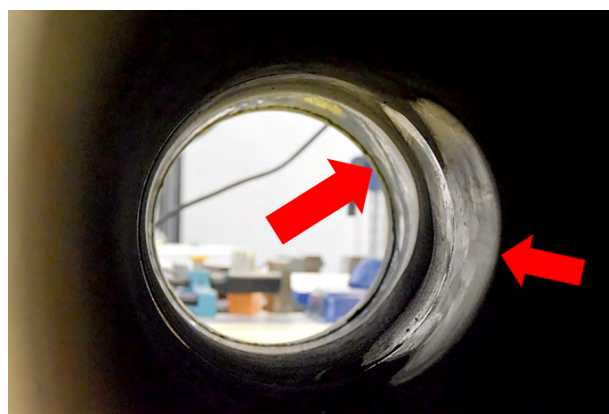
Fig. 2. Polished surfaces inside the pipe

Inside the pipes, the presence of visually polished surfaces were found on both analysed samples, as well as large areas with deposits. The polished surfaces are clearly visible in Figure 2. According to the distribution of the shiny surface, it can be concluded that these are the surfaces that were most affected by the steam stream after its dividing by passing through the component 56T. It was found that the greatest decrease in the thickness of the pipe's material wall occurred precisely in the area where polished surfaces occurred.

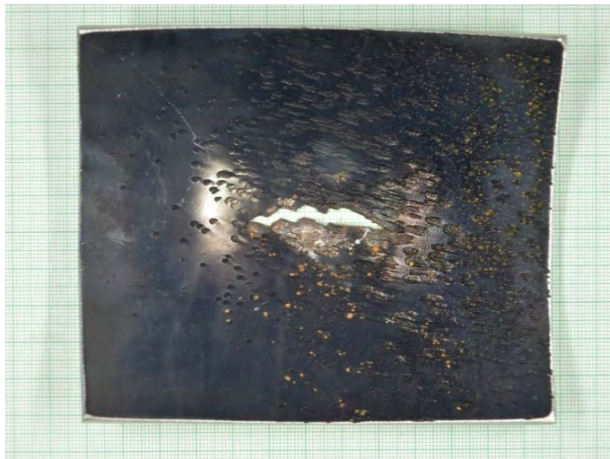
Fig. 3. Sample M2.1

- the measured length of the leak is approximately 41.8 mm;

- the material of the sample showed no signs of damage from the outer side;
- the pipe material was partly polished, and partly with traces of damage that appears with erosion corrosion from the inner side (Figure 3);
- the greatest loss of material occurred in this area.

As it is shown in Figure 3, particles remained trapped in some of the pits, which can escalate the disruption of the oxidation layer. Some could remain trapped there even after the pipeline was shut down, and subsequently a small layer of iron oxide formed around them (orange coloured areas).

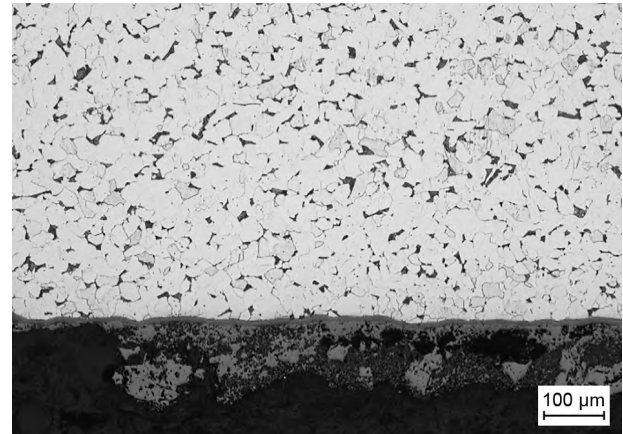
Fig. 5. A cut

In Figure 4 is shown the cut plan for the sample marked M2.3. The A cut was chosen at the border between the polished surface and the captured deposits. It is an area where the loss of the base material of the pipe was not so significant. This passing is very well visible in Figure 4. In the polished state, it is nice to see that the deposits have two layers in Figure 5. The first layer is probably formed with its own oxides from that area. It's because the layer is thin, homogeneous and of equable thickness. The second layer, which is significantly inhomogeneous and has a variable thickness, was probably gradually deposited on top of the original layer of oxides. In the case of the inhomogeneous layer of deposits, it can be said that these are released material oxides from the polished areas of that pipe together with other particles brought from other parts of the pipeline. This is supported by the findings in the C cut (Figure 6).

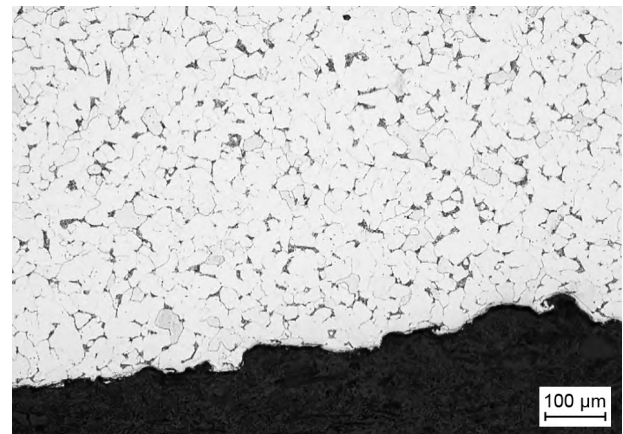
Fig. 6. C cut

This is the place the most affected by the loss of material on sample M2.3. As can be seen, erosion corrosion occurred in this exact spot. No layer of protective or other oxides is visible here. The deformation of the outer grains of the inner surface is visible. This deformation was caused by the impacts of particles or droplets contained in the steam.

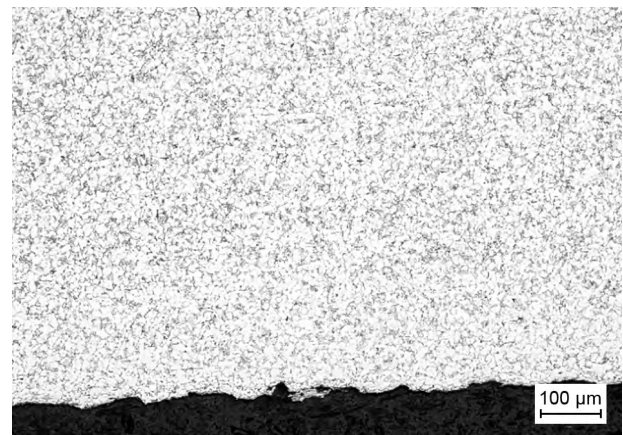
Fig. 7. D cut

The last metallographic evaluation of sample M2.3 was performed in the area of the D cut. It is a part of the sample, located right after checkpoint 56T. The border between the C and D cuts was located approximately in the middle of the weld (in the direction of steam flow), a rapid change in material loss is visible (Figure 4). In contrast, before the weld, there is a material with minimal change in its thickness. This part of the pipeline was chosen precisely to compare possible changes in the structure of the material. As can be seen from the figures, in Figure 7 the microstructure is significantly finer, together with a higher pearlite content, when compared to the microstructure captured in Figure 6 (or Figure 5).

However, it is fair to say that the surface in Figure 7 is like Figure 6 without visible protective oxides, and quite distinctly fractured. Similarly, deformations of

surface grains are not absent after the impact of small particles/droplets contained in the steam. Nevertheless, a significantly increased resistance of the used material was observed with this sample. This implies that D cut contains a more suitable material for a specific use, and it corresponds to the regulation and standard EN 10028-2.
