# Corrosion failure of stainless-steel in caustic soda lines

Bhupendra Gaur

Worley India Pvt. Ltd., Navi Mumbai, India

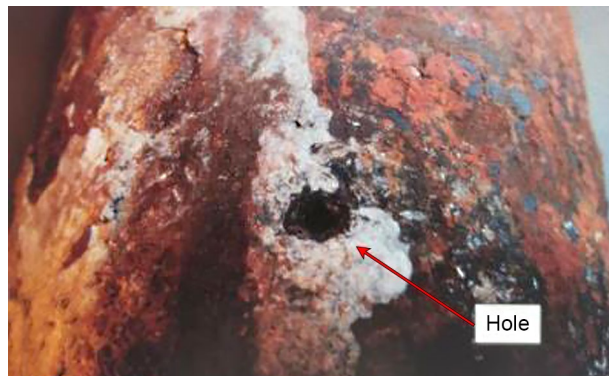
The photograph in Figure 1 shows the affected portion of 2" primary line after the removal of the insulation. It is clear from the picture that corrosion occurred at one location in the straight section of the line resulting in a big hole. The latter facilitated leakage of fluid during running plant and was primarily discovered through the salt accumulated over insulated line, at the affected location. For internal inspection, the damaged spool was longitudinally cut into two pieces (bifurcated). Consequently, the whole inner surface of the pipe was found to be suffered from general caustic corrosion to a measurable extent, including the hole bearing site as shown in the photograph (Fig. 2). In order to identify the

Fig. 1. Outer surface of the line with perforation and salt accumulated at leakage point

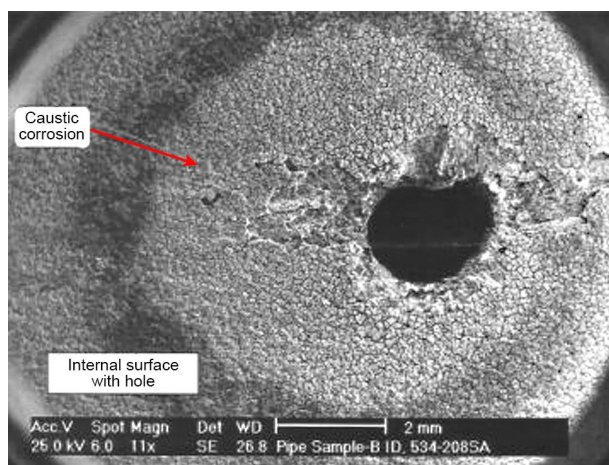
Fig. 2. Caustic corrosion throughout the inner surface of the line including the perforation site

in the inclusions) could have accelerated the corrosion at the inner dia of the pipe. Moreover, the temperature of fluid was also recorded to exceed by about 30 °C then the allowable operating limit which could also have contributed to the obtained high value of corrosion-rate (like many other cases) but only to a small extent (as per referred isocorrosion chart) as a significant increase in corrosion is expected around 100 °C temperature in 50% caustic solution. Still, some refereed literature [15] has indicated that there is a real possibility that type 300 series SS may undergo rapid general corrosion in hot 40% to 50% caustic than indicated in isocorrosion diagrams.

The safe limits indicated are 70 °C for 50% caustic and 80 °C for 40% solution. Thus, numerous inclusion defects in the parent material as well as periodic excursions in the process and operating condition of the fluid (than the permitted limits), could have jointly promoted the overall corrosion of the caustic line, with domination of the former aspect over the latter ones. For the leakage; however, poor workmanship adopted during plugging (by spot welding) of a hole in the pipe wall (attributed to a manufacturing defect) might be considered as the main culprit though metallurgy of the weld-electrode was noticed sound.

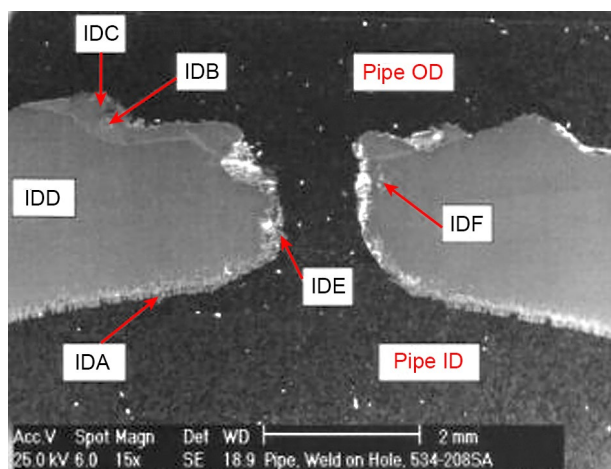
the pipe using spot welding. However, this plug weld is found at and adjacent to the outer dia of the pipe only, without through thickness penetration (up to the inner dia), thereby leaving a cavity at the inner pipe surface. The same defect could also have become a hot spot for fast propagation of the localized corrosion (and complete wall perforation) originated by the general caustic attack occurring at the whole pipe (inner diameter). Besides, the rate of general corrosion noticed in the present case is around 1 mpy which is also higher side of the values indicated in isocorrosion chart [14] for SS316 in caustic soda solutions. The measured depth of attack varies from 0.06 mm to about 0.1 mm at the inner diameter of the pipe. Thus, it became essential to find out the source of enhanced general corrosion as well, in the current material environment system. To start with, confirmation of the metallurgical integrity of the construction material, using a detailed micro-analytical characterization technique, was carried out on a pipe sample. Cross-sectional analysis of the corroded surface disclosed a number of inclusion defects in the body of bulk material as shown in a typical photograph (Fig. 4) containing oxygen, magnesium, aluminium, silicon, sulfur, calcium, etc. Here, one should note that the reaction of hydroxyl ions (the main ingredient of caustic soda) with aluminium, magnesium and silicon (present

Fig. 3. Microscopic analysis made at the cross section of the hole location revealing the existence of certain spot-weld at and near the outer surface

- Leakage in 2" primary line has occurred due to poor metallurgy of the construction material as well as improper practice used to repair a manufacturing defect (external plug-welding of a revealed pit/ pin-hole without full wall penetration, leaving a cavity at the inner dia. of pipe). The material contained numerous stringer-like bands of inclusions bearing elements of high reactivity to hydroxide (caustic soda). There may be a limited contribution of unfavourable service conditions (encountered periodically) also. To avoid current failure, complete piping should be replaced with a new one having no metallurgical- and manufacturing- defects. There is no need to upgrade the material of construction at this stage.

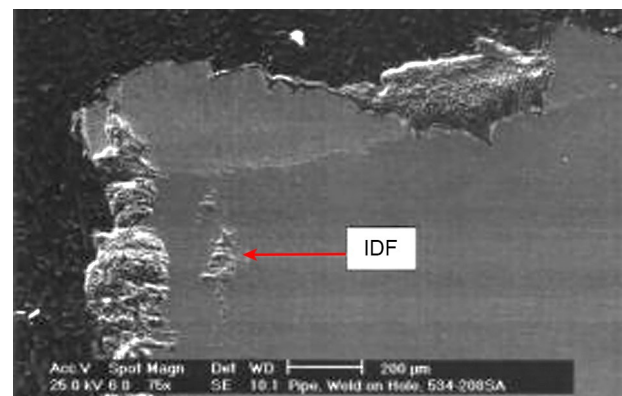
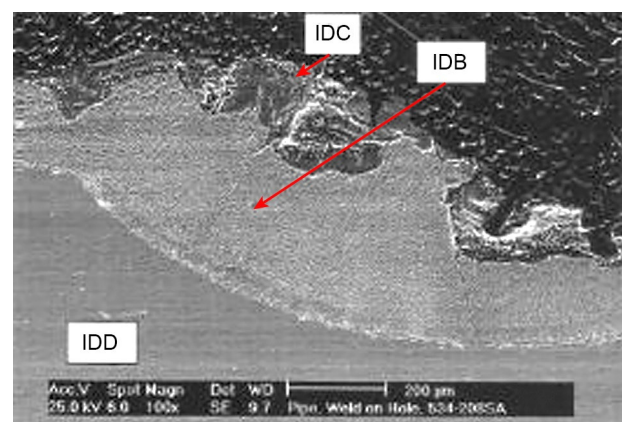
Fig. 4. Cross-sectional magnified view of the perforated location showing: a) inclusions in the body, b) spot weld at the outer surface

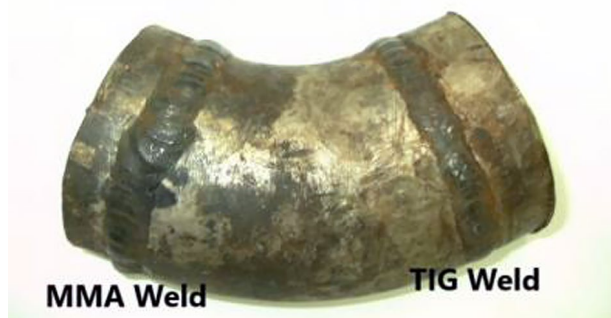
The picture of the damaged elbow is shown in Figure 5. In this case, leakage took place at one side weld of the elbow (made to join it with the upstream pipe) while the other one (downstream side weld) was found okay. On axial cutting of the elbow with the intent of internal inspection, the entire root of the affected (circumferential) weld was found to be eaten-away to a measurable extent, though the weld cap was noticed still intact (except wall perforated sites) as shown in Figures 6 and 7. Also, whole inner surface of the elbow is found

Fig. 5. Failed elbow showing poor welding at one side (left) weld joint

- Leakage of one side weld at 1.5" elbow is diagnosed to have taken place due to poor workmanship (including method, cleanliness and consumables) adopted during its welding with the adjacent pipes resulting in localized dissolution (corrosion) of the weld root. Other types of corrosion can be attributed to poor metallurgy of the construction material and intermittent excursions in process/ operating conditions. Besides, elbows are the area SCC prone components of piping due to the containment of bending stresses, in the normal course. To get rid of all these problems, the following precautions are recommended:

- a) *Ensure proper metallurgy of the elbow material.*
- b) *During a welding activity, approved weld procedure specification (WPS) shall be fully complied. Besides, special attention shall be given to using an appropriate weld consumable as well as avoiding any source of contamination.*
- c) *Process and operating conditions shall be closely monitored to avoid chemical and temperature excursions, as these may exponentially aggravate the corrosivity of fluid.*

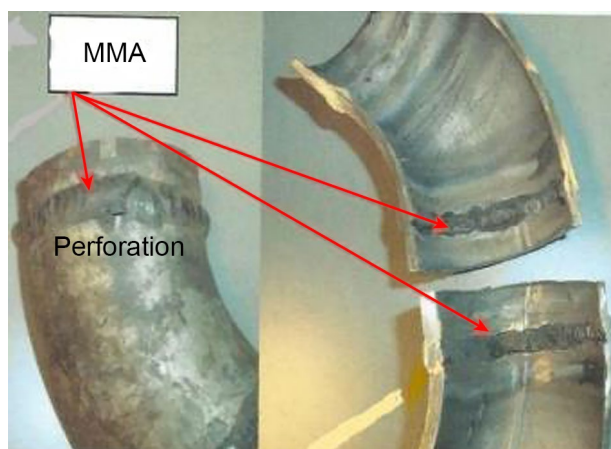
Fig. 6. Poor welding resulted in dissolution/corrosion of weld-root at one side (MMA) weld of the elbow

to be carried out in the shop, while MMA one at the site without proper precautions of contamination and control of weld processes. Further, chemical analysis of the damaged weld showed only 8% chromium and 5% nickel which are below the SS316 weldment requirement. This creates doubt on the use of proper weld consumables as it doesn't conform to the specifications of TIG or MMA weld electrodes for the subjected material. The low content of principal alloying elements could have reduced the overall corrosion resistance of weldment thus making it susceptible to general caustic corrosion. Also, the chemistry of weldment would have facilitated its anodic dissolution and cathodic protection of adjoining elbow and piping material. Besides, the area ratio of small anode to large cathode would have further accelerated the corrosion attack of the weld root than it would have naturally corroded in the caustic solution. Moreover, high carbon peaks were additionally noticed in the SEM (EDS) analysis of corroded weld which is a clear indication of the presence of certain carbonaceous material (such as grease) during the execution of the welding operation at the site. In short, poor workmanship adopted during welding work may be attributed to result in the failure of this weldment. In the case of sound weld; however, weldment composition conformed to the requirement of SS316 consumables (AWS 5.9 Class ER316). Here, it is worth clarifying that the chemical composition of parent (elbow) material also met the standard requirement of SS316 with respect to constituent elements. Now, some light will be thrown on the third mode of corrosion damage experienced by the elbow, i. e., the SCC. From cross sectional microscopy (shown in Fig. 8), it may be noticed that the cracks are dominantly of transgranular type, thus might be caused by caustic stress corrosion cracking (CSCC). Though chloride SCC (Cl-SCC) can also result in similar cracks, but chlorides contamination is not detected during caustic's chemical analysis. Besides, chloride cracks normally have the appearance of more branches and secondary cracks than those seen in the microphotographs of the affected section. Some of the literature [15] indicates that chlorides, a common contaminant in concentrated caustic, do not aggravate SCC and may even play an inhibitive role. Hence, the role of Cl-SCC may be eliminated in the occurrence of current cracking failure. Further, dissolved oxygen may also promote the degree of SCC in some cases but fluid in lines under the subject is mostly in a stagnant state with minimal turbulence. Besides, the solubility of oxygen will be questionable at prevailing temperatures and caustic concentrations. Thus, a possible contribution of oxygen in the initiation and propagation of SCC in the present case may also be ruled out. Now, certain impurities elements like aluminium and magnesium present in elbow material (found as inclusion in the elbow material) may react with caustic at the prevalent service conditions to form

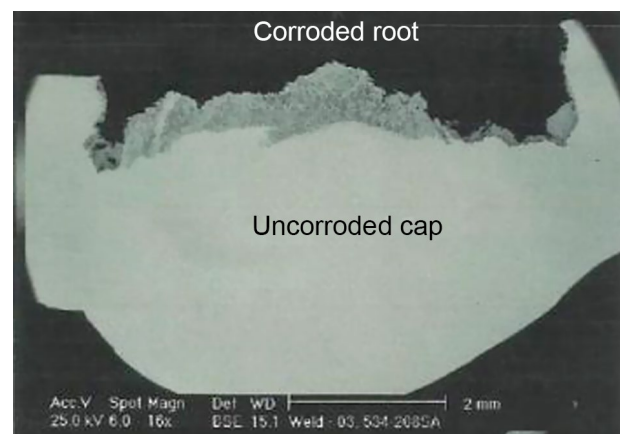
Fig. 7. Cross sectional microphotograph of the corroded weld route in case of one side (MMA) weld of the elbow

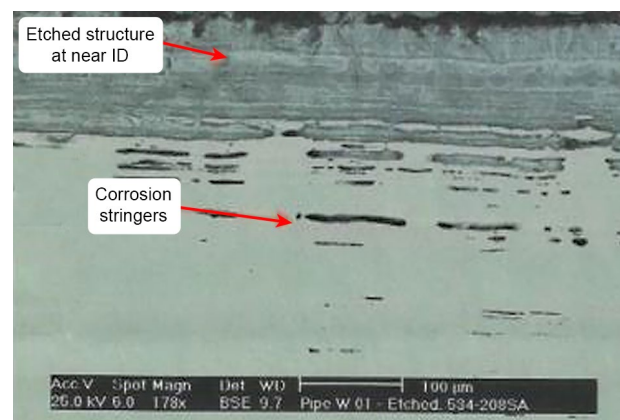
to be attacked by general caustic corrosion causing a loss of about 3% in wall-thickness (amounting to 0.09 mm) within a short period of about 3 years. Corrosion sectional microscopy of the affected (inner) thickness evidently revealed corrosion stringers scattered even into the depth of the metal wall, as shown in Figure 8. Moreover, stress corrosion cracking (SCC) is also noticed on the inner dia of the elbow (as well as attached pipes) as shown in Figures 9 and 10 with a crack-depth of about 1 mm. The cracks are noticed to be of transgranular type. The occurrence of SCC in the current material environment system has become a matter of serious concern. The intensity of cracking was most severe in high stress portion (bend) of the elbow. From Figure 9, it may further be noticed that a few long stringer-like corrosion zones cross the stress corrosion cracks. Forthcoming paragraph will deal with the probable causes of experienced corrosion damages as well as associated mechanisms, based on the results of different evaluations, analyses and characterization.

Fig. 8. Corrosion sectional microphotograph of the corroded surface and bulk material of elbow, showing corrosion stringers

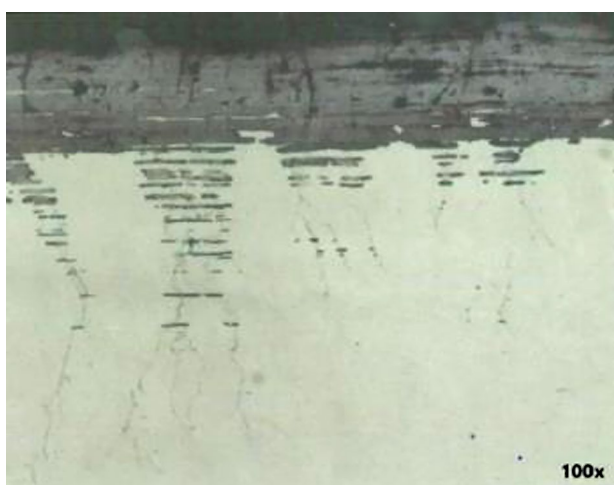
Fig. 9. Light glycidic etched structure revealing inclusion's dissolution at the crack-path interface. A few inclusion at cracks/inclusion-intersections were dissolved by hydroxyl ions

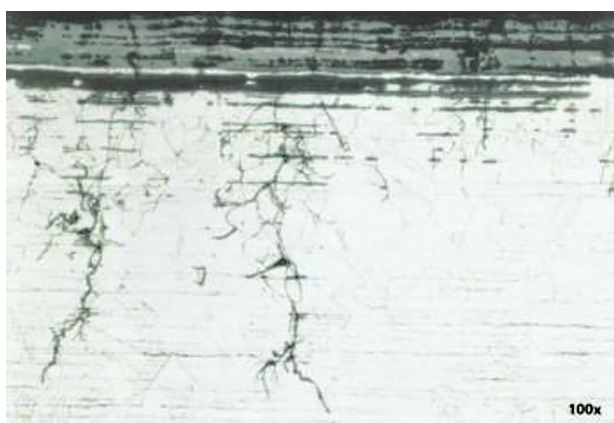
Fig. 10. Corrosion sectional microphotograph of the corroded surface and Stress corrosion cracking (dominantly transgranular- with a few intergranular cracks). About 1 mm deep cracks are noticed within 2 cm on both sides of the root weld (MMA) and originated at the ID of the elbow. General caustic corrosion is also evident on the inner surface as well as sub-surface metal

metal hydroxides and possibly generate some hydrogen gas. Thus, there is a remote possibility of intergranular corrosion cracks (noticed at a few locations) which might be a result of hydrogen embrittlement; however, SCC cracks are dominantly of transgranular nature. The best explanation for the long stringer-like corrosion zones that cross the stress corrosion cracks is the transport of hydroxyl ions down to crack and followed by their reaction with inclusion elements (Fig. 9). Finally, it may be concluded that observed SCC is dominantly a case of CSMC. Here, it is very important to note that SS316 is not prone to CSMC at the designed conditions and such damage is expected only above 100 °C (even above 120 °C as per certain industry's experiences). Hence, the cause of CSMC in the current scenario may be attributed to poor metallurgy of elbow material as well as periodic excursions in process/operating conditions.
