# The outdoor lighting of the Wawel Royal Castle and its contribution to the occurrence of light pollution

Faculty of Environmental Engineering and Energy,  
Cracow University of Technology

**Citation:** Łygan, J., Czaplicka, A. (2024). The outdoor lighting of the Wawel Royal Castle and its contribution to the occurrence of light pollution. *Technical Transactions*, e2024012. <https://doi.org/10.37705/TechTrans/e2024012>

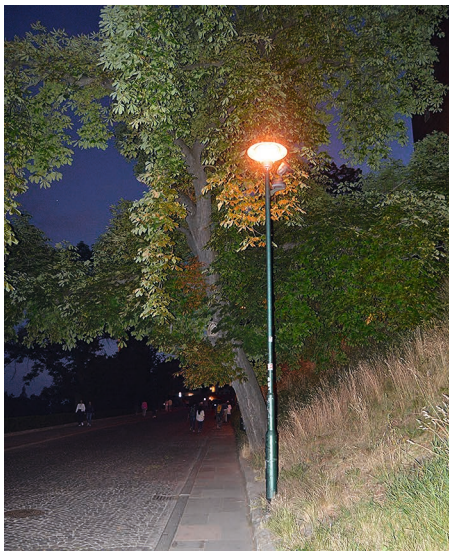
At first, the park lamps were taken into consideration. These are light sources located along routes leading to the area of Wawel Hill. They emit white light with a low correlated colour temperature and a wide spatial distribution (Fig. 2). Although lamps fulfil their role of illuminating the pavement, the light emitted is scattered. This phenomenon is intensified by the high pole height. What is more, lamps can cause glare due to the high light intensity. Therefore, the park lamps were classified as partially correct lighting.

**Fig. 2.** Example of a park lamp at night  
(by Jakub Łygan)

In order to improve their functioning, it is proposed to decrease the height of poles where light sources are mounted. It is also worth moving filament at a maximum height in a cover to reduce light scattering. In addition, it is suggested to use a reflector inside the cover to reflect light through the ground direction.

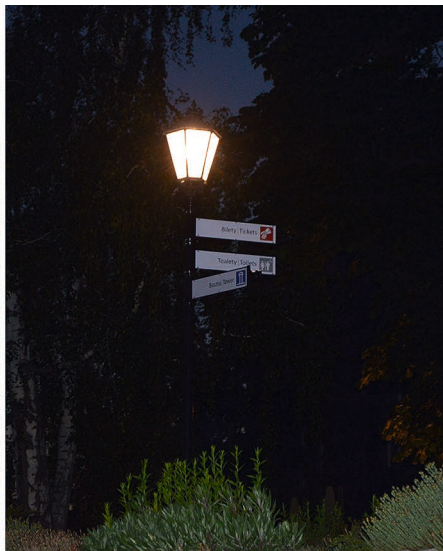
**Fig. 3.** Example of an old-fashioned lamp at night  
(by Jakub Łygan)

The old-fashioned lamps are another group being discussed. This kind of lamp appears in the area of Wawel Hill in a number of 4. They emit light with a bit lower correlated colour temperature than the park lamps (Fig. 3). Although the old-fashioned lamps are shielded from above, the filament in a luminaire is placed not high enough. This leads to light emission in all directions, including upwards. They were classified as partially correct lighting. Their performance may cause glare and make a small contribution to the formation of skyglow.

As in the case of the park lamps, it is proposed to move the filament to a maximum height in a cover to reduce light scattering and use a reflector inside the cover. Furthermore, an increase in correlated colour temperature and an increase in light intensity would reduce the occurrence of glare.

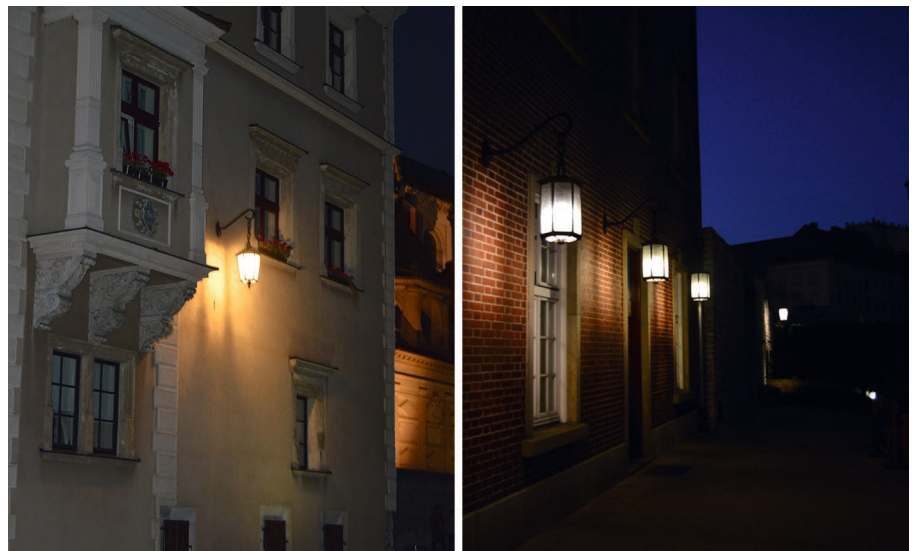
The façade lamps are present almost all over Wawel Hill. They emit light with a warm colour, which, as in the case of lamps discussed above, is scattered, and makes a contribution to the presence of light pollution. Some of the façade lamps illuminate the adjacent wall instead of the ground which makes them incorrect lighting (Fig. 4). It should be noted that lamps mounted on the walls of the conference centre have reflectors inside their cover (Fig. 5). These lamps and mounted along the way to the castle were classified as correct lighting. The remaining façade lamps due to the lack of reflectors were categorized as partially correct lighting.

**Fig. 4.** Façade lamp illuminating improperly  
(by Jakub Łygan)

**Fig. 5.** Façade lamps as the correct lighting  
(by Jakub Łygan)

Incorrect lighting should be removed or adjusted by decreasing its height above the ground to make it possible to illuminate traffic roads. For all other lamps, it is suggested to use reflectors like in these façade lamps mounted on the walls of the conference centre.

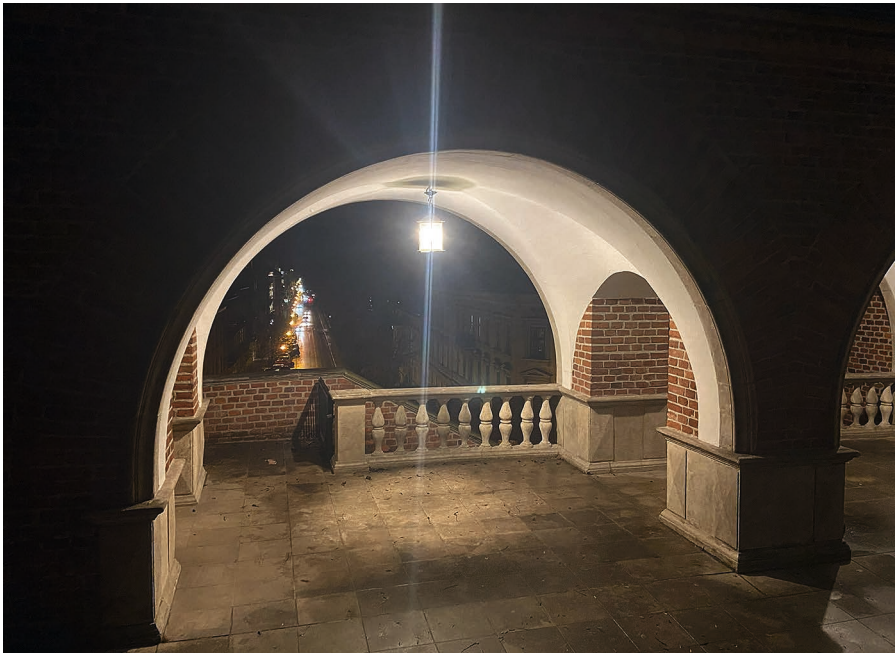
Suspended lamps are one of the smallest groups of light sources present in the area of the Wawel Royal Castle. There are two lamps that cause glare located close to Arms Gate and they are an example of incorrect lighting (Fig. 6). All the other suspended lamps were classified as correct lighting.

**Fig. 6.** Glare caused by suspended lamp  
(by Jakub Łygan)

To improve performance of incorrect lighting the cover should be changed to a semi-transparent one with a reflector inside.

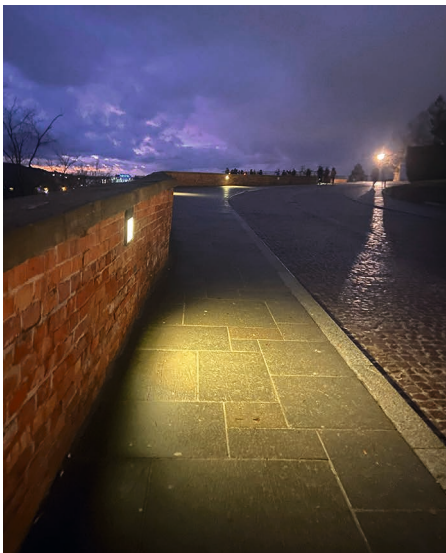
A further light source to be assessed are wall lights. They emit a beam of low-intensity light downwards at angle of approximately  $45^\circ$  (Fig. 7) and are designed to illuminate the pavement. These light sources do not influence the occurrence of light pollution.

**Fig. 7.** Example of wall light at night  
(by Jakub Łygan)

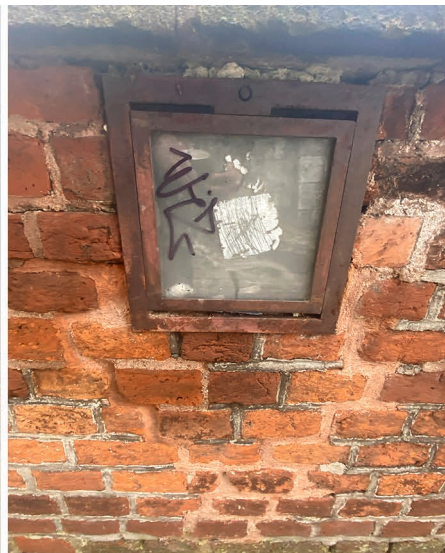
**Fig. 8.** Wall light excluded from use  
(by Jakub Łygan)

Wall lights mounted at the level of Cathedral Museum and Seminary are excluded from use. Lamps look neglected and it has not been possible to verify their working condition (Fig. 8). Due to their appearance, it is suggested to replace them with wall lights similar to these mounted in the other parts of the wall.

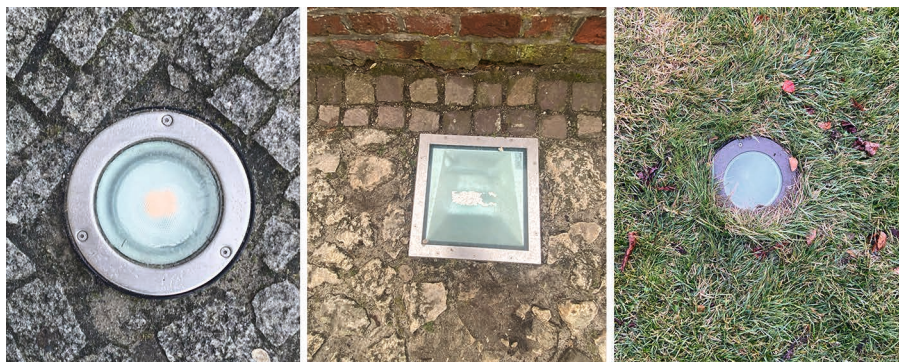
Lamps with circular luminaries placed nearby Arms Gate, Vasa Gate, Danish Tower, Thieves Tower and the Statue of John Paul II are examples of incorrect lighting (Fig. 12). The light beam is emitted at an angle of  $90^\circ$  to the ground, so it does not illuminate the targeted object. Thus, it results in intensification of the sky glow. Moreover, pavements lights cause glare and in bad weather condition they may be dangerous due to risk of slipping.

Pavement lights installed in the recesses of Hen's Foot are an example of correct lighting (Fig. 13). Due to the positioning of the lamps in the recesses, close enough to the walls, the light beam is limited by the arcades. Next to the Hen's Foot is the Danish Tower, where the lamps are installed in a similar way, but the light beams have no limited way out and increase the phenomenon of artificial sky glow.

**Fig. 12.** Pavement lights located next to the Vase Gate (by Jakub Łygan)

**Fig. 13.** Illumination of the Hen's foot  
(by Jakub Łygan)

It is suggested to remove all pavement light with the exception of lighting located in the recesses of Hen's foot. Where lighting is necessary, it is proposed to use lamps emitting light towards the object. The light emitted by the lamps should be directed from top to bottom, directly at the object, so as not to contribute light pollution.

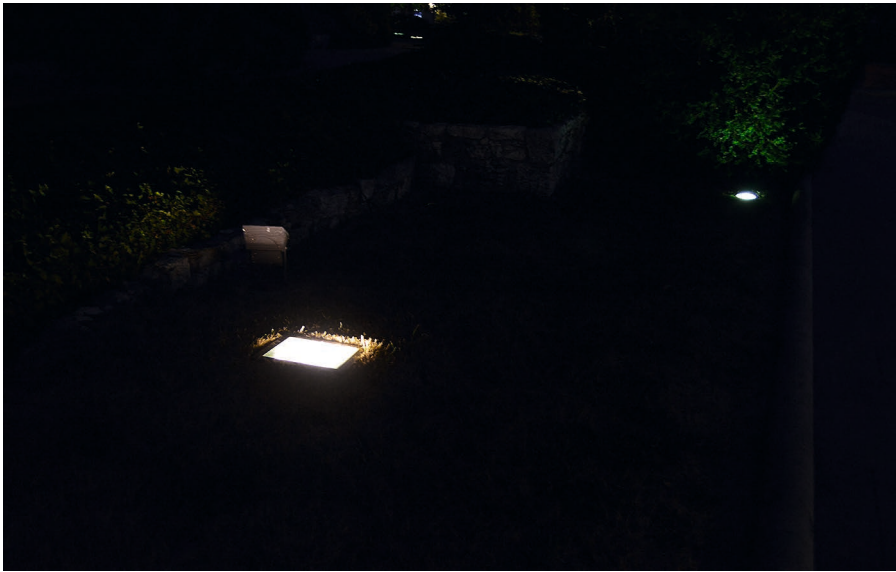
Both rectangular and circular pavement lights installed in the ground are example of incorrect outdoor lighting (Fig. 14). They inefficiently illuminate the space, wasting electricity and can contribute to the brightening of Cracow's night sky by directing light beams into the sky.

**Fig. 14.** Pavement lights installed in the pawn at night (by Jakub Łygan)

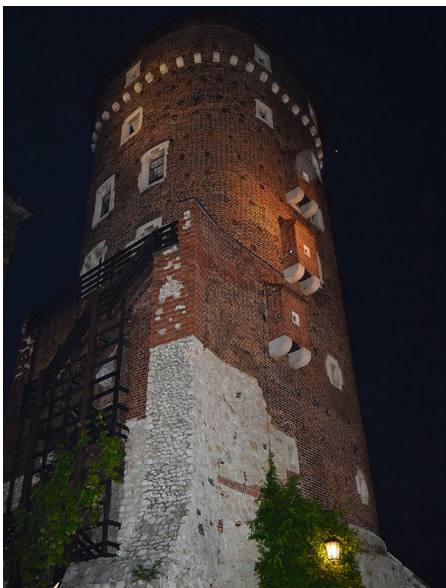
The first floodlights to be analysed are those used to illuminate the Sandomierz Tower (Fig. 15). In total, ten floodlights illuminate the tower, however three of them are out of use. One of the other floodlights illuminating the tower from its western wall is an example of an incorrect light source. It emits high-intensity light beam that is scattered and, apart from Sandomierz Tower, illuminates the conference centre and the road (Fig. 16). This results in formation of artificial sky glow and cause glare and trespassing. Remaining floodlights have been assessed as partially correct lighting. They can cause glare and their light colour temperature could be higher. For the same reason floodlights illuminating Thieves Tower from western and eastern side were classified as partially correct lighting (Fig. 17).

**Fig. 15.** Illumination of the Sandomierz Tower (by Jakub Łygan)

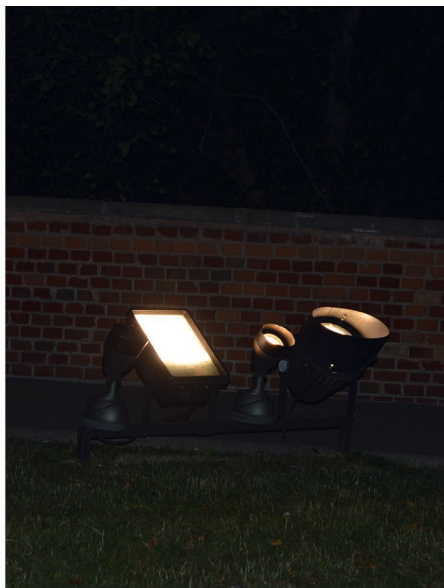
Floodlights used to illuminate the back wall of administration building do not contribute to formation sky glow, but their installation is incorrect (Fig. 18). Light sources are embedded in the wall too high or at too large angle, so that part of the light beam is reflected from the edge of the wall. Thus, it results in loss of energy.

**Fig. 18.** Incorrectly mounted floodlight  
(by Jakub Łygan)

To reduce the impact of floodlights on the formation of light pollution, these installed on the south-west part of Presbytery's should be removed. Then due to the clutter it is suggested to remove some of floodlights installed on the roof of the Royal Kitchens and on the lower terrace of Royal Garden. For light sources located in the wall of the upper terrace of Royal Gardens it is proposed to reduce the angle of the floodlights in relation to the ground. In addition, it is proposed to remove one of the floodlights illuminating the western wall of the Sandomierz Tower. Floodlights illuminating towers, facades should be fitted with cover panel, allowing the light emitted to be directed towards the object and limiting the emission of light above the horizontal plane. It is also suggested that the angle of the floodlights, which illuminate the back wall of the administration building, should be reduced in relation to the ground. It can be also possible to change their reposition by bringing them forward so that the light emitted is not reflected off the top edge of the wall.

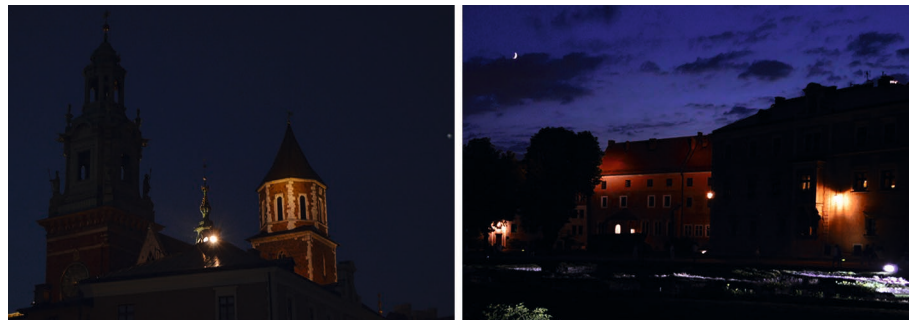
The Senator Tower is illuminated by three floodlights. Its western wall is illuminated by floodlight 65 metres away, which is incorrect light source (Fig. 26). Shaft of light is directed into the area between the edge of the roof and walls, so that the roof is also illuminated. This may result in the phenomenon of brightening night sky, by emission of light into the environment (Fig. 27). Eastern wall is illuminated by two floodlights 10 metres away. Due to the excessive presence of other light sources they were classified as partially correct lighting. Next to them there is a set of three floodlights illuminating the south wall of the Royal Palace which are an example of incorrect light sources (Fig. 28). The light beam emitted by them is sent out at an incorrect angle, which results in its emission into a space, contributing the formation of night sky glow.

**Fig. 26.** Light beam emitted by headlight directed into Senator Tower (by Jakub Łygan)

**Fig. 27.** Illumination of Senator Tower (by Jakub Łygan)

**Fig. 28.** Illumination of southern façade of the Royal Palace (by Jakub Łygan)

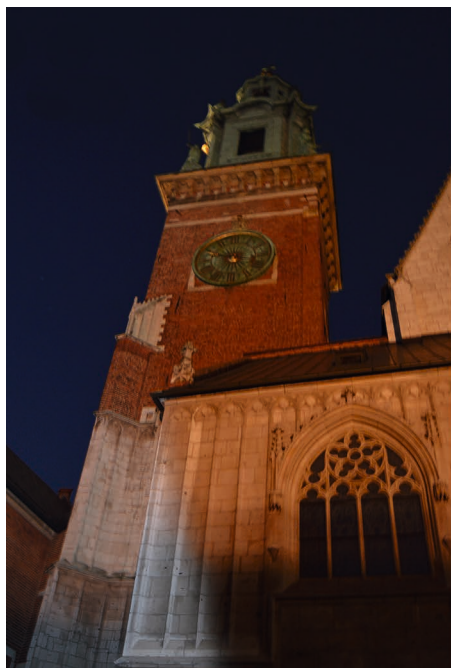
Floodlights illuminating the Clock Tower and façade of the cathedral were assessed as partially correct light sources. The beam of light is directed at the boundary between the dome and the tower walls. The floodlights are mounted high enough that the risk of flare to pedestrians is negligible. The intensity of the light emitted is not high, but the colour seems too cold. Whereas, floodlights illuminating the Silver Bell Tower were classified as incorrect lighting. Light beam is directed at the roof of the tower, which results in emission of light into space and consequently formation of artificial sky glow.

**Fig. 21.** Illumination of the Clock Tower  
(by Jakub Łygan)

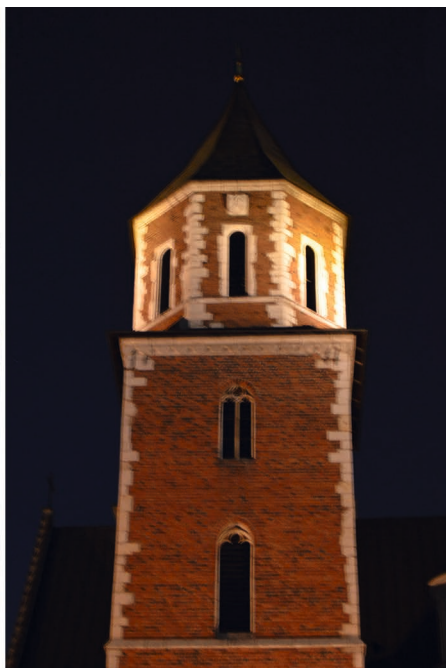
On the roof of the Royal Kitchens nine floodlights are installed, which are responsible for illuminating the south façade of the cathedral and the Silver Bell Tower (Fig. 23). The light emitted by these floodlights directed towards the façade is characterized by low intensity and white colour. Meanwhile, the two floodlights illuminating the Silver Bell Tower are similar to the others illuminating this tower (Fig. 24). Thus, they were assessed as incorrect light sources, while the remaining, due to clutter phenomena, were classified as partially correct light sources.

**Fig. 22.** Illumination of the Silver Bell Tower  
(by Jakub Łygan)

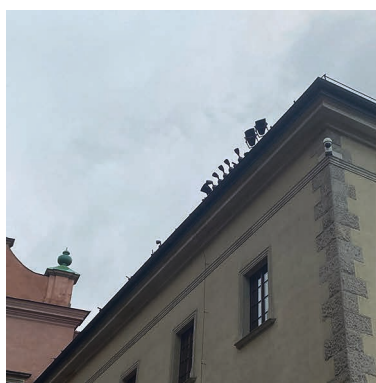
**Fig. 23.** Example of clutter phenomenon  
(by Jakub Łygan)

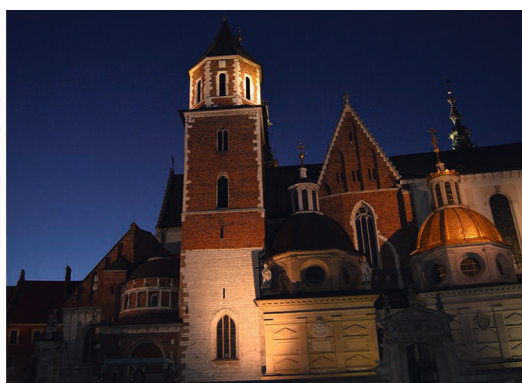
**Fig. 24.** Illumination of the Silver Bell Tower  
and façade of cathedral (by Jakub Łygan)

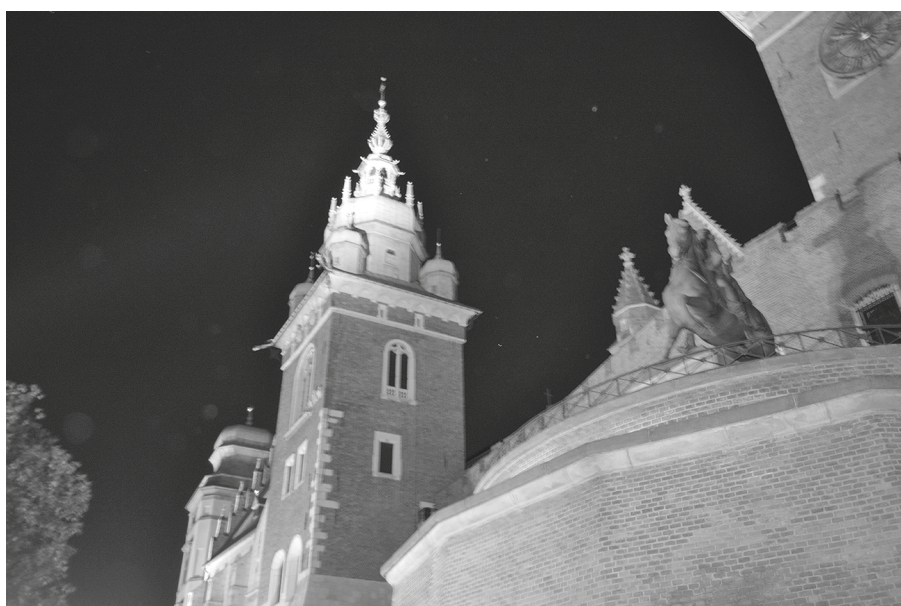
**Fig. 25.** Illumination the Sigismund Tower  
and Kosciuszko monument (by Jakub Łygan)

Light sources are used to illuminate the Kosciuszko monument, the Sigismund Tower and the Clock Tower (Fig. 25). A part of the light beam directed at the Sigismund Tower is emitted above the horizontal plane. This light is characterised by its high intensity and cool colour. The same applies to the beam of light directed at the Clock Tower. In the case of the Kosciuszko monument, the beam of light directed towards it also illuminates the buildings behind.

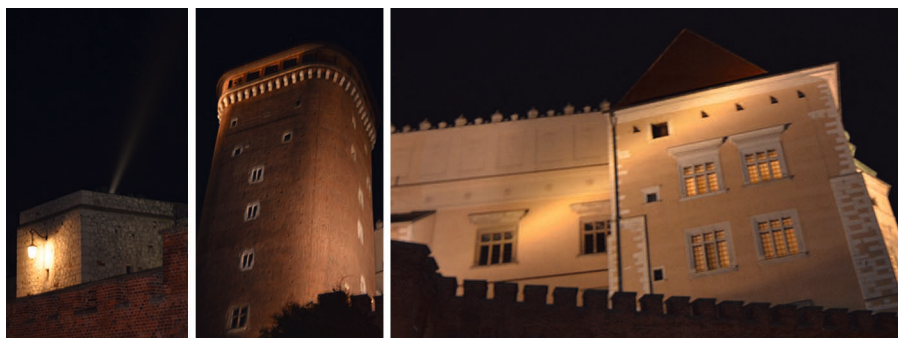
The eastern facade of the Royal Castle, including the towers there, is illuminated by 27 floodlights in total. Floodlights located in the wall of the upper terrace of Royal Gardens were identified as partially correct lighting (Fig. 29). They emit white light with a high colour temperature, which is directed at façade at an angle that prevents the light from emitting into half-space. However, some of emitted light falls on the plants in the Garden. Floodlights standing along the wall in the lower terrace of the Royal Garden are incorrect light sources (Fig. 30). Due to their excess, they cause a clutter phenomenon.

**Fig. 29.** Example of lighting located in the upper terrace of Royal Gardens (by Jakub Łygan)

**Fig. 30.** Example of glare caused by headlights located in the lower terrace of Royal Gardens (by Jakub Łygan)

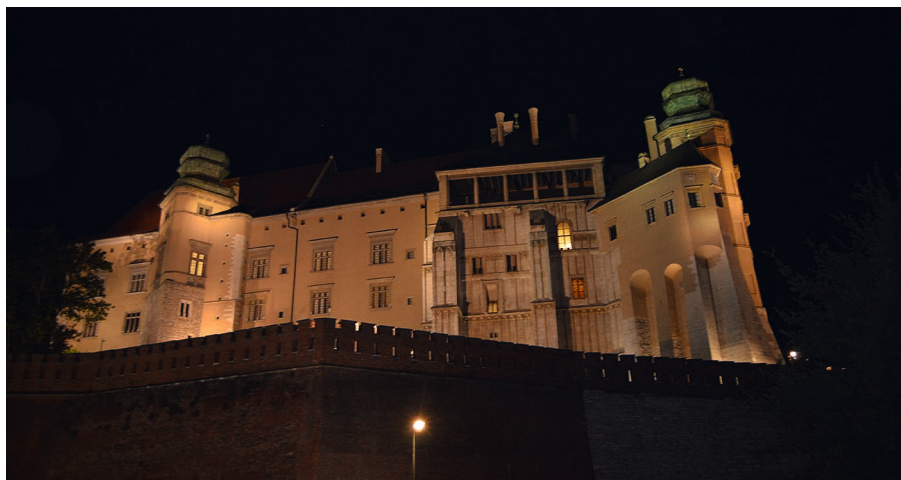
They emit white light characterised by high intensity, which can cause a glare effect. Part of the light is directed to the roof of the Royal Palace and on the domes of the towers, unintentionally illuminating the chimneys (Fig. 31). This means that light is emitted above the horizontal plane, increasing the brightness of night skyglow. Some of the emitted light also falls on the plants. Two floodlights located in the south-east corner of the wall were identified as incorrect light sources. Due to their incorrect mounting and the angle of the emitted light, the beam is not properly directed.

**Fig. 31.** Illumination of the eastern façade of the Royal Wawel Castle (by Jakub Łygan)

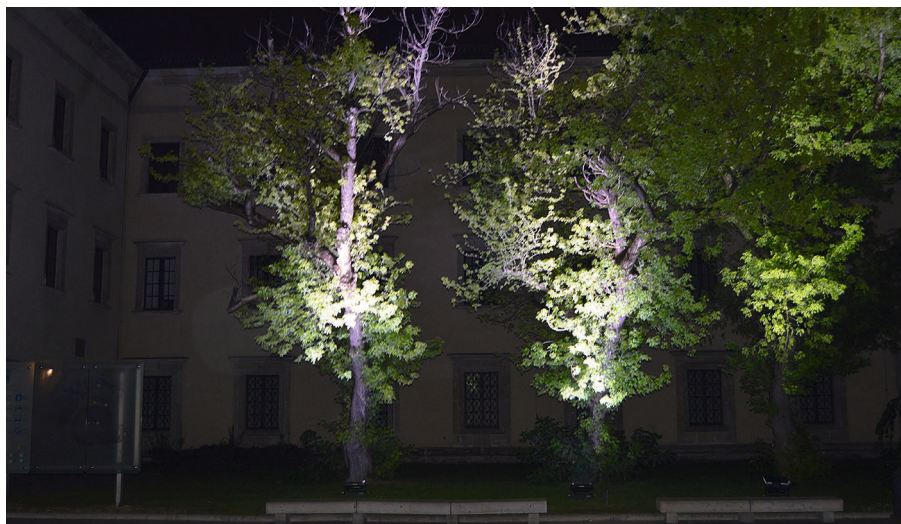
Illuminators were classified as incorrect lighting. They are used to illuminate plants that should be free from artificial light (Fig. 32). What is more, illuminators emit high-intensity light beam with high colour temperature. They can also cause glare.

**Fig. 32.** Light pollution phenomenon caused by illuminators (by Jakub Łygan)

Due to the negative impact that artificial light has on plants, it is proposed to remove these light sources.
