# Unexpected Twists: A 61-Year-Old Male with Repeated HeartMate II Complications and Subsequent Replacement with HeartMate III

Amit Alam, MD<sup>a,b</sup>; Christo Mathew, MD<sup>a,b</sup>; Elie Dib, MD<sup>a</sup>; Aayla Jamil, MBBS<sup>a</sup>; Cesar Guerrero-Miranda, MD<sup>a,b</sup>; Brian Lima, MD<sup>c</sup>; Dan Meyer, MD<sup>a</sup>; Aldo Rafael, MD<sup>a</sup>; Shelley Hall, MD<sup>a,b</sup>; Susan Joseph, MD<sup>a</sup>

<sup>a</sup>BAYLOR UNIVERSITY MEDICAL CENTER, DALLAS, TEXAS; <sup>b</sup>TEXAS A&M UNIVERSITY COLLEGE OF MEDICINE, BRYAN, TEXAS; <sup>c</sup>NORTHWELL HEALTH, MANHASSET, NEW YORK

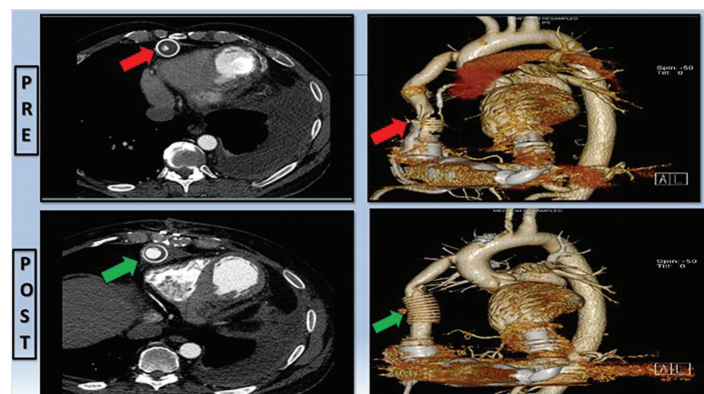
**Figure 1.**

Interrogation of the HM2 revealed very frequent low-flow alarms with occasional speed drops and power spikes. A computed tomography (CT) scan revealed a complete “twist” of his outflow graft causing LVAD obstruction (Figure 1, top panel). Despite giving up his smoking habits, the patient had already chosen not to pursue transplant candidacy for personal reasons and thus opted for device exchange. His diagnosis of outflow graft twisting was confirmed in the operating room, and the patient underwent a successful LVAD exchange (Figure 1, bottom panel).

Top row: Preprocedural computed tomography imaging showing a complete “twist” of the outflow graft causing left ventricular assist device obstruction. Bottom row: Postprocedural imaging shows device exchange without twisting.

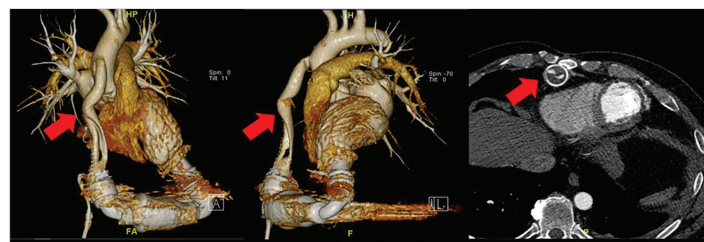
**Figure 2.**

Subsequent CT chest scans with 3-dimensional analysis showed significant proximal obstruction of the outflow tract concerning for repeat twisting, with a minimum diameter of less than 1 mm (Figure 2). It was recommended to proceed with either orthotopic heart transplantation (OHT) or LVAD

Chest computed tomography showing proximal obstruction of the outflow tract.

exchange. After discussion with the transplant team, the patient opted for another exchange for several personal reasons. HM2 to HM3 LVAD exchange via redosternotomy and left subcostal approach was performed. There was intraoperative external compression of the graft from old, dark, thrombotic, gelatinous material within the bend relief with no twisting evident (Figure 3). Additionally, extensive adhesions were noted that did not allow for in-situ repair of the graft. The patient had a stable postprocedural course and a postoperative complication for sternal wound debridement. He was discharged 2 weeks after HM3 implant.

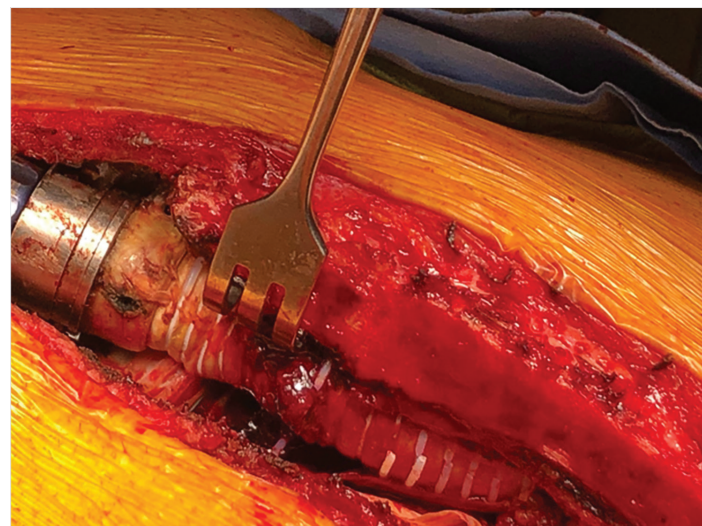
**Figure 3.**

Intraoperative photo of external compression of the graft from old, dark, thrombotic gelatinous material within the bend relief without evidence of graft twist.
