# SURVEY ON ROAD-TYRE CONTACT PATCH PATTERN AND WEAR RELATED ASPECTS

AZODO Adinife Patrick<sup>1</sup>

**Abstract:** Motor vehicle end-users approaches to tyre safety issues in automobiles translate to a number of tyre failure risk factors. This study basically assessed tread wear pattern of tyres in passenger cars used on Nigeria roads. The result obtained showed that 75.4% of the assessed tyres showed uneven wear pattern resulting from incorrect tyre-road contact effects. This observed high proportion of uneven tyre tread wear pattern implies high rate of inconsequential regard for tyre safety.

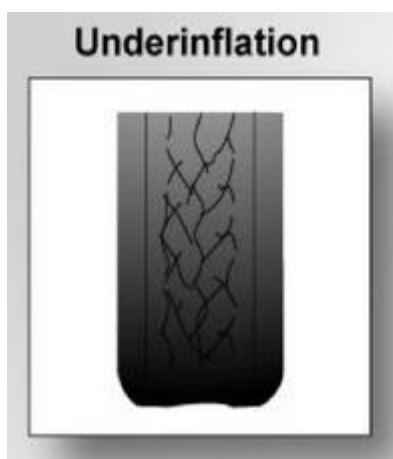
Under-inflation; wear at the edges of the tyre tread (Figure 1) [16, 19].

Figure 1. Wear due to under inflation (<https://www.rv.net>)

| Characteristics/variables | Frequency (n) | Percentage (%) |
|---|---|---|
| Under-inflation | 153 | 32.4 |

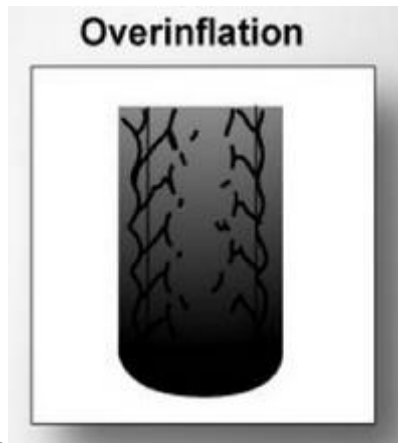
Over-inflation of tyre; wear at the middle of the tyre tread (Figure 2) [16, 19].

Figure 2. Wear due to over inflation (<https://www.rv.net>)

| Characteristics/variables | Frequency (n) | Percentage (%) |
|---|---|---|
| Over-inflation | 48 | 10.2 |

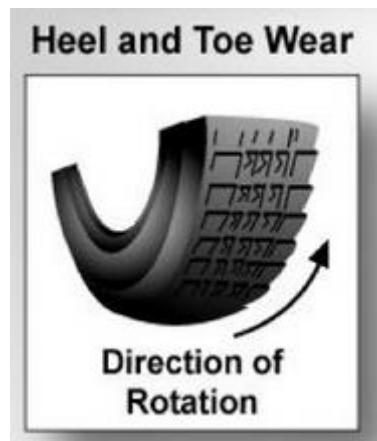
Heel/toe tire wear; circumferential faster of one side of the tread than the other side (Figure 3) [16, 19].

Figure 3. Wear due to heel and toe effects (<https://www.rv.net>)

| Characteristics/variables | Frequency (n) | Percentage (%) |
|---|---|---|
| Toe tire wear | 75 | 15.9 |

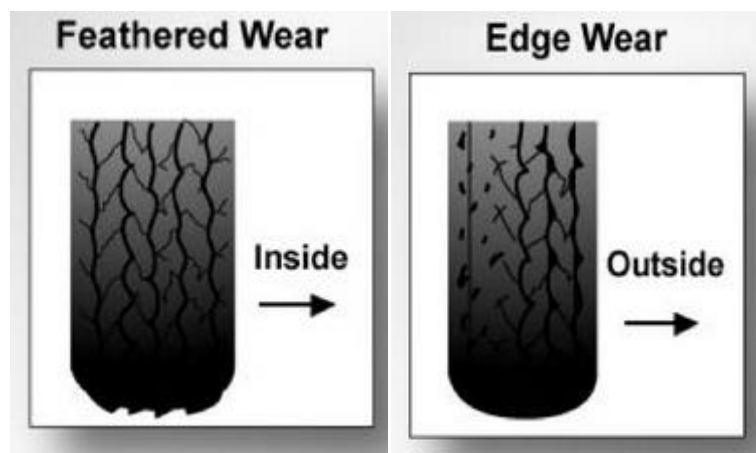
Feather edge tire wear; worn lower/smoothen on one side and higher/sharper on the other on the tread ribs (Figure 4) [16, 19].

Figure 4. Wear due to feathered edge (<https://www.rv.net>)

| Characteristics/variables | Frequency (n) | Percentage (%) |
|---|---|---|
| Feather edge tire wear | 63 | 13.3 |

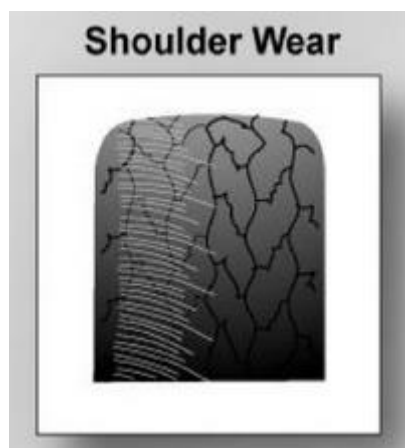
One-sided shoulder tire wear; significant inside or outside shoulder tread rib more worn than the other (Figure 5) [16, 19].

Figure 5. Wear due to shoulder wear (<https://www.rv.net>)

| Characteristics/variables | Frequency (n) | Percentage (%) |
|---|---|---|
| One-sided shoulder tire wear | 17 | 3.6 |
