## FIRE RISK ANALYSIS AND FIRE SAFETY DESIGN IN HISTORICAL SOCIOCULTURAL BUILDINGS

**Method:** The checklist method prepared in accordance with the fire regulations in Turkey and the risk analysis method defined in NFPA 101 A were used together. In this study, fire risk analysis was evaluated on a sample historical theater building in Turkey.

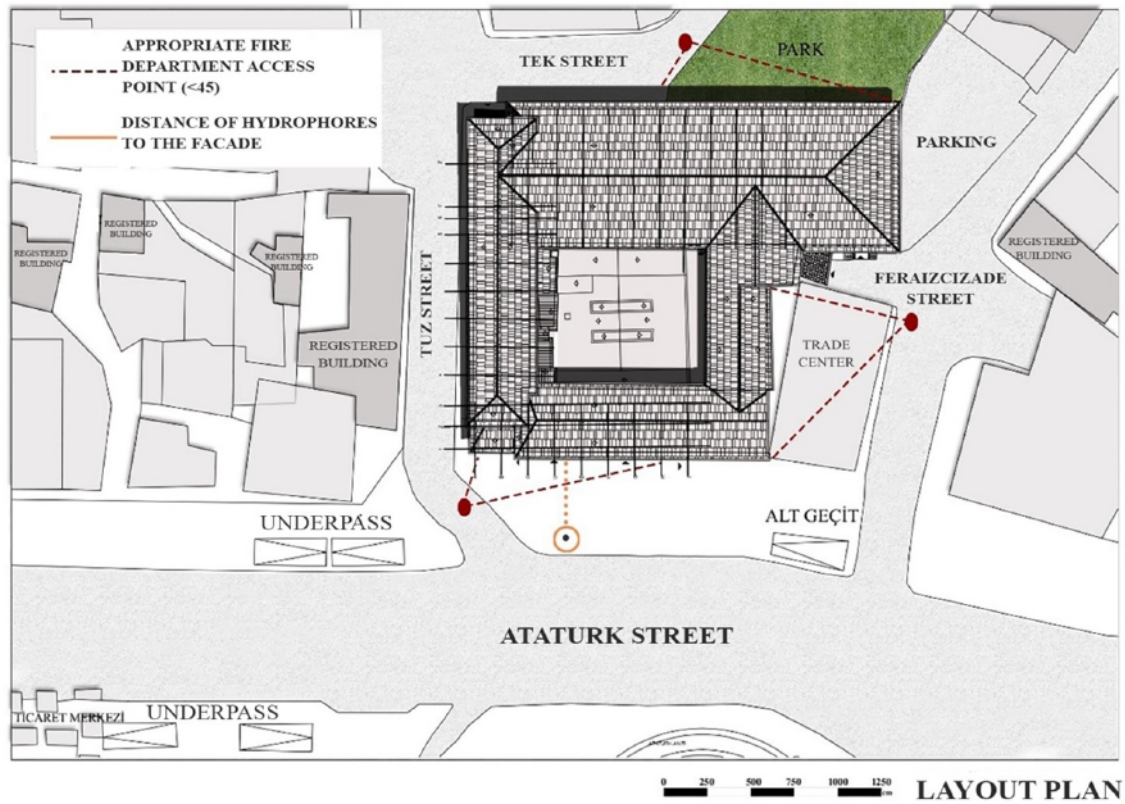
Figure 2.  
Examination of the Layout of the Theatre Building According to BYKHY Articles. (Created by the author)

Access and access routes to the building: According to BYKHY Article 22, access to the building is ensured in such a way that the fire department does not exceed a horizontal distance of 45 m as shown in Figure 2. According to BYKHY, the distances of hydrants to buildings show compliance between 5 and 15 meters.

Evacuation route requirements and distances: Fire stairs are not protected against fire and do not have a fire safety vestibule. As the Theatre Building is a historical building, since the provisions of BYKHY are stated in the historical building section as "In cases

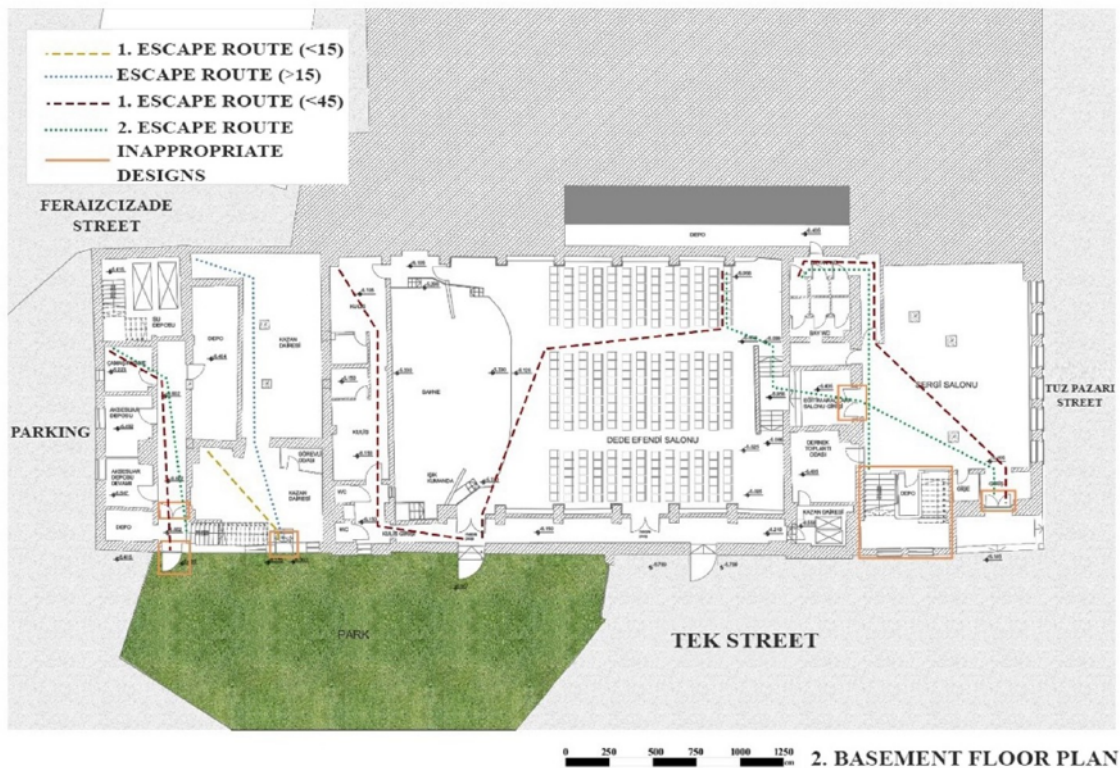
Figure 3.

Analysis of Escape Routes in the Existing Second Basement Floor Plan (yellow line; single escape distance suitable according to BYKHY, blue line; unsuitable escape distances, maroon line; suitable double escape distance, green line; alternative escape, orange line; represents unsuitable designs). (Created by the author)

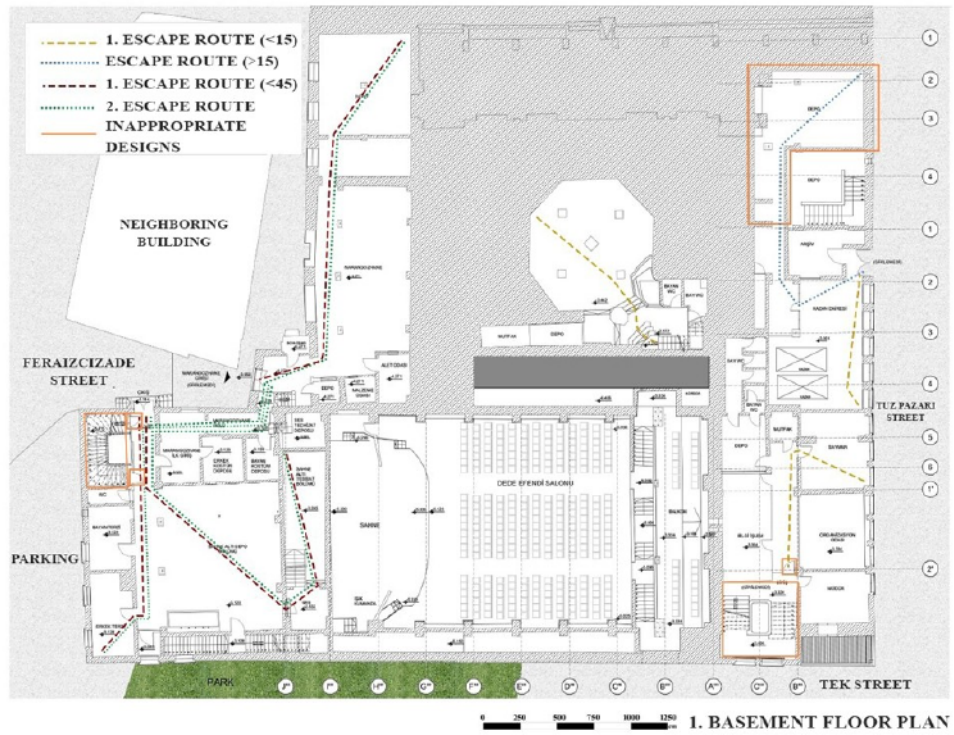
Figure 4.  
Analysis of Escape Routes in the First Basement Floor Plan. (Created by the author)

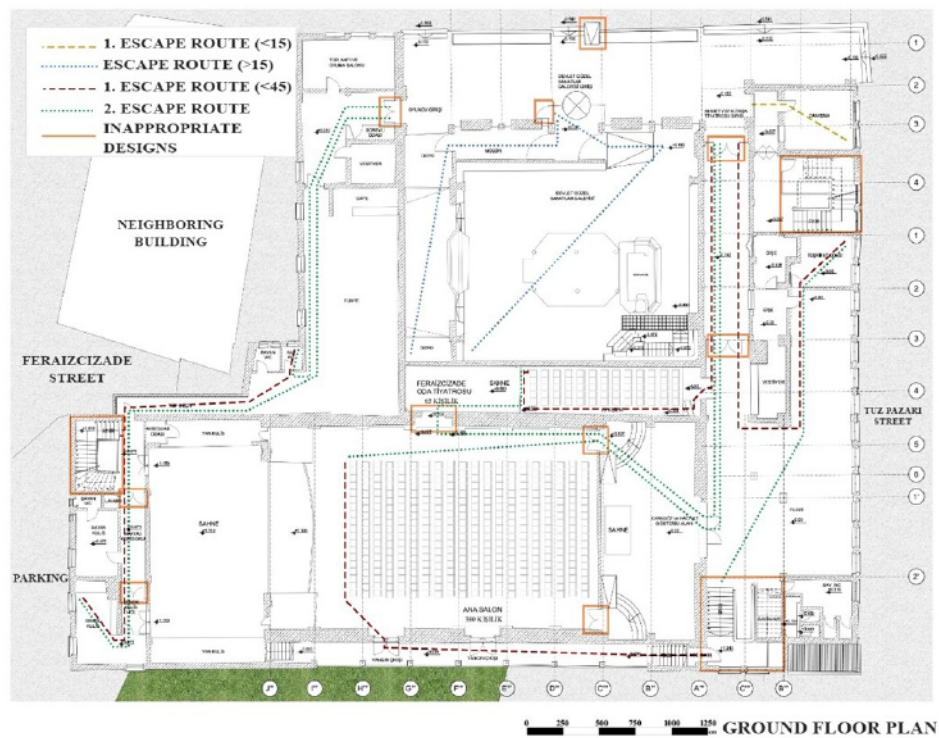
Figure 5.  
Analysis of Escape Routes in the Ground Floor Plan (Created by the author)

| Fire Risk | Location of the Measure | Measures to be Taken | Intervention on the Historical Building |
|---|---|---|---|
| Exit door width less than the calculated exit width | State Fine Arts Gallery ground floor | The existing door should be replaced with a door that matches the calculated width | Expanding the door opening involves intervention in the originality of the building. The relevant institution should be consulted. |
