# NEW PRECAUTIONARY STUDIES AND RESULTS FOR REDUCING BIRD CAUSED FAULTS IN OVER HEAD LINES

**Abstract:** Studies for the prevention of bird-induced malfunctions have been examined in the literature. In studies in the literature, some precautions have been taken to prevent birds from being placed in undesirable dangerous spots on conductors and poles. It has been observed that some of the measures are efficient and some are inefficient. In this direction, a number of measures have been taken to Turkish Transmission Network. When evaluated in terms of the number of individuals and wing spans in Türkiye, storks and seagulls are expected to cause the most malfunctions in OHLs. However, it has been observed that the habitats of seagulls are generally near the sea. It has been observed that storks use OHLs and poles on their migration routes, nesting and resting. It has been determined to the degree that storks are mostly responsible for bird-related malfunctions. Turkish Electricity Transmission Corporation has taken various measures to reduce bird-related faults in OHLs. Sheet galvanized metal assembly was carried out in May 2019. Sheet plates are mounted horizontally (flat) on the mi

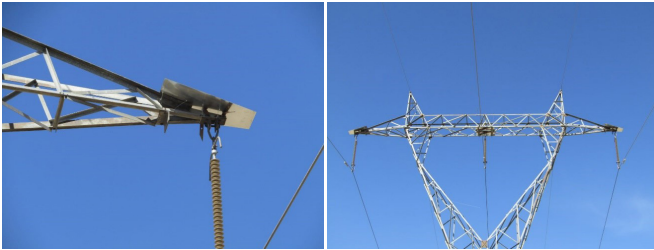
Figure 3: (a) Installation on the console end of the pole; (b) Installation on 3 phases of the pole

During the installation process, sheet metal materials must comply with TS EN 10346 standards and have a minimum thickness of 1.5 mm. As shown in Figure 3, in the 154kV OHL, the mid-phases are installed at below the bracket, while the corner phases are installed inclined towards the upper part of the bracket. In rainy weather, an incline will be provided to prevent bird droppings accumulated on the plate from flowing onto the insulator. During plate installations, care must be taken not to damage the galvanization of the pole. Therefore, the plates will be connected using galvanized steel wires through the connection holes (a distance of 30 cm between connection points at each corner).

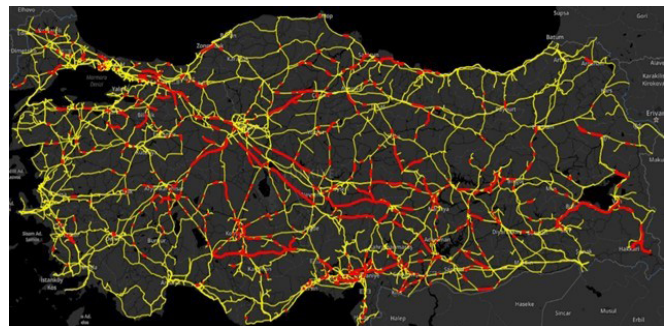
Figure 4: Locations of bird-related faults on the map of Türkiye

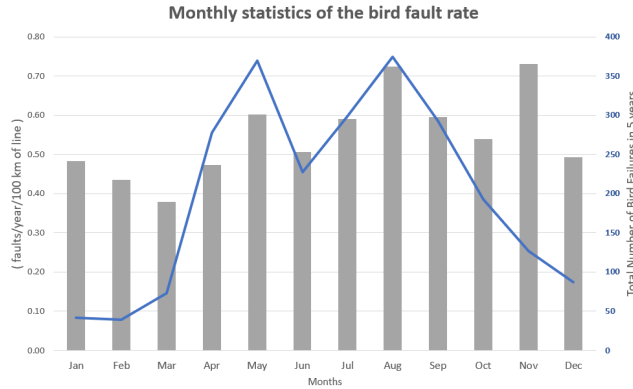
In Figure 5, the monthly distribution of faults caused by birds on OHLs from January 2019 to December 2024 is displayed. The number of faults shows an increasing trend from February to May. The fault counts peak in May and August, coinciding with increased bird activity. From August onward, there is a declining trend. The obtained graph aligns well with the pattern of bird migration.

Figure 5: Failure rate and average number of failures per 100 km line caused by birds in the TEİAŞ network by months in the period 2019-2024

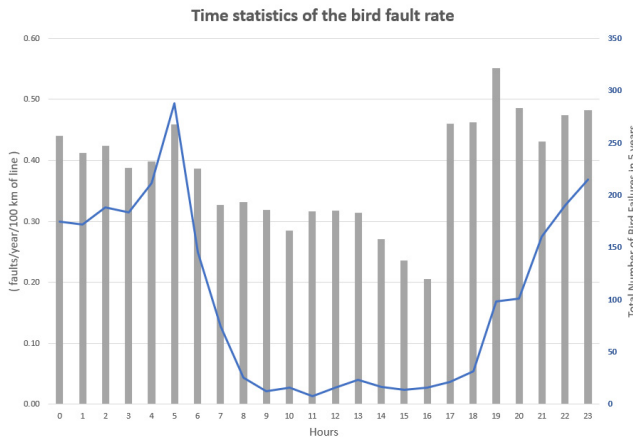
In Figure 6, faults caused by birds have been analyzed in hourly intervals from January 2019 to December 2024. The faults predominantly occur in the early hours of the morning. However, it has been observed that faults can occur at any time during the day. The number of faults is highest from 4 AM to 5 AM. This difference in the hourly distribution is closely related to the habits of birds. Birds that use OHLs typically begin digesting their food at night and defecate before flying in the morning. The occurrences of faults on the lines parallel the moments when birds defecate.

Figure 6: Failure rate and average number of failures per 100 km line caused by birds in the TEİAŞ network according to hours in the period 2019-2024

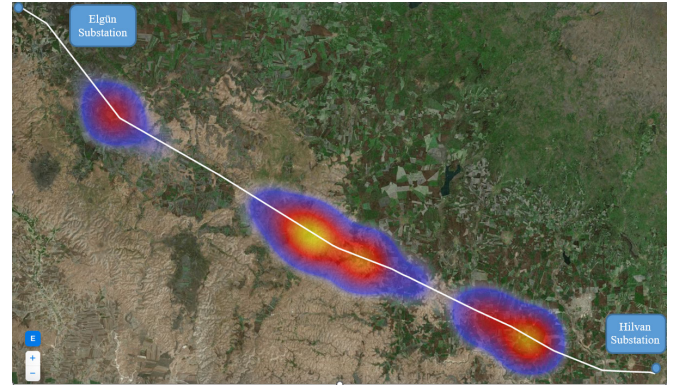
The OHL with the highest number of bird-related faults in the Turkish electricity system is the 400 kV Elgün - Hilvan OHL, as shown in Figure 7. Information regarding the fault clearing counts before and after the installation of sheet metal shields is presented in Table III. This OHL, with a

length of 92.74 km, is generally located over agricultural areas. The fault zone has been confirmed through observations conducted in the region with high bird density. Significant bird droppings have been observed on the poles during the inspections. The installation of sheet metal shields on this line was carried out on December 11, 2022. As a result of the installation, the number of faults has significantly decreased.

Figure 7: 400 kV Elgün – Hilvan OHL fault intensity map

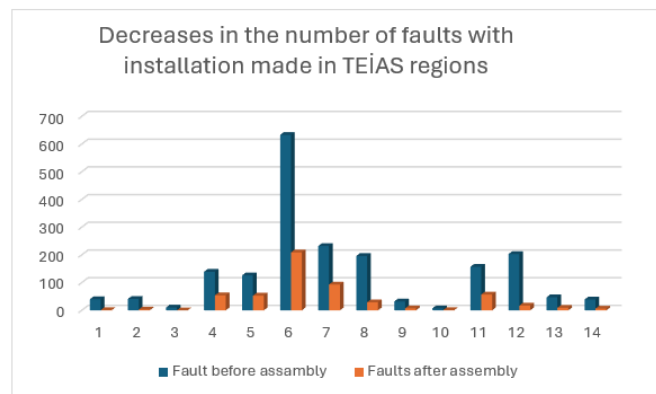
Significant progress has been observed in the OHL with the highest number of fault records in the Turkish electricity system as a result of the installations, as given in Table 3. In Table 4, there have been significant reductions in the number of faults in many regions as a result of sheet metal shield installations. The reason for the decrease in some regions remaining around 60% is the excessive bird density and birds perching on the poles where installations have been done, subsequently moving to other poles without installations. It is believed that as the number of installations on poles increases, the number of faults will decrease further.

Figure 8: Decreases in the number of faults
