## TECHNICAL CONDITION ASSESSMENT OF AGING HYDROTECHNICAL STRUCTURES IN SOUTHERN POLAND USING PERIODIC INSPECTION DATA

**Abstract:** The aim of this study is to evaluate the technical condition of selected hydrotechnical structures in Southern Poland, based on data collected from periodic inspections and diagnostic testing conducted between 2018 and 2023. The analyzed structures, primarily built in the 1960s–1980s, include culverts, weirs, locks, spillways, and embankments. Most have been in operation for over 60 years and are classified as importance class I or II. The methodology involved a review of inspection protocols and test results, including non-destructive and destructive tests such as Schmidt hammer testing, core specimens with compressive strength analysis, ultrasonic testing, water permeability, frost resistance, and water chemical aggressiveness. Each structure was assessed using a pointwise and verbal rating system. Key findings indicate widespread surface erosion, carbonation, and cracking of concrete elements. Although all structures operate in similar aquatic conditions, testing procedures varied significantly, revealing a lack of a standardized diagnostic approa

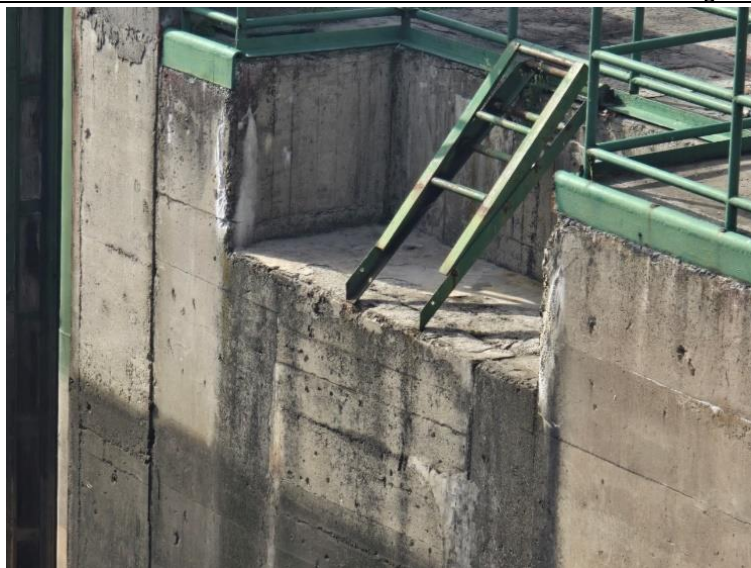
Fig. 1. Structure D, lock wall, carbonation (source: own photo)

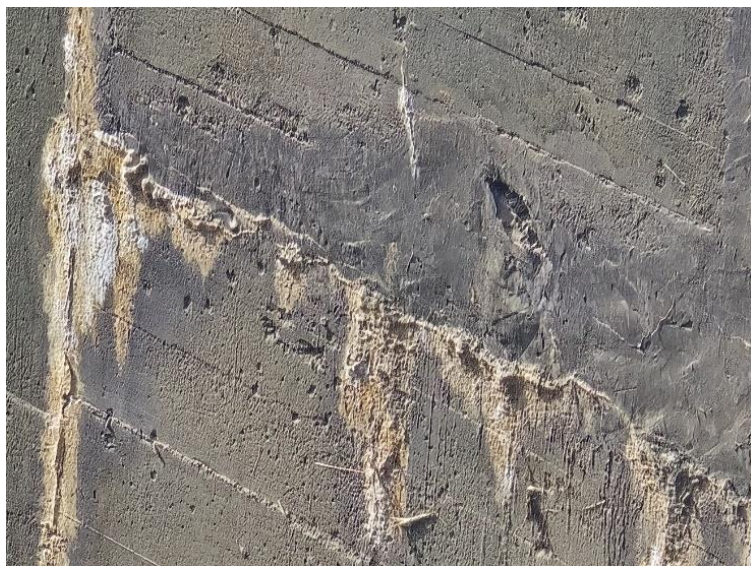
Fig. 2. Structure E, weir, carbonation and leaks (source: own photo)

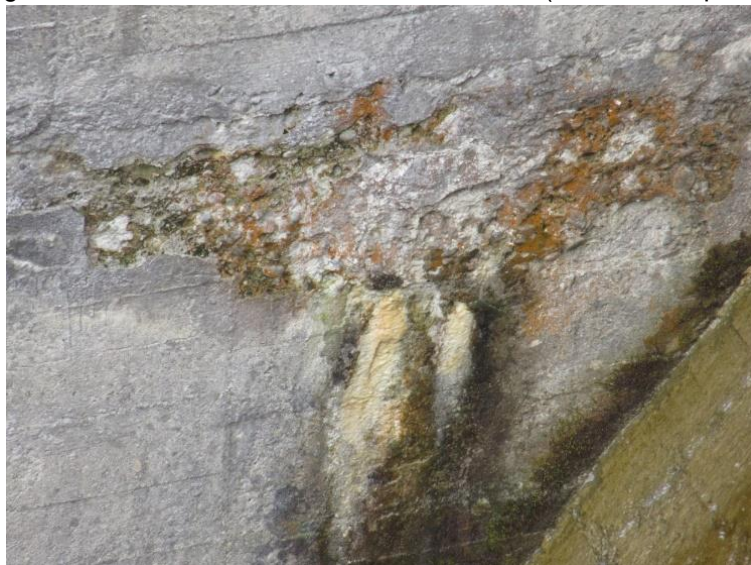
Fig. 3. Structure A, overflow, carbonation and erosion (source: own photo)

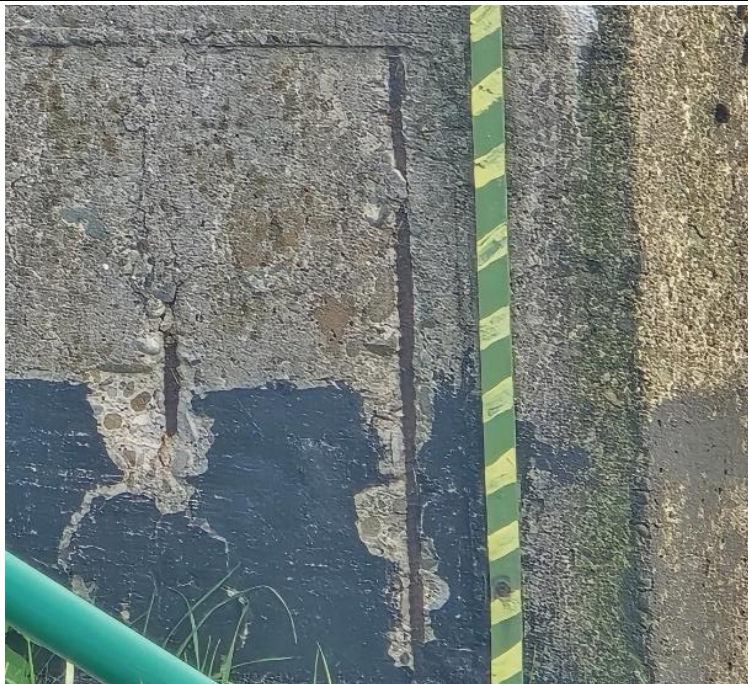
Fig. 4. Structure B, culvert, corrosion and visible reinforcement (source: own photo)

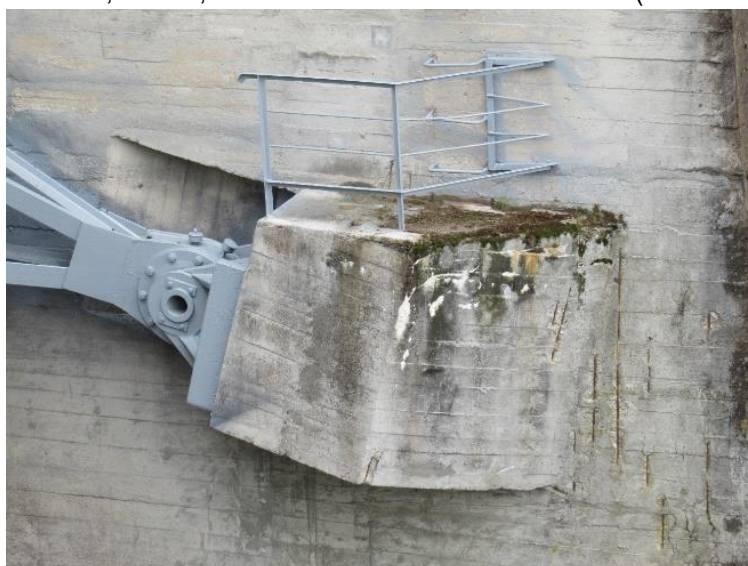
Fig. 5. Structure E, lock wall, corrosion and visible reinforcement (source: own photo)
