# **FATIGUE-INDUCED CRACK AN AIRCRAFT FIRE EXTINGUISHER OUTLET DISCHARGE SYSTEM: A MAINTENANCE CASE STUDY OF AN AIRBUS A330-900**

## **Abstract**

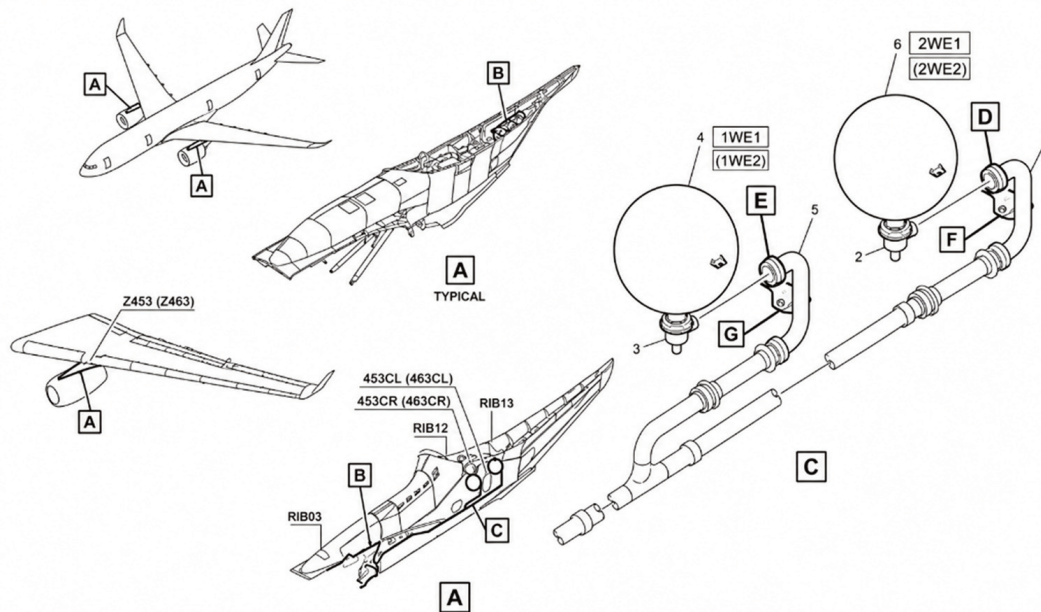
Inspection during C-Check maintenance identified a visible surface crack on the outlet discharge component of the Airbus A330-900 engine fire extinguisher system, as shown in Figure 2. The component was located in the engine nacelle area, specifically Zone 420 in the E area, where aircraft system components are exposed to repeated mechanical vibration, temperature fluctuations, and operational loading. The estimated crack length was less than 5 mm, indicating an early-stage visible structural defect. Although relatively small, the crack was significant because its location in the fire-extinguishing-agent distribution path means that leakage could reduce discharge pressure and impair delivery of the extinguishing agent to the engine nacelle.

**Fig. 2.** Airbus A330-900 engine fire extinguisher system and outlet discharge location in the engine nacelle area, showing the installation zone and observed crack location.

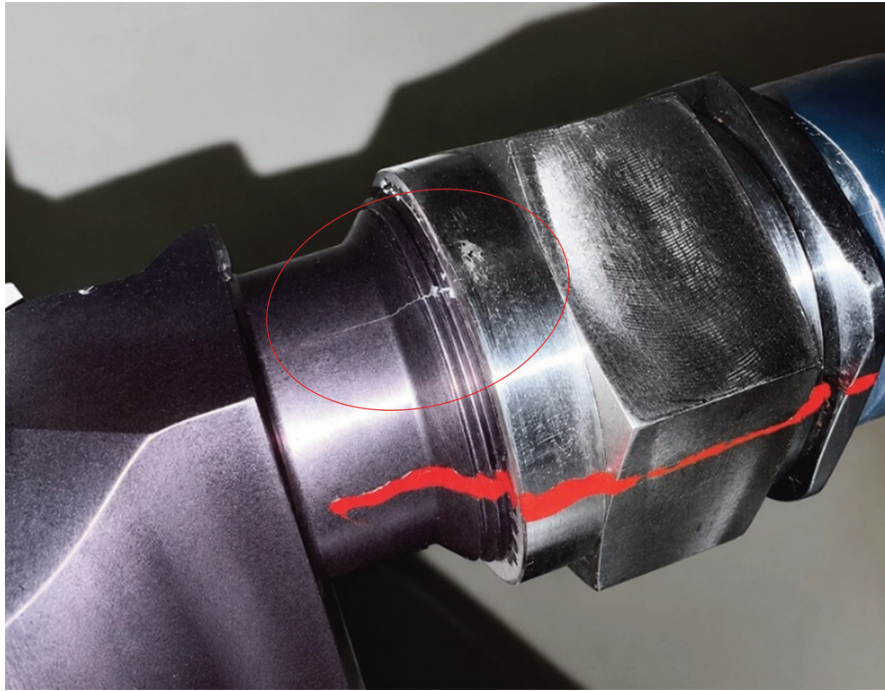
The crack location on the outlet discharge is shown in Figure 3. Based on visual inspection, the crack appeared consistent with a stress-influenced defect rather than an isolated random surface mark. However, because no fractography, dye penetrant testing, ultrasonic testing, or microscopic material characterization was performed, this observation should be interpreted as indicative rather than conclusive. Previous studies have shown that fatigue cracks in aerospace materials may follow local stress fields, microstructural anisotropy, or residual-stress paths under vibration and cyclic loading (Muhammad et al., 2021; He et al., 2023; Hui et al., 2025).

**Fig. 3.** Close-up visual observation of the crack on the outlet discharge component.

The crack was detected after the aircraft had accumulated 5,642 flight cycles and 10,834 flight hours. This exposure range was considered consistent with early fatigue damage under repeated service loading. Accumulated cycles are commonly used in maintenance and damage-tolerance assessments because crack initiation often develops at stress risers, local defects, or microstructural features under cyclic loading (Lv et al., 2020; Nikishkov et al., 2021; Moroney & Verma, 2023; Delpuech et al., 2024; Khashaba & Alssayegh, 2025). Therefore, the observed crack was treated as physically consistent with high-cycle fatigue in a component exposed to engine vibration and thermal cycling.

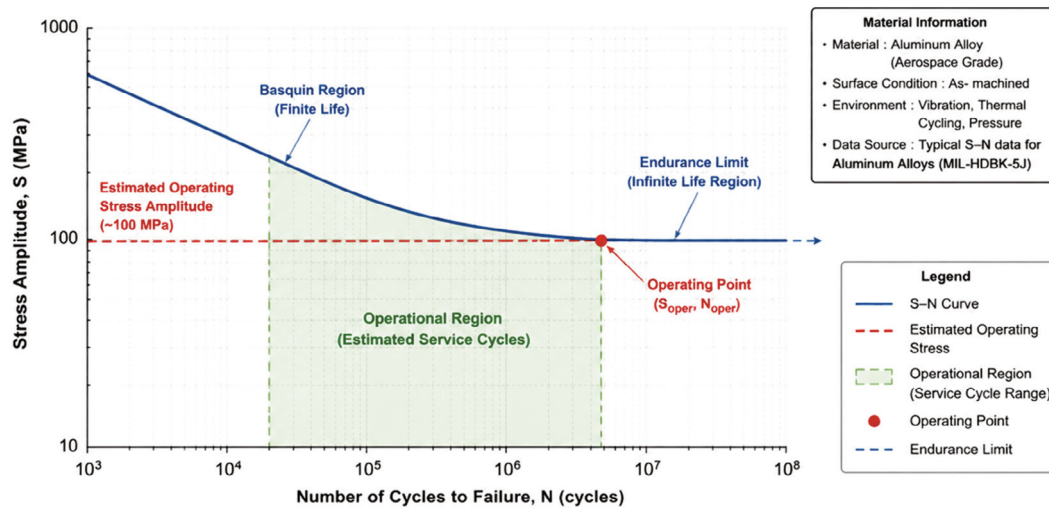
The estimated fatigue condition was consistent with high-cycle fatigue, commonly associated with low-amplitude, high-frequency cyclic stress. The simplified S–N curve was used to locate the estimated operational region, as shown in Figure 4. This interpretation follows the common use of S–N curves and Basquin-type equations to describe the relationship between stress amplitude and fatigue life (Fang et al., 2017; Khashaba & Alssayegh, 2025).

**Fig. 4.** S–N curve with operational region highlighted.

A stress amplitude of approximately 95 MPa was used to represent localized cyclic loading in the engine nacelle environment. The estimated fatigue behavior was within the order of the observed operational exposure of 5,642 flight cycles. This result suggests that the outlet discharge component was operating in a fatigue-sensitive regime, where increases in vibration intensity, resonance, or thermal stress could accelerate crack initiation and early propagation. Because the exact high-cycle fatigue response depends on alloy type, geometry, notch condition, residual stress, and loading ratio, this result should be interpreted as a semi-quantitative assessment of fatigue plausibility rather than a deterministic fatigue-life prediction (Fang et al., 2017; Khashaba & Alsayegh, 2025).

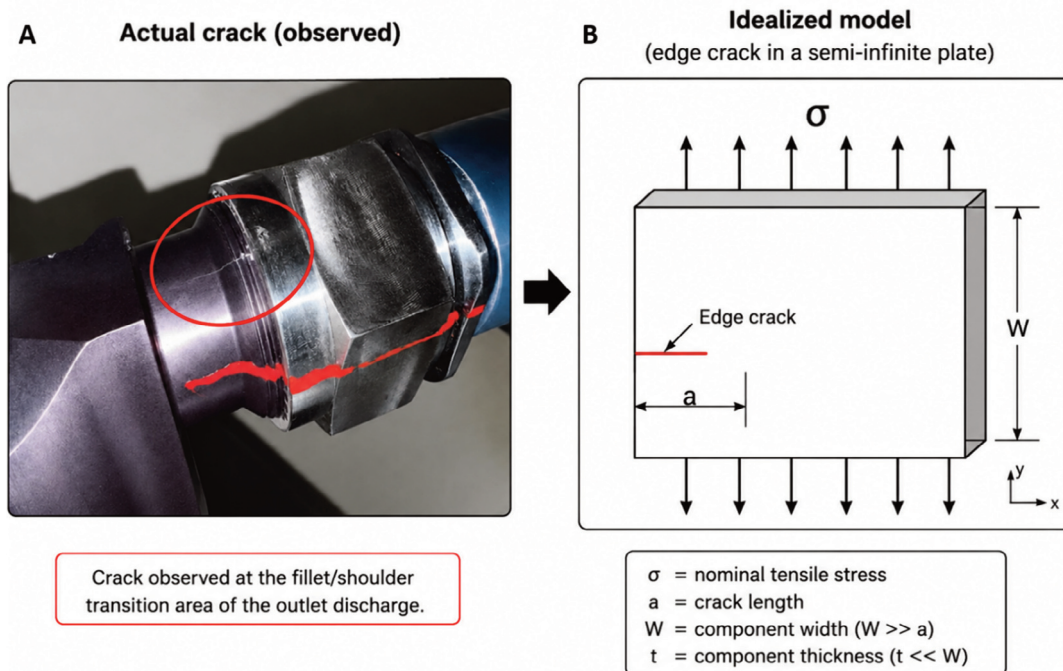
Crack propagation was evaluated using the Paris Law approach described in the Methodology. As shown in Figure 5a, the observed defect was idealized as a small edge crack subjected to tensile cyclic loading. The stress-intensity-factor range was estimated using a standard edge-crack approximation with a geometry correction factor of  $Y = 1.12$ , corresponding to a small edge crack in a semi-infinite plate under uniform tensile stress (Tada et al., 2000; Anderson, 2017). The value was used as a first-order approximation to represent the observed defect because detailed crack geometry and finite-element stress analysis were unavailable. Paris-type crack-growth relations are widely used in aerospace fatigue crack-growth and damage-tolerance analyses, including studies involving aluminum alloys and advanced joint structures under cyclic loading (Fang et al., 2017; Muhammad et al., 2021; Uygur, 2024; Bai et al., 2025).

**Fig. 5a.** Comparison between the observed crack (A) on the outlet discharge component and the simplified edge-crack model (B) used to estimate the stress intensity factor. The crack was located at the fillet/shoulder transition region and exhibited an approximate visible length of 5 mm.

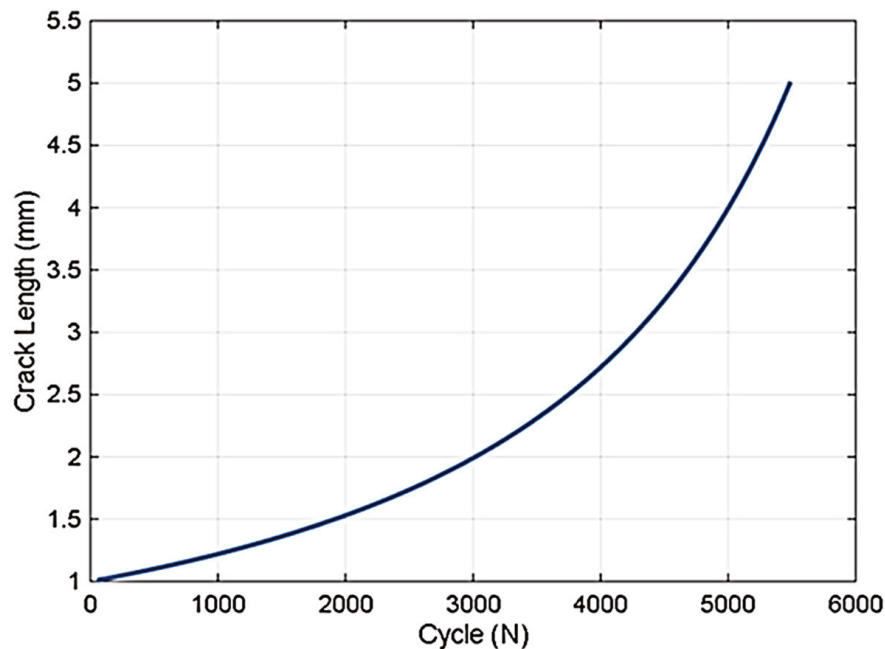
**Fig. 5b.** Crack-growth curve obtained from MATLAB-based Paris Law simulation under elevated cyclic loading conditions.

The MATLAB simulation produced a nonlinear crack-growth trend from 1.0 mm to approximately 5.0 mm after about 5,500 cycles (Figure 5b). At approximately 5,000 cycles, the crack length reached about 4.0 mm. The predicted crack size is comparable to the observed defect of approximately 5 mm at the verified aircraft exposure of 5,642 flight cycles and 10,834 flight hours. This result suggests that fatigue-driven crack propagation is physically plausible under the assumed loading and material conditions.

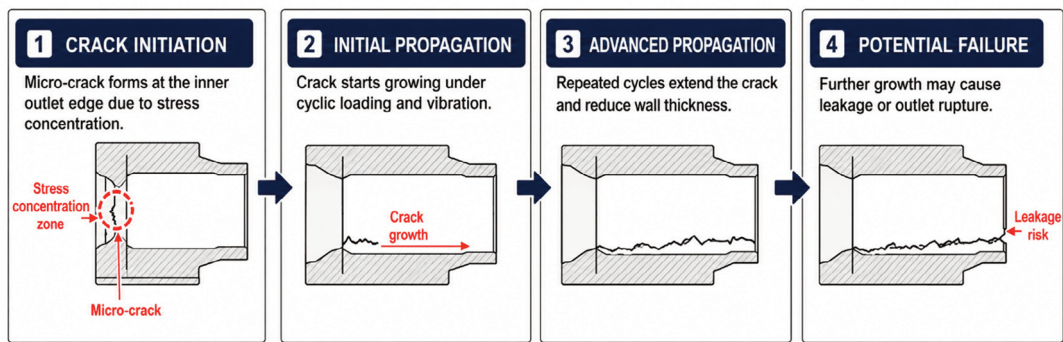
The observed failure mechanism was interpreted as a combined effect of fatigue, vibration-induced stress, and thermal stress. As illustrated in Figure 6, microcracks may initiate under cyclic loading and then propagate gradually under continued service exposure. Thermal expansion and contraction may further intensify local stress near geometric transitions or constrained areas, while vibration and resonance may increase cyclic stress amplitude. This interpretation is consistent with studies on thermo-vibration coupling, vibration fatigue, and aerospace material fracture, which show that vibration, resonance, thermal expansion, and stress concentration may interact in crack initiation and propagation (Fang et al., 2017; Muhammad et al., 2021; He et al., 2023; Liu et al., 2024; Hui et al., 2025).

**Fig. 6.** Schematic of crack initiation and propagation mechanism.

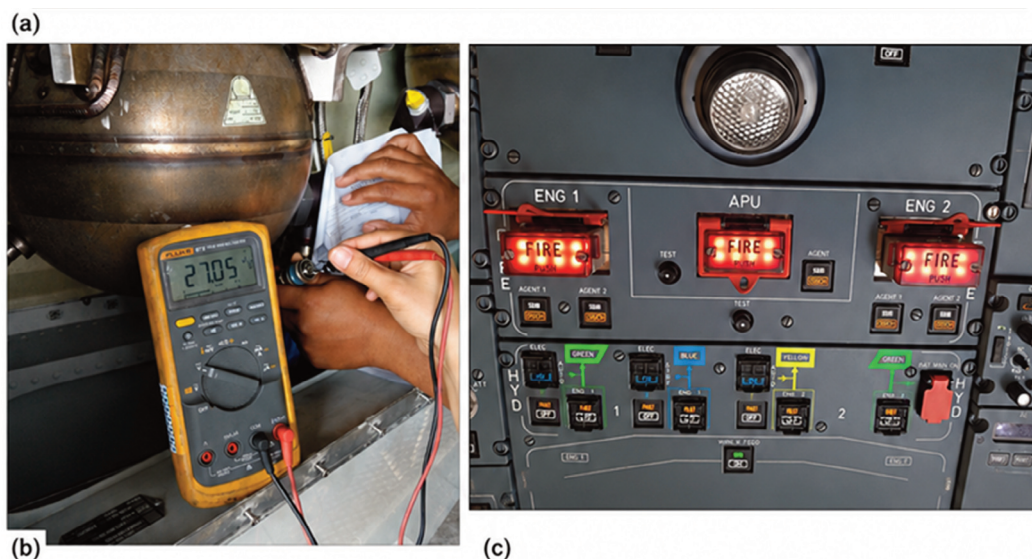
**Fig. 7.** Post-maintenance functional test sequence of the fire extinguisher system:  
(a) cropped excerpt of the approved task card used as the maintenance reference;  
(b) verification process performed on the aircraft; and (c) normal cockpit fire panel indication confirming system serviceability.

Corrective maintenance was performed by replacing the cracked outlet discharge component with a serviceable unit through the robbing method. After replacement, an operational test was performed to verify system functionality, as shown in Figure 7. For confidentiality and ethical reporting purposes, Figure 7(a) presents only a cropped excerpt of the approved task card, while operationally sensitive information has been omitted. The test confirmed that the system returned to a serviceable condition, with no observable leakage and normal flow characteristics. These results support component replacement as an appropriate corrective action when a structural defect affects a safety-critical fire-extinguishing distribution component. This decision is consistent with damage-tolerance and reliability-based maintenance frameworks, which support replacement or refurbishment when a detected damage state threatens design margin or system safety (Shekhter et al., 2015; Lv et al., 2020; Moroney & Verma, 2023; Khashaba & Alssayegh, 2025).
