# Defect analysis of Ag coatings on aluminum castings

*Cast aluminum alloys are one of the most widely used structural materials in electrical engineering due to their good mechanical properties, high thermal and electrical conductivity. Passive Al<sub>2</sub>O<sub>3</sub> layer formation on the aluminum surface reduces its electrical conductivity. Thus, the Ag coating electrodeposition on the aluminum substrate material allows increasing the electrical conductivity. The coating quality depends not only on the composition and on the quality of the electrolytic bath and technological parameters of the deposition, but a very important factor is the surface material pre-treatment prior to coating. In this study, the causes of the defect occurrence in the form of blisters on the Ag coating surface were analyzed. Blistering is a characteristic sign of local low adhesion strength of the coating to the substrate. Microscopic analysis showed the presence of AlSi fragments between the coating and the substrate, which were formed during machining of the Al casting surface. The difference in electrical conductivity between the AlSi particles and the aluminum matrix created an inhomogeneous f

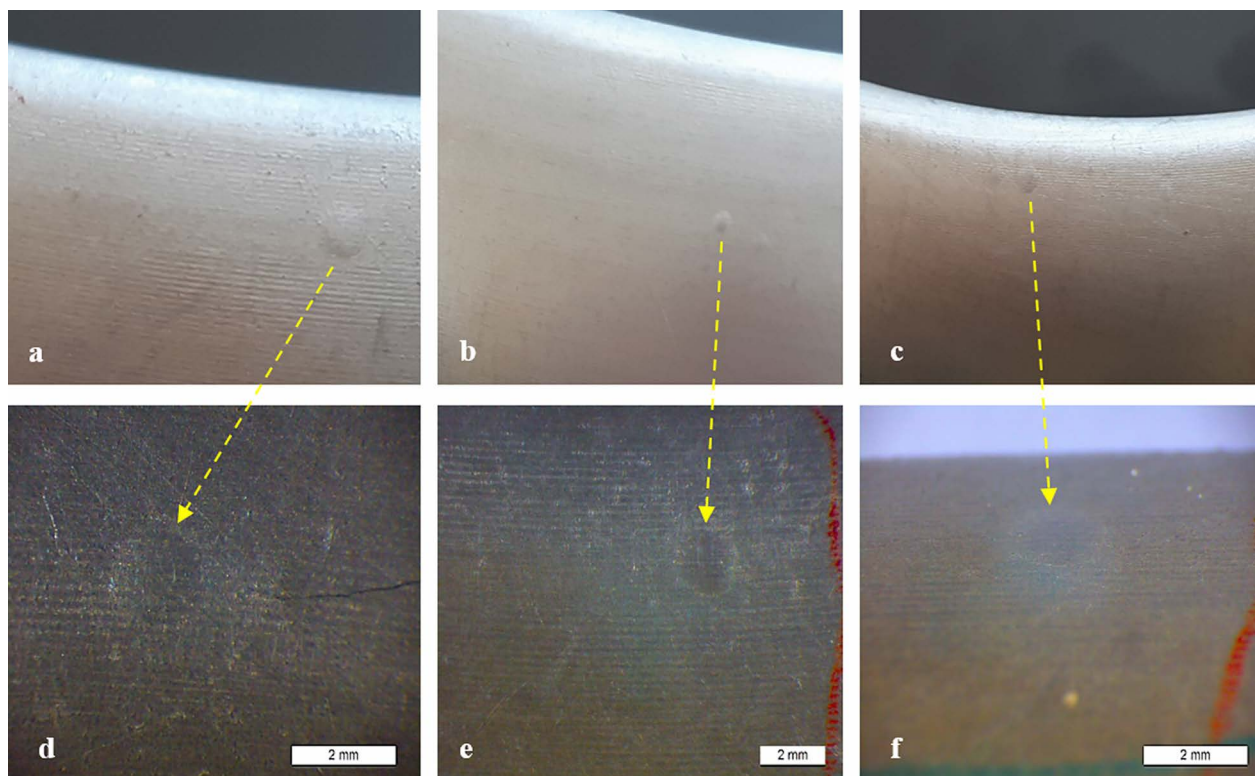
In Figs. 1a-c, the defects on the Ag coating surface are visible. The stereomicroscope images confirmed the occurrence of defects with different sizes, Figs. 1d-e. Figs. 1a and 1d represent sample 1, Figs. 1b and 1e represent sample 3, Figs. 1c and 1f represent sample 5. According to [10], the lack of coating adhesion can be manifested by blisters formation. Coating adhesion problems are almost always caused by deficiencies in pre-treatment operations, such as incomplete removal of grease, oils, impurities or oxides.

As can be seen mainly in the stereomicroscope images, Figs. 1d-f, the Ag coating surface roughness is high and follows the surface roughness and texture of the AlSi7Mg0.3-T6 alloy aluminum casting surface after its machining (turning and milling). The average roughness value determined from five measurements, expressed by the mean arithmetic profile deviation, was at  $R_a \sim 6.3 \mu\text{m}$ . The surface micro geometry contributes significantly to ensuring a quality coating after deposition in terms of its uniform thickness and sufficient

Fig. 1. Defects on aluminum casting surface (indicated by arrows): a) and d) represent sample 1, b) and e) represent sample 3, c) and f) represent sample 5, d)-f) were documented on the stereomicroscope

adhesion to the substrate material. The silicon present in the aluminum casting remains on the surface of the casting as a component that cannot be chemically removed in the casting pre-treatment, thus leaving the surface rougher [10]. Silicon that is part of the microstructure cannot be chemically removed, but silicon that is on the surface can be removed. Si which is part of the surface increases its roughness.

Substrate pre-treatment prior to coating is essential to obtaining a high-quality, well adhesive coating. A clean, degreased surface is characterized by high activity for the formation of adhesion forces between the deposited coating and the metallic substrate material. The presence of hard and brittle particles (in our case AlSi phase) impairs the adhesion between the substrate and the coating. In this case, the answer is to use e.g.,

HF + HNO<sub>3</sub> solution, which removes Si, and the surface will be prepared for plating in this way.

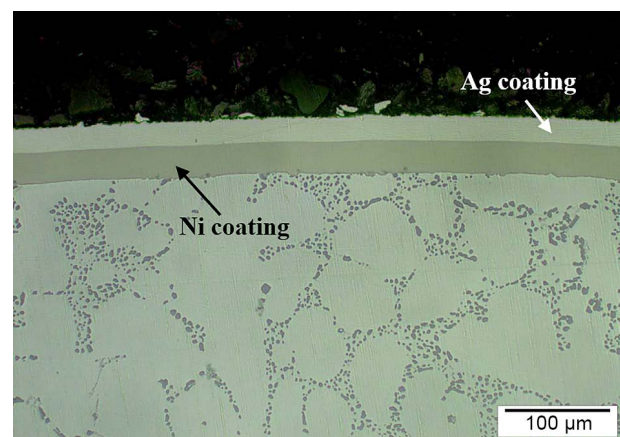
sured using a light microscope, which had a value of 29.64  $\mu\text{m}$  for sample 1; 30.44  $\mu\text{m}$  for sample 3; respectively 28.07  $\mu\text{m}$  for sample 5, Fig. 3. The nickel layer uniformly covered the Al alloy surface. Fig. 3 also shows the casting surface with the Ag layer of coating. The average Ag coating thickness showed a value of 21.66  $\mu\text{m}$  for sample 1; 22.17  $\mu\text{m}$  for sample 3 and 21.67  $\mu\text{m}$  for sample 5.

Fig. 3. Coating composed of Ni interlayer with an average thickness of 29.64  $\mu\text{m}$  and Ag coating with an average thickness of 21.66  $\mu\text{m}$  (sample 1), non-etched state

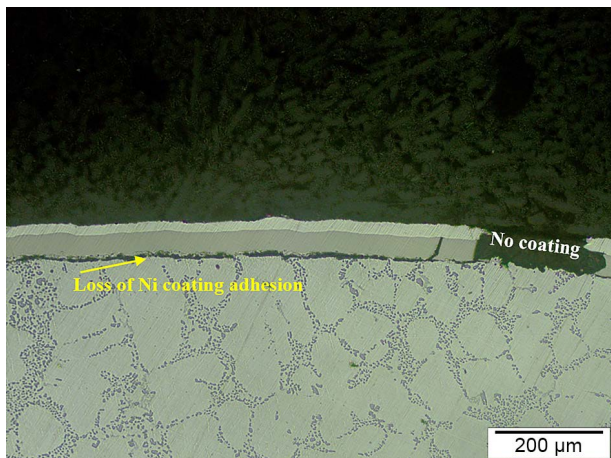
In Figs. 4 to 8, sample 1 (according to Fig. 2) is shown after cross-sectioning. Fig. 4 shows a cross-section of sample 1 with Ag coating and Ni coating missing

Fig. 4. Coating defects on sample 1: missing coating and loss of Ni coating adhesion, non-etched state

at the observed defect location (according to Figs. 1a, d). The Ni coating adhesion to the aluminum substrate material was very weak, therefore the coating detached from the surface.

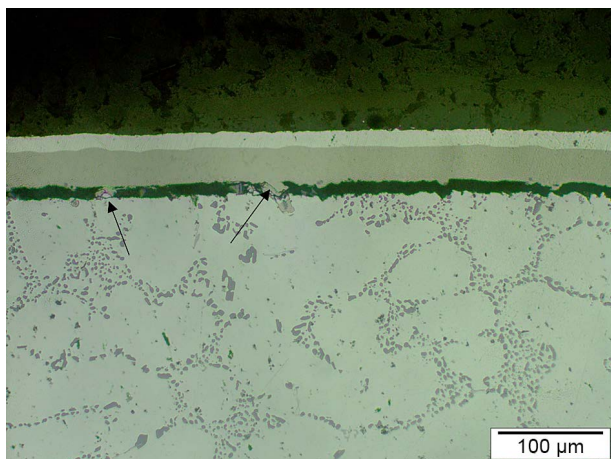
Fig. 5. Closer look at the Ni coating separation from Al material, non-etched state

On closer observation, in Figs. 5 and 6, it could be seen that the region between the separated coating and the casting surface is formed by fragments (in Fig. 5, some fragments are indicated by arrows). As mentioned before, the lack of adhesion strength of the electroplated metallic coating to the substrate material is most often due to the pre-treatment quality of the substrate surface, but as the authors in [11,12] state, with nickel deposition being a process highly sensitive to impurities in the electrolyte as well.

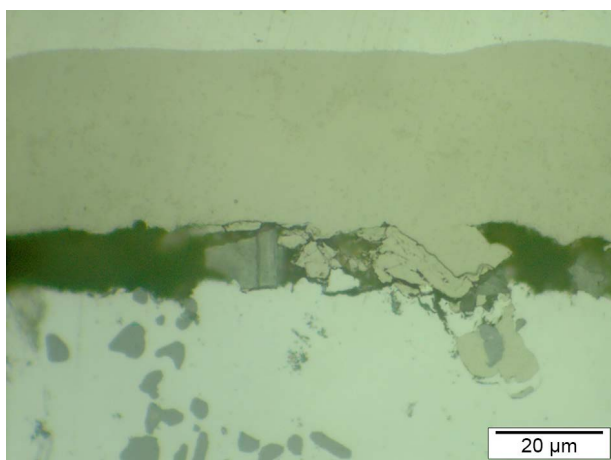
Fig. 6. Close-up view at 1000 x magnification of the location of Ni coating separation from Al alloy with the presence of fragments, non-etched state

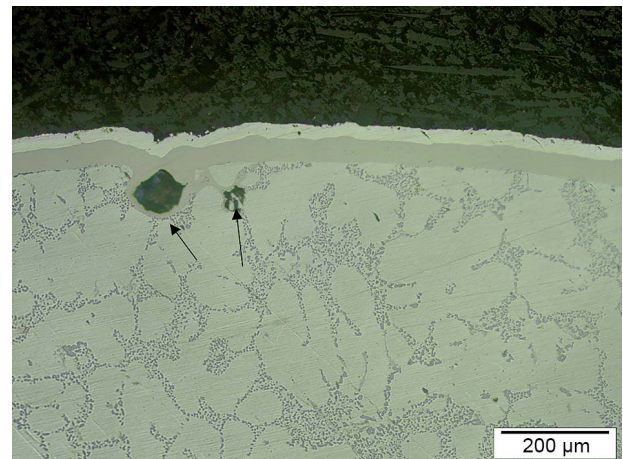
Fig. 7 shows a cross-section of sample 3 (according to Figs. 2b,e showing the presence of pores in the AlSi7Mg0.3-T6 aluminum alloy, which were partially covered by Ni coating. Pores in aluminum alloys are the result of the production process; they are related to higher gas content during refining, insufficient or high-

Fig. 7. Pores in the microstructure of Ni-coated aluminium alloy casting, non-etched state

speed during casting, or improper setup. Casting shape with uneven wall thickness may also be the cause. Product shape with excessive wall thickness difference is also a common problem [13]. Pores in Al castings are also formed e.g. due to inappropriate low-pressure casting parameters [14].

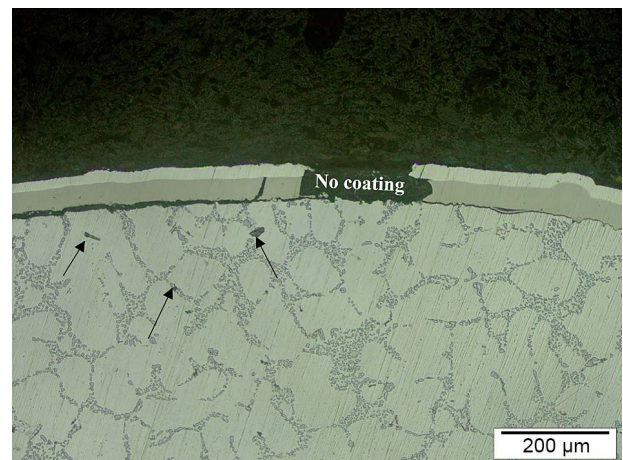
Fig. 8. Pores in the microstructure of the aluminium alloy after etching (some are marked with arrows) on sample 3, etch. 0.5% HF

After visualizing the AlSi7Mg0.3-T6 alloy microstructure after etching, pores at several locations in the microstructure became apparent (some are indicated by arrows in Fig. 8).

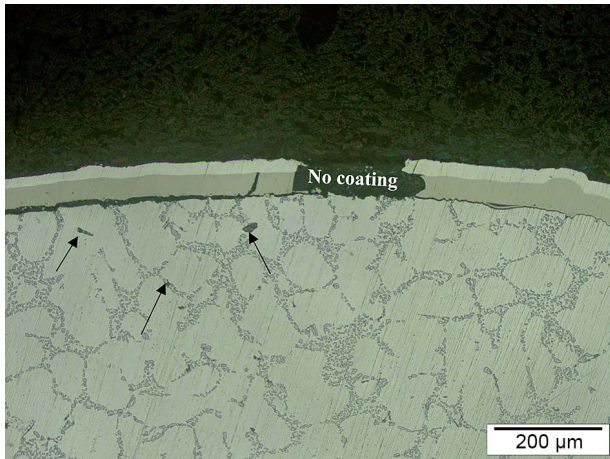
Fig. 9. Sample 5 with a layer of Ni and Ag on the surface. The arrow indicates the region of pores at the aluminium alloy/Ni coating interface, etch. 0.5% HF

In Fig. 9, sample 5 (according to Figs. 2c,f is documented after cross-sectioning. Pores were observed on the aluminum casting surface (under Ni coating). There were also residues of Ni coating in the pores.

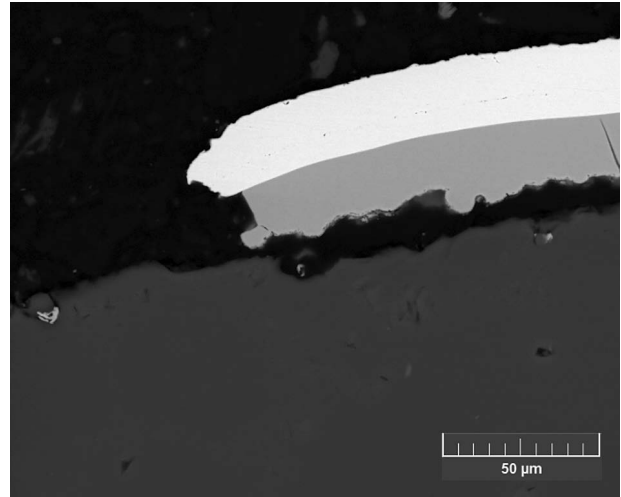
Fig. 10. Location of Ni coating adhesion loss to aluminium substrate material (SEM)

Scanning electron microscope (SEM) analysis of defects was performed using the backscattered electron method (BSE analysis). Observation results with the determination of the coating and the aluminium casting chemical composition by EDS analysis are shown in Figs. 10 to 12 and Tabs. 1 and 2. Fig. 10 shows a detail of the separation location of Ni coating from the aluminum substrate material, which was observed on sample 1 (Fig. 4).

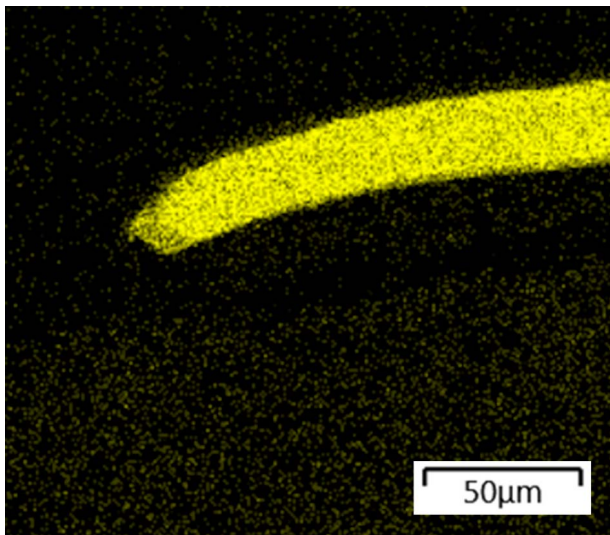
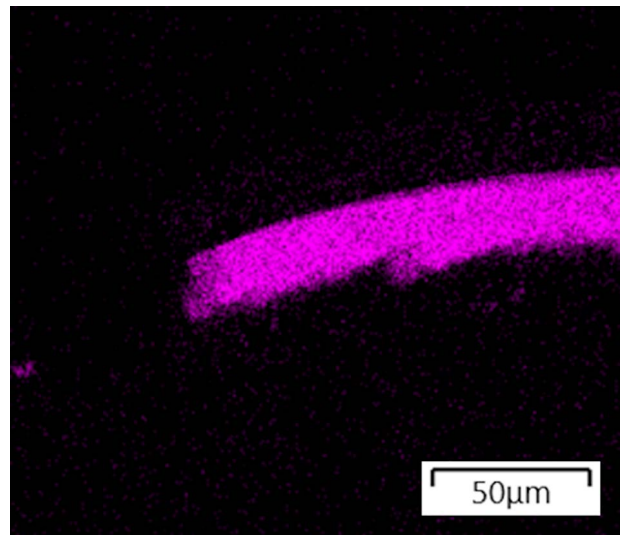
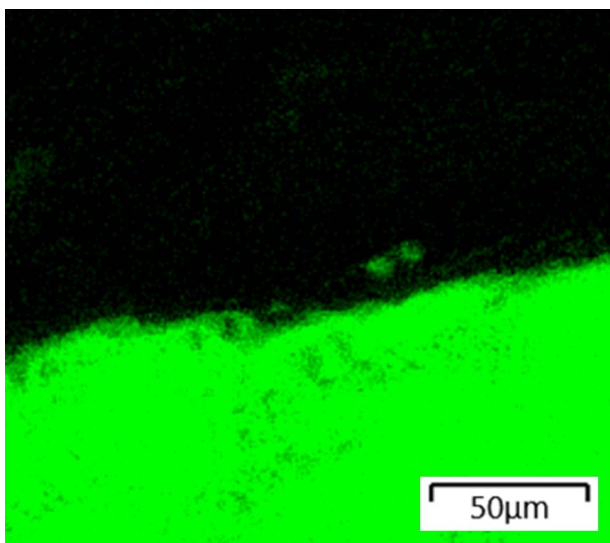
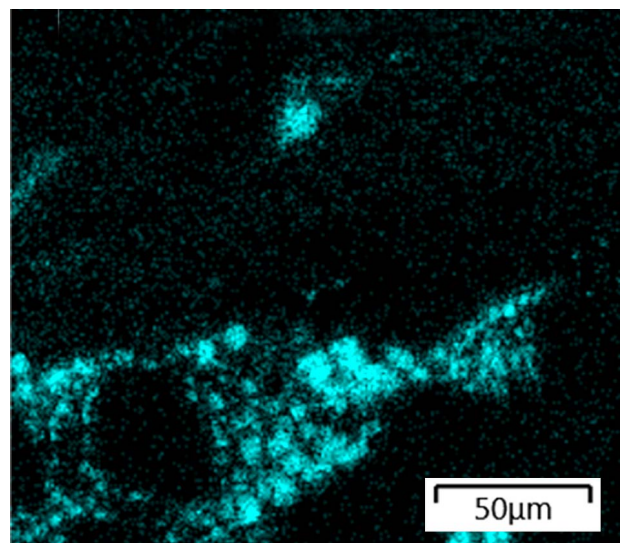
Fig. 11. Map of the analysed coating elements distribution and Al alloy (from Fig. 10)

A map of the distribution of the analyzed elements from the SEM observations is shown in Fig. 11. While Ag coating is well adherent and uniformly covers Ni coating, Ni coating itself is non-uniform and without adhesion to the Al alloy substrate material.

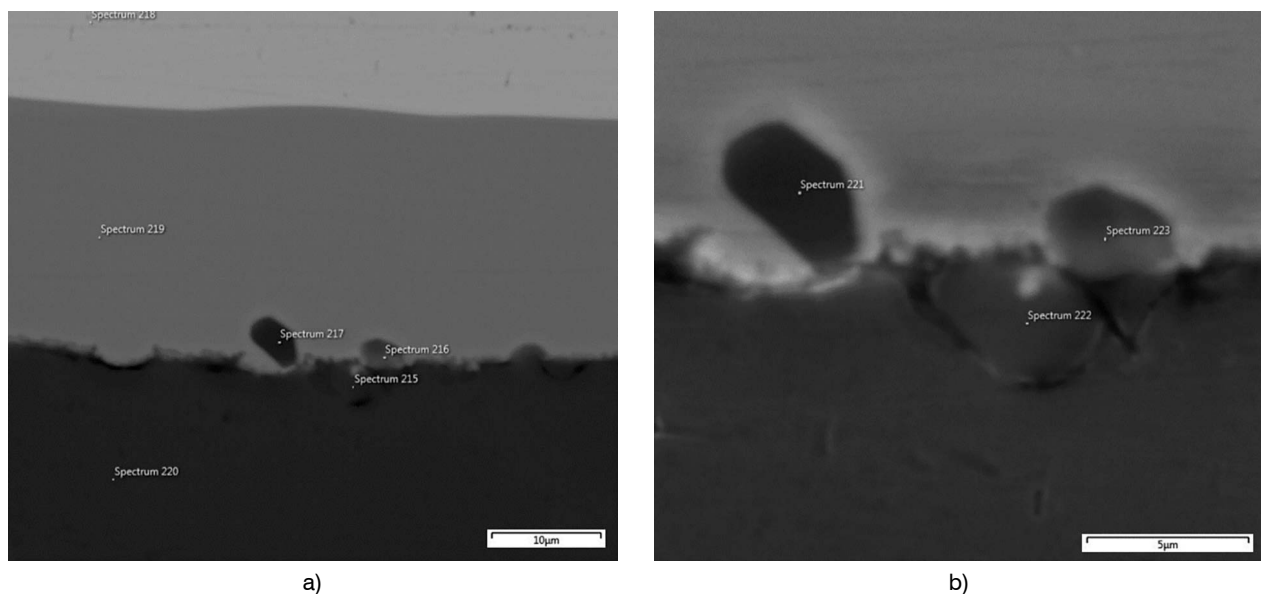
Documentation in Fig. 5 and the close-up in Fig. 6 showed the presence of debris at the location of Ni coating separation from the Al alloy. That location was analyzed by SEM and is shown in Fig. 12. EDS SEM analysis showed the presence of AlSi-based particles and Tabs. 3 and 4, which were part of the structure of the Al alloy. These particles are brittle and already during the surface mechanical pre-treatment they crumble into smaller fragments and separate from the surface. If they remain attached to the surface after electro-nickel-plating, they contribute to the loss of the adhesive strength of the deposited coating to the substrate material.

As reported by the authors [15], particles in Al alloys adversely affect the adhesion of electroplating coatings. The difference in electrical conductivity between the particles (in our case AlSi) and the aluminum matrix of the alloy creates an inhomogeneous field during electroplating, which leads to defects formation in Ni layer [16].

Fig. 12. Particles at the Ni coating and Al alloy interface: a) Spectrum 215-220 with EDS SEM analysis, b) detail on particles present, Spectrum 221-223 (SEM)
