# THE IMPACT OF VRANCEA MARCH 4, 1977 EARTHQUAKE ON THE BUILT ENVIRONMENT OF CRAIOVA

**Abstract:** Considering the adverse effects of 1977 Vrancea earthquake in Craiova, in addition to the old single-family residential buildings that suffered significant damage, newly built collective housing blocks constructed between 1960 and 1975 also showed major structural issues. A total of 69 buildings comprising 121 sections were identified. Fortunately, no collective residential buildings collapsed. Craiova had the highest number of large residential buildings damaged after Bucharest. Craiova was not considered a seismic zone according to the 1963 seismic zoning code, and therefore the structural requirements and seismic design regulations were not incorporated into the design of its buildings. This changed in 1978 due to the new seismic design code enforced at that time, when the structural systems made of masonry walls were replaced by large prefabricated panels in residential buildings with a height regime of ground floor plus four stories (GF+4S). Unfortunately, for the buildings damaged by the March 4, 1977 earthquake, only partial repair and retrofitting works were carried out.

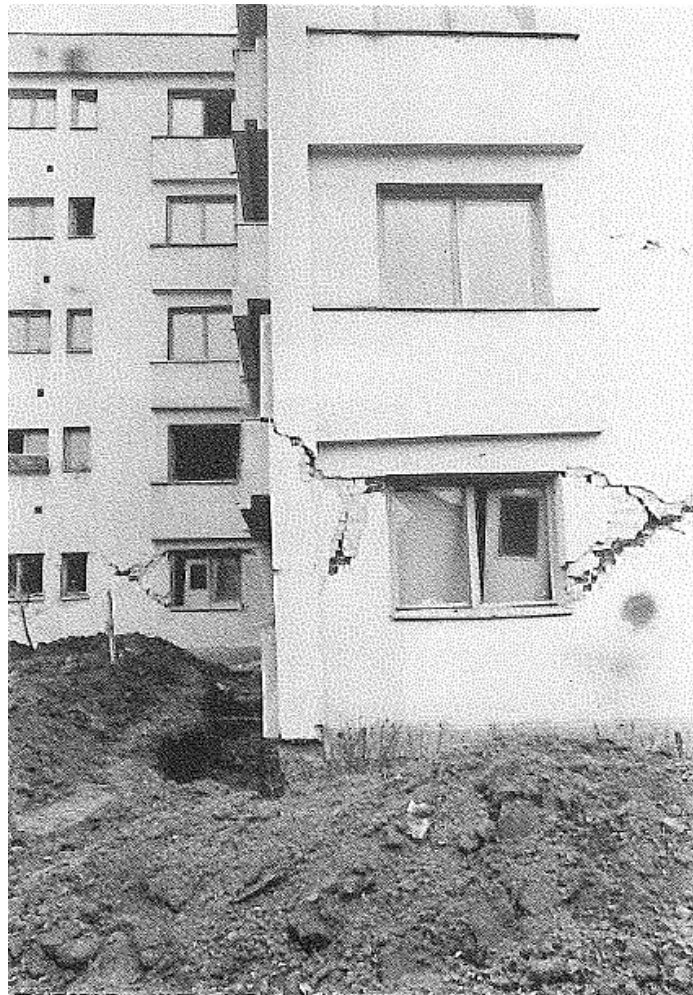
Among the buildings with ground floor and four stories (GF+4S) height regime, 28 apartment blocks were severely damaged, while another 151 sustained light damage. Most of the heavily affected buildings followed the GF +4 typology and featured a structural system consisting of unreinforced masonry walls. The floor slabs were made of prefabricated elements supported by reinforced concrete beams. Although vertical confinement columns were present in some sections, they were only constructed up to the first floor, as the city of Craiova had not been classified as a seismic risk zone. This building typology was widespread throughout the city, yet damage was concentrated primarily in the Valea Roşie and Piaţa Gării districts.

**Fig. 3.3** - GF+4 Masonry Buildings Severely Affected by the March 4, 1977 Vrancea Earthquake [8]

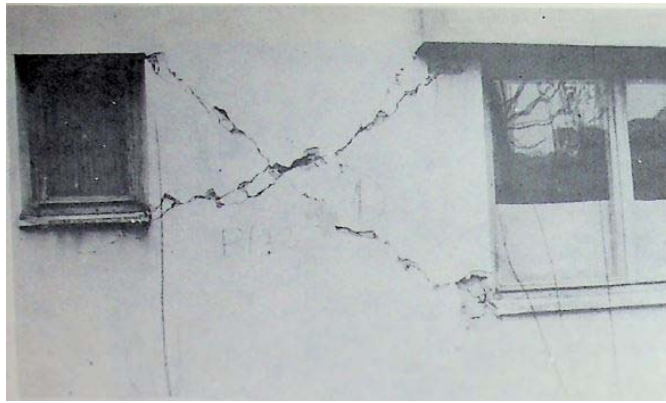
**Fig.3.4** - Masonry wall at the ground floor of a GF+4 building [8]

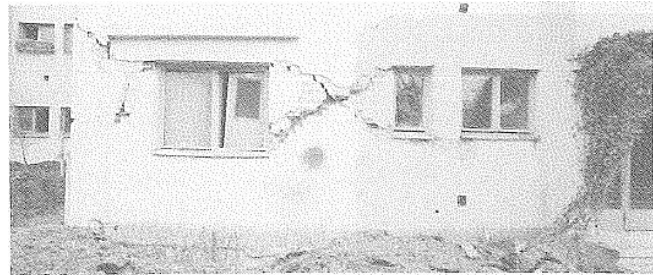
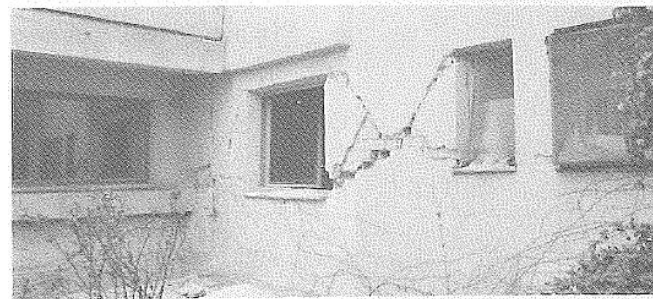
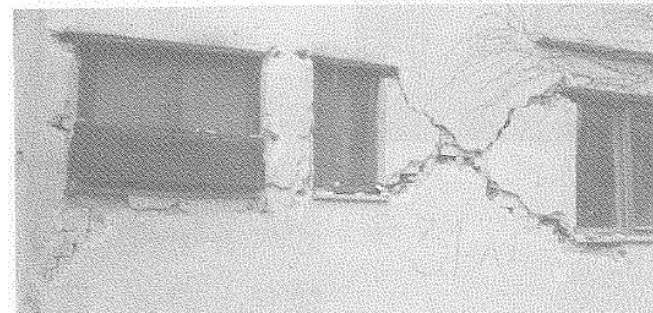
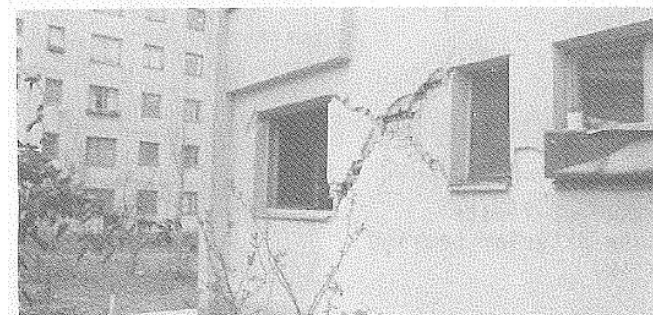
Major damage included cracks in masonry piers, X-shaped fissures, corner blowouts, and similar structural failures. Fortunately, no buildings with a height regime of GF+4S or higher collapsed. Although GF +4S masonry buildings were widespread throughout Craiova, they were severely affected in two districts and lightly damaged in one [6-8].

**Fig.3.5** - Masonry wall at the ground floor of G+4 buildings [8]

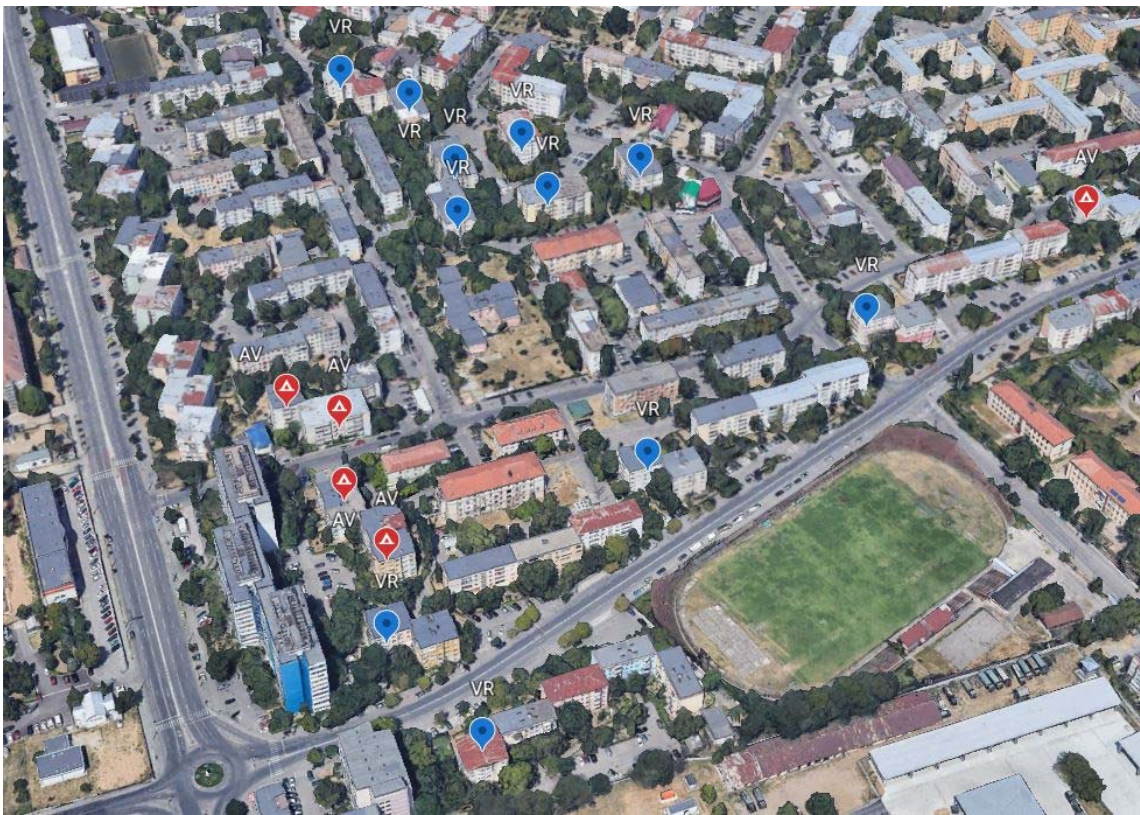
**Fig. 3.7** - Damaged buildings in the Valea Roşie District

- The very high percentage of damaged buildings in the Valea Roşie neighbourhood is also since the foundation soil is sensitive to moisture - macroporous soils [4].

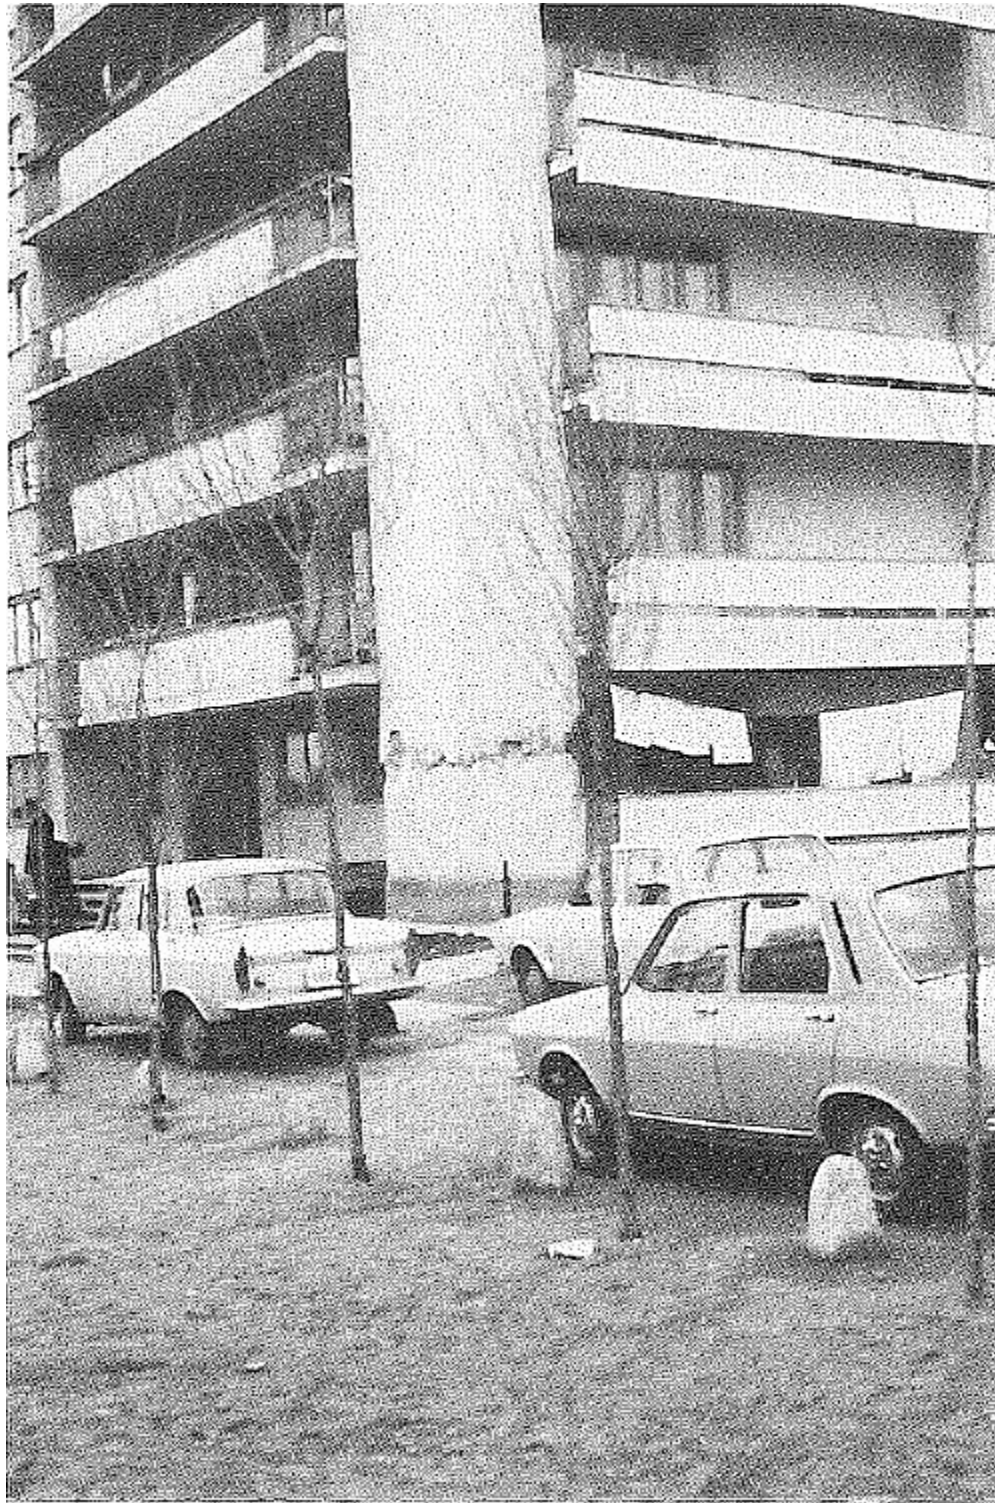
Also from the Valea Roşie district, there is a unique photo showing a GF+10S building affected by the earthquake, with a horizontal crack running across a wall on the ground floor.

**Fig. 3.8** - GF+10E Building Damaged in the Valea Roşie District [8]

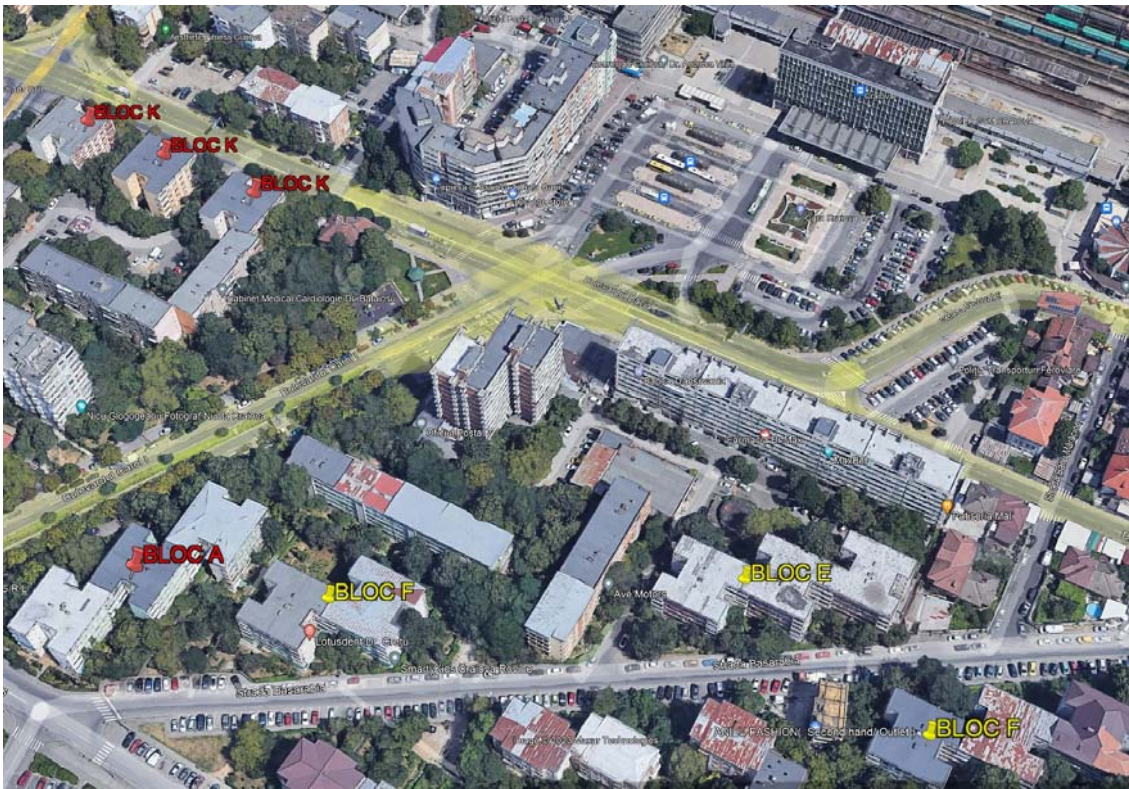
Another district where GF+4S masonry buildings were severely damaged was Piaţa Gării. In blocks H, A, and K, the masonry walls were cracked such as “*We could see our neighbours through the cracks in the walls.*” [5]. Unfortunately, no photographs of these buildings taken immediately after the 1977 earthquake are available. Their floor plans follow an H-shaped layout. A total of 18 such buildings were identified in the area surrounding Craiova’s train station.

**Fig. 3.9** - Typology of Damaged Buildings in the Piața Gării District

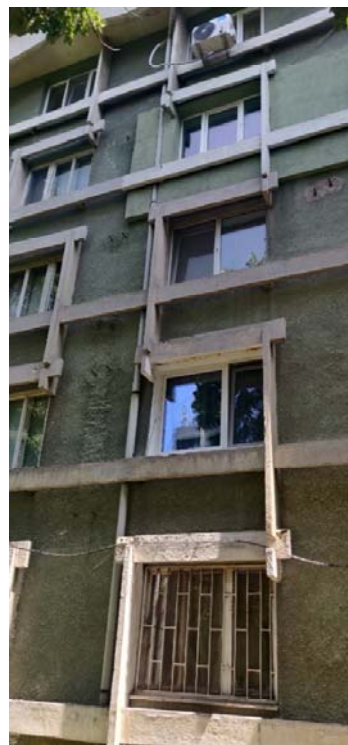
**Fig. 3.10** - Tie rods on the exterior wall of Block A

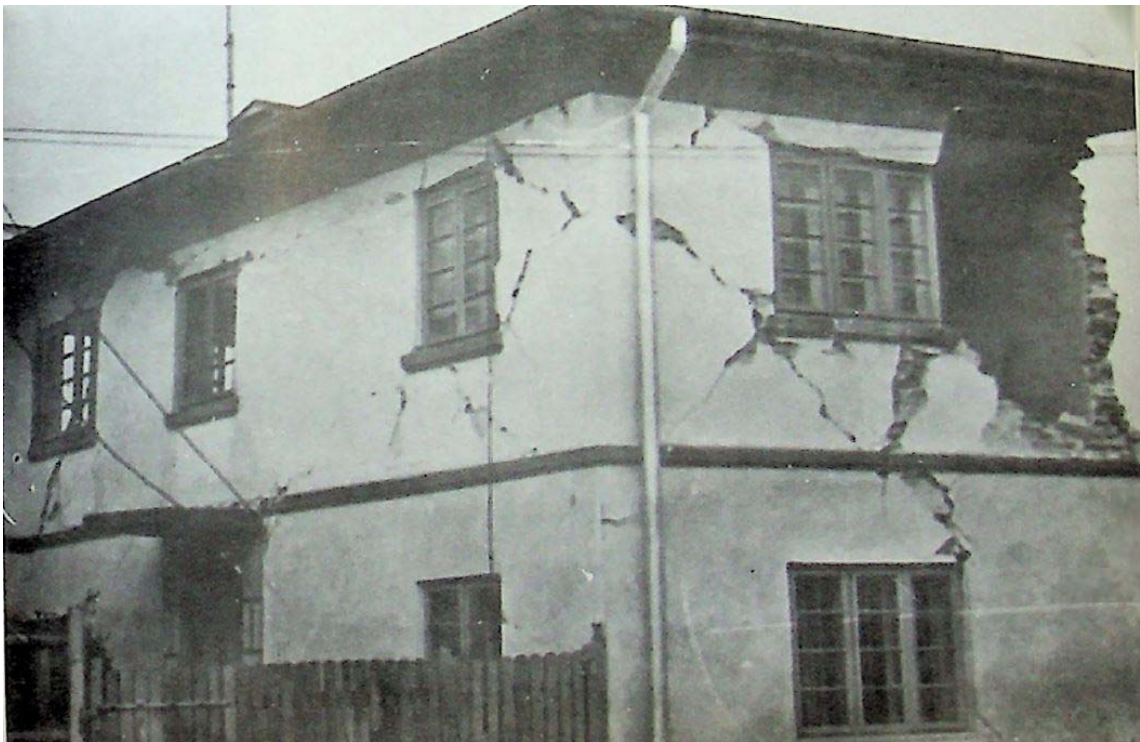
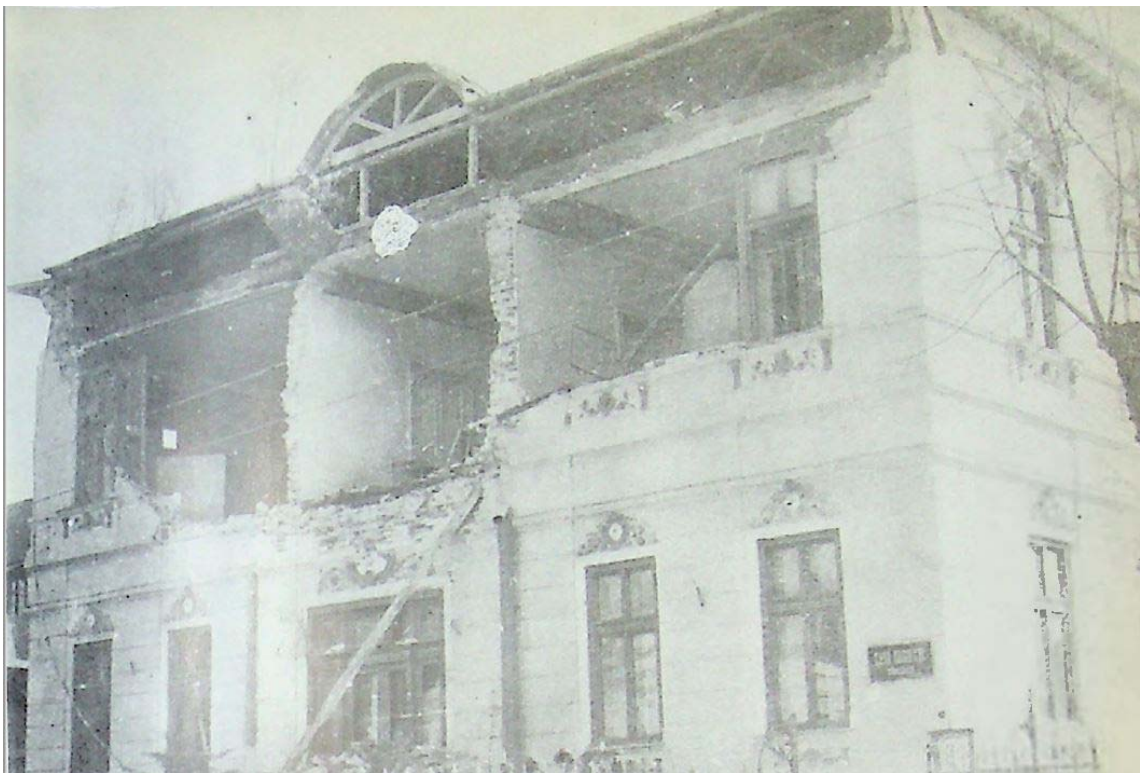
Significant damage occurred both in the centre of Craiova and in the peripheral neighbourhoods, where the built environment was old and construction materials lacked reinforced concrete.

**Fig. 3.11** - Damaged buildings in the central area of Craiova [5]

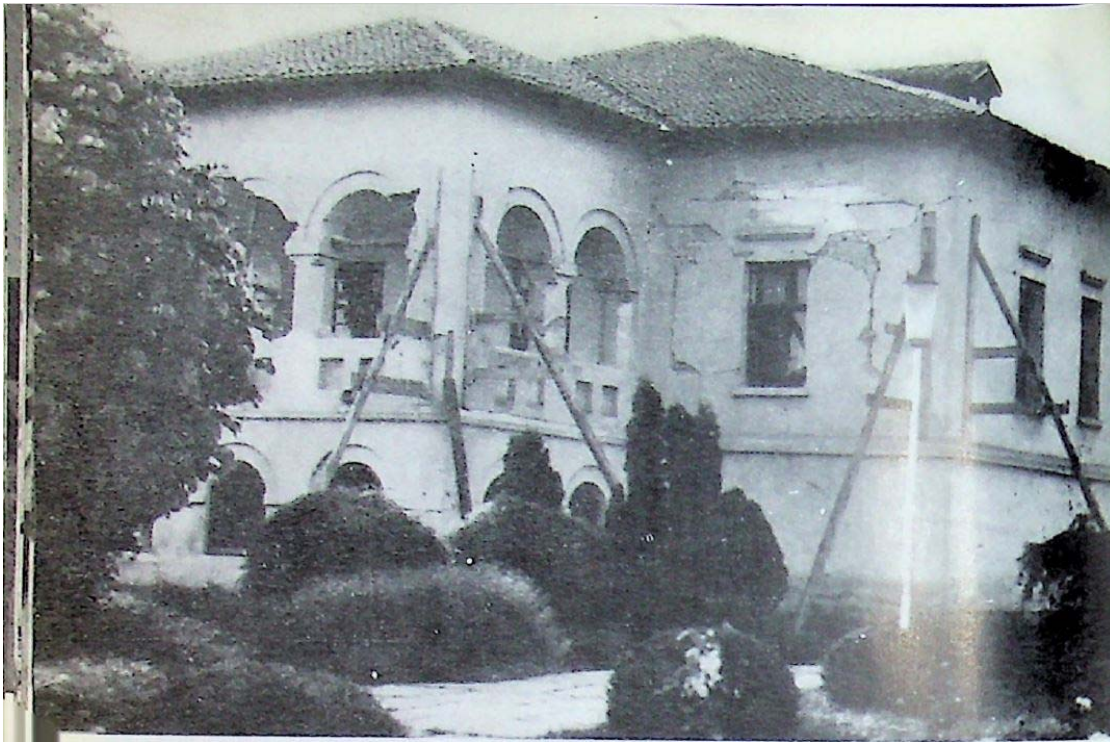
**Fig. 3.12** - Casa Băniei after the March 1977 earthquake [5]

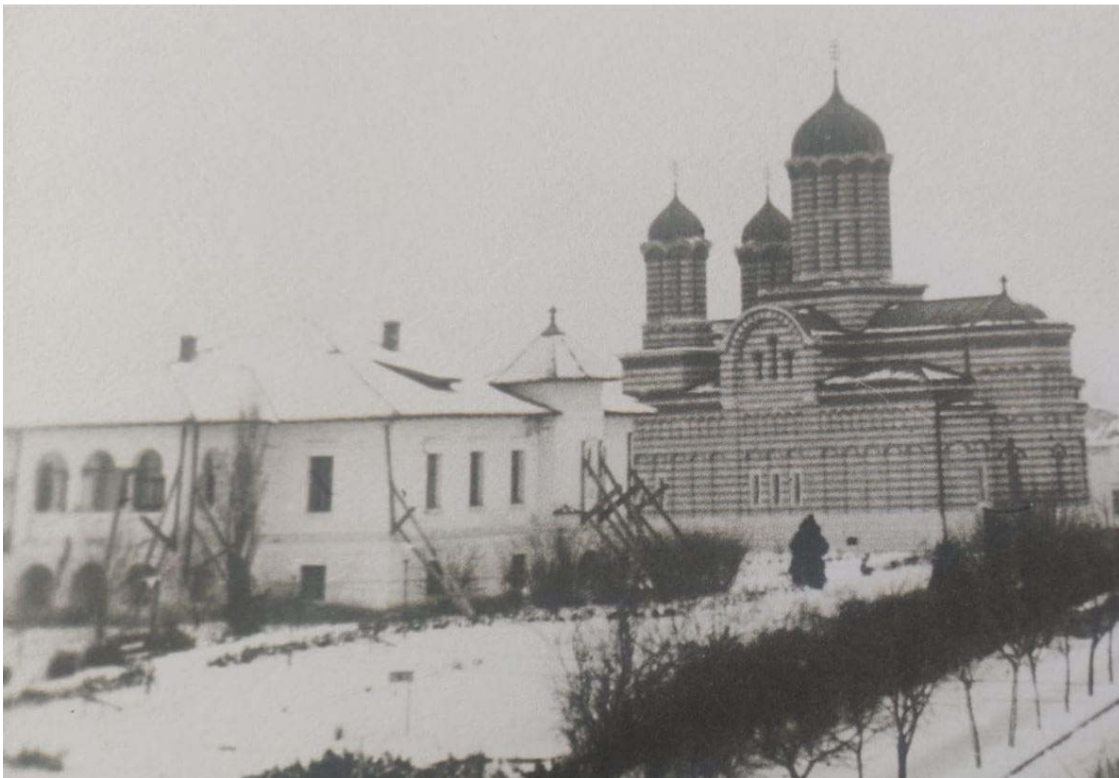
**Fig. 3.13** - Casa Băniei after the November 1940 earthquake

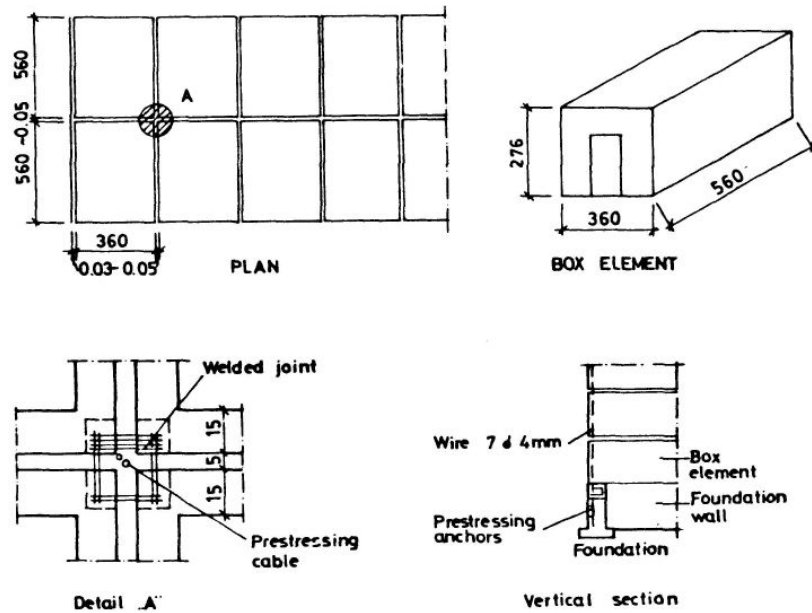
The study [16] mentions a building in Craiova that experienced a particularly unusual failure. In structures with “spatial box” systems, the columns between the prefabricated concrete boxes were reinforced with post-tensioning. This reinforcement was anchored at the foundation level into the bands of the slab above the basement. In one such building under construction, a failure of the anchorage was observed at the slab above the first floor.

Fig. 3.14 - Prefabricated blocks in Craiova known as “Spatial Boxes” assembled through vertical post-tensioning – execution details [16]

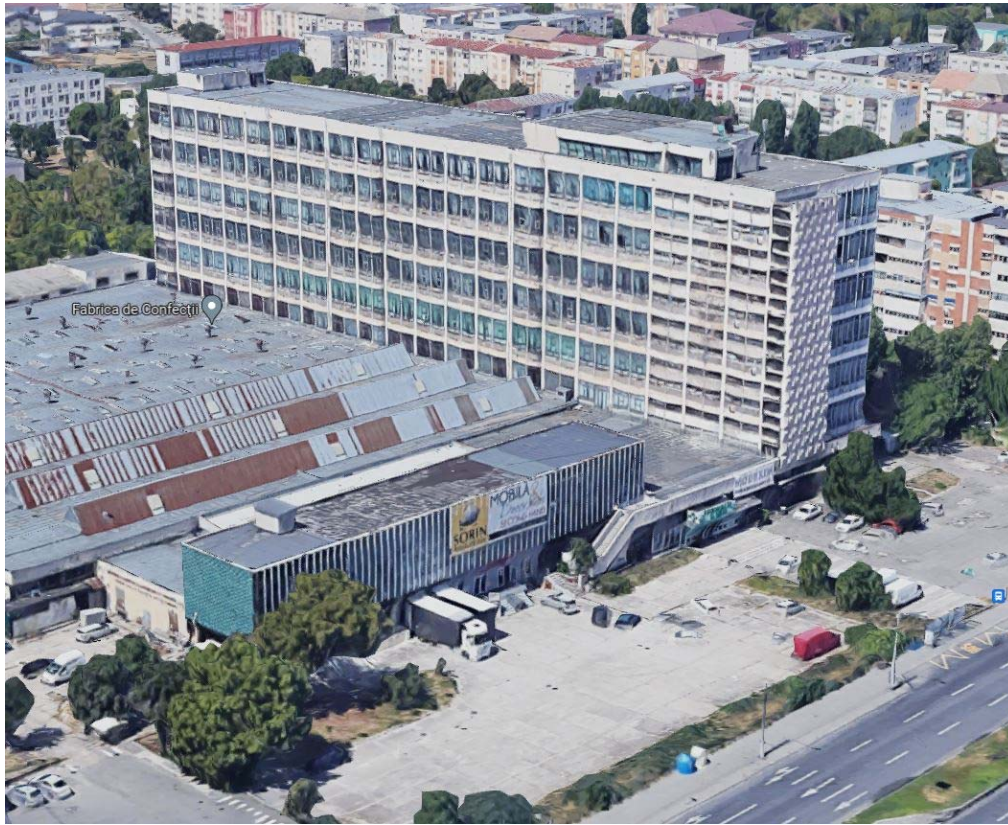
The highest number of casualties occurred at the Garment Factory, a slender GF+6S building with tall floors designed to allow natural ventilation. The building comprises three sections connected by joints, with a total length of approximately 140 meters. During the evacuation, panic among the large number of female workers rushing down the main staircase caused the handrail between the 3rd and 2nd floors to collapse, resulting in people falling down the stairwell. Amid the chaos caused by the earthquake and the railing collapse, three individuals jumped out of windows. In total, 14 people lost their lives and over 39 sustained serious injuries. The building itself did not suffer significant structural damage [5].

Fig. 3.16 - The Garment Factory Building
