# POSSIBLE APPROACHES OF NUMERICAL MODELLING OF SEEPAGE ANOMALIES AND CUT-OFF WALL SOLUTIONS FOR EARTHFILL DAMS

Emília BEDNÁROVÁ <sup>1</sup>, Juraj ŠKVARKA <sup>1\*</sup>, Marián MINÁRIK <sup>2</sup>, Branislav VLČEK <sup>3</sup>

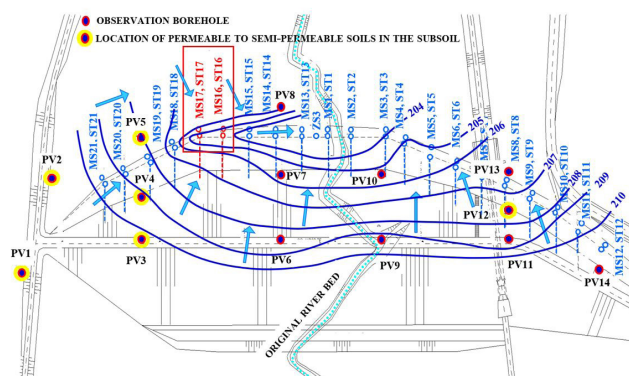
A detailed inspection suggested that the open bottoms of several shafts, together with defects in the collecting pipe, were the likely cause of the observed suffusion phenomena. To address these issues, the drainage system in the left downstream slope was reconstructed in 2019. The reconstruction included the replacement and leveling of the collecting pipe, as well as concreting the bottoms of shafts MS13 to MS21. These measures eliminated the transport of fine particles into the shafts and reduced the seepage collected in the left-hand part of the dam foundation (Fig. 4). Nevertheless, groundwater levels in boreholes PV7 and PV8 remained above the specified limits, i.e., the threshold values (Fig. 5). This situation provided the rationale for conducting a detailed study to clarify the causes of the development of the anomalous seepage and to propose remedial measures.

**Fig. 4** Position of observation boreholes and an overview of the development of seepage through the body and subsoil of the dam

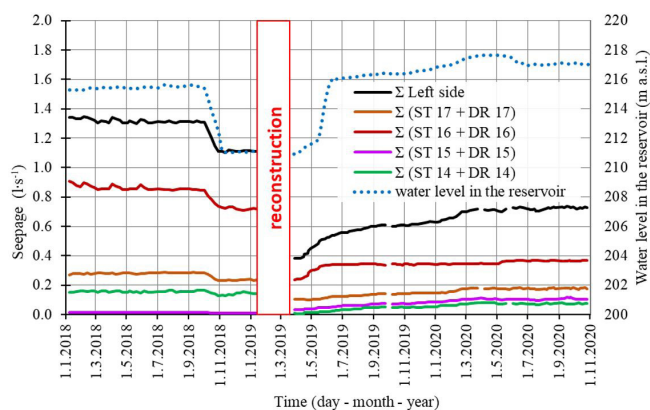
Fig. 5 Development of seepage – left-hand drainage system

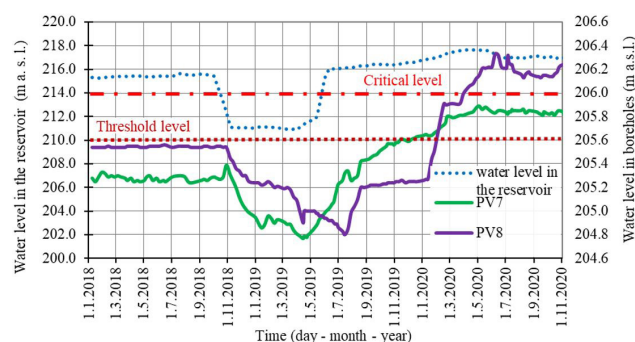
Fig. 6 Development of the water level in the reservoir and in observation boreholes PV-7 and PV-8

Without simulating an additional inflow into the subsoil, the initial calculations showed that the groundwater levels calculated did not correspond to the in situ measurements in PV7 and PV8. In particular, the simulated values for PV8 were consistently lower than the in situ measurements. This confirmed the significant role of the relief drainage system, which effectively captures seepage through the PV6–PV8 profile but does not intercept water bypassing the dam along the left valley slope (Fig. 6).

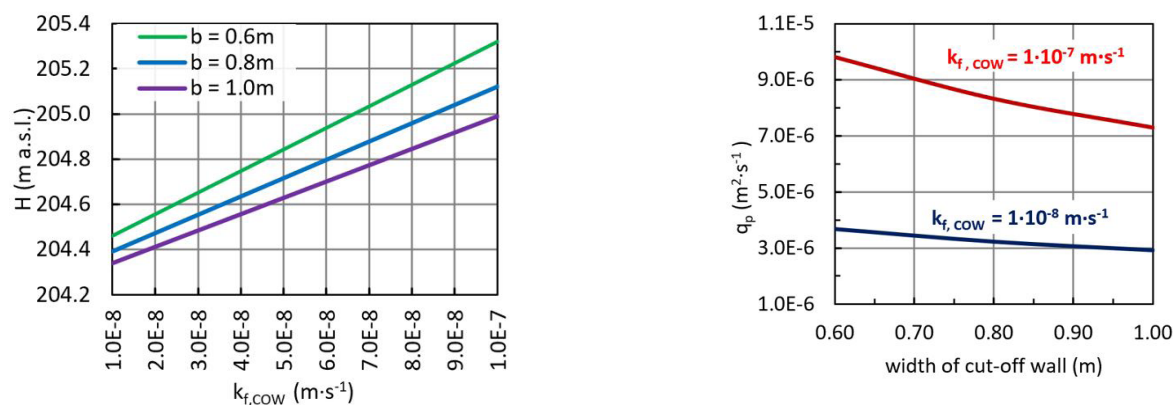
Figure 9 illustrates the relationships between the groundwater levels only in borehole PV8 and the seepage values in the PV3–PV5 profile for the different cut-off wall variants. The simulations indicate that the hydraulic conductivity of the wall has a stronger effect on efficiency than its thickness. In addition, the risk factors related to the filtration stability, such as the seepage rates and hydraulic gradients, were analyzed. These parameters were significantly reduced by the introduction of a cut-off wall; they reached values below the critical thresholds and thereby eliminated the risk of suffusion and internal erosion in the affected area.

**Fig. 10** Effect of the hydraulic conductivity of the cut-off wall and its width on a) the development of the levels in the PV-8 boreholes. b) the development of seepage in the dam's subsoil in the profile PV3 - PV5 at a maximum operating level of 218.60 m a.s.l.

The results clearly demonstrate the positive effect of a cut-off wall on reducing groundwater levels and seepage in the area of the dam examined. A comparison of the variants tested shows that a cut-off wall with a hydraulic conductivity of  $1.0 \cdot 10^{-8} \text{ m} \cdot \text{s}^{-1}$  provides a greater reduction in seepage and groundwater levels than a wall with  $1.0 \cdot 10^{-7} \text{ m} \cdot \text{s}^{-1}$ . For instance, a cut-off wall with  $k_f = 1.0 \cdot 10^{-8} \text{ m} \cdot \text{s}^{-1}$  and a thickness of 0.6 m achieved a more significant improvement than a wall with  $k_f = 1.0 \cdot 10^{-7} \text{ m} \cdot \text{s}^{-1}$  and a thickness of 1.0 m.
