# An inventory of selected sources of light pollution in Tarnów

**Keywords:** light pollution, Tarnów, inventory of lighting, improper lighting

## 2. Tarnów – inventory of artificial lighting sources in selected areas

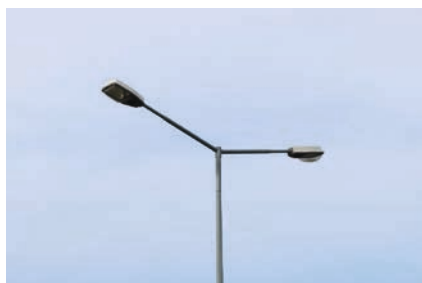
There is also another type of sodium lamp with a newer design on Tarnów streets, which contributes less to light pollution (Fig. 5). The filament is wholly hidden within the shield, but the lamp cover is still convex, so the light scatters on it.

**Fig. 5.** A lamp with a newer shield type but still with a convex cover (photo by: I. Esmund)

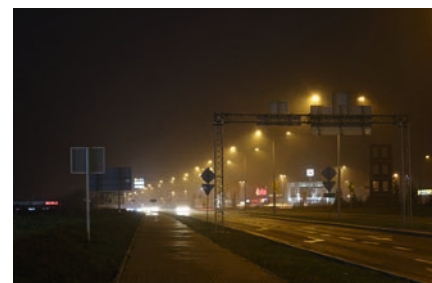
Figure 6 shows the weaker upward emission of light from the newer lamps. Most of the light rays indeed illuminate the street, which is connected with the correct lamp setting. The factor that causes light pollution is, in this case, the convex cover upon which the light rays scatter. Insufficient lighting of the pavement on the street is another noticeable issue. Placing lamps between two lanes only makes the road well lit. However, the problem should not be solved by, for example, lifting the lamp shields. Such an action would increase the excessive lighting of the area, while at the same time deteriorating the illumination of the road.

**Fig. 6.** The effect of using lamps with newer shields, Błonie St. (photo by: I. Esmund)

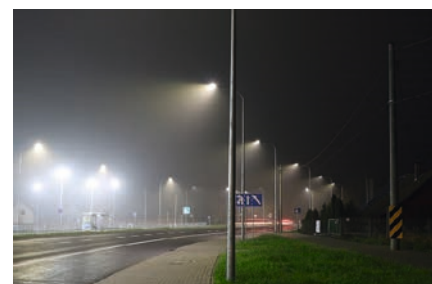
**Fig. 8.** Light directed in different ways on Błonie St. (photo by: I. Esmund)

Figure 8 shows LED lamps located on Błonie St. on the outskirts of Tarnów. This proves that the proper construction of artificial light sources, as described above, brings positive effects. The foggy weather demonstrates that the light is only slightly scattered below the line of the horizon. Incident light illuminates a specific space, only the street and pavement, nothing more. It should be noted that not all LED lamps are mounted in the right way. It may be even noticed that the orientation of each differs slightly from the orientation of the next. As a result, light is spreading at different angles. Lamps on the left side of the street are positioned more correctly.

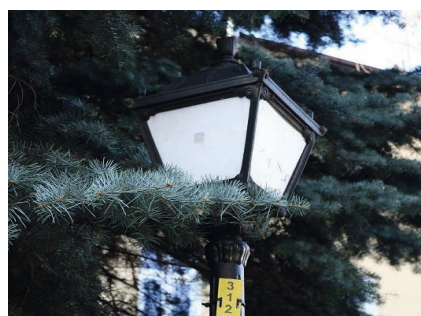
One of the inventoried examples of park lamps are those found on Sándor Petőfi Sq. on Krakowska St. (Fig. 17). In addition to the problems discussed earlier, Fig. 18 shows new issues worth addressing. First, grass and tree trunks are illuminated as strongly as the pavement. Even the shadow cast by one of the trees is visible. In this case, there is a phenomenon the light-trespass – light reaching places that it should not enter or where it is entirely unnecessary. However, the nearby pavement could be better illuminated. Worth noting is the darker area at the base of the lamp and the lighter area under the trees.

**Fig. 17.** A park lamp in Sándor Petőfi Sq., on Krakowska St. (photo by: I. Esmund)

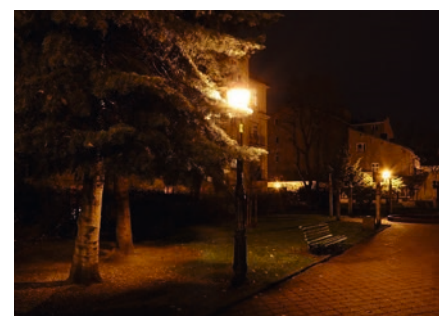
**Fig. 18.** A park lamp in the square at night (photo by: I. Esmund)

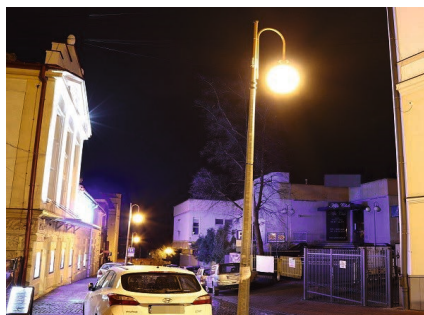
**Fig. 20.** Lamp with a spherical cover at night, Staszica St. (photo by: I. Esmund)

Another type of park lamp is the one with a spherical cover, without a top visor. An example of such a lamp can be found on Staszica St. (Fig. 19). The photograph of this lamp taken at night (Fig. 20) confirms that as a result of the lack of any cover, lighting causes the excessive emission of light into the environment and the pollution of the night sky with artificial light. As well as the ground, the lamp illuminates a fragment of the wall visible on the right. This is the most harmful and improper type of park lamp.

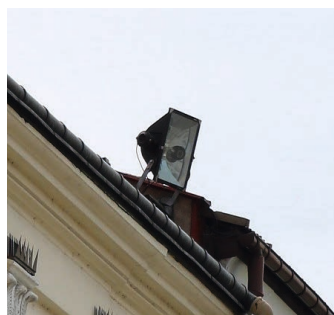
**Fig. 22.** The circled spotlight from Fig. 21 in close-up (photo by: I. Esmund)

The reflector presented in Fig. 22 is one of several that illuminate Tarnów Town Hall. Their construction is correct. Models with flat or even concave covers were used, as well as opaque shields; as a result of this, light is directed in only one direction. In this case, the light pollution is caused by the improper, practically vertical alignment of the reflectors. The light propagates horizontally instead of downwards. In this way, it is dispersed, and a large part of it is dispersed upwards.

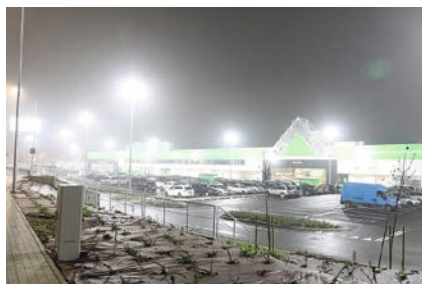
A view of the described car park at night is presented in Fig. 31. The applied light is so intense that it causes the phenomenon of glare. Our eyes are dazzled; a long time often passes before they adjust to the changing lighting conditions. This situation is hazardous, especially for drivers who suddenly reach this area from less-lit places. During the period while their eyes are adapting to the new light intensity, an accident or collision may occur. Additionally, a light-trespass

**Fig. 31.** View of the car park at night time (photo by: I. Esmund)

phenomenon occurs – the lighting of surfaces that should not be illuminated. This light illuminates the grassy roadsides and pavement by the main road, which is also lit by street lamps. These surfaces are therefore illuminated twice, which is entirely unnecessary. The floodlights used also contribute to an increase of the phenomenon of artificial sky glow, i.e. the light glow over the city. Therefore, all three categories of light pollution occur in the described area.

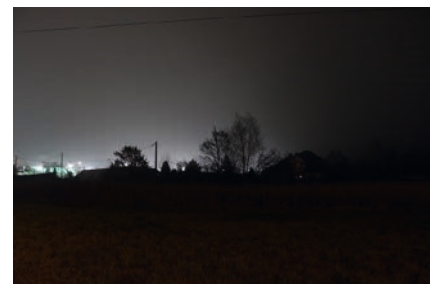
**Fig. 32.** Parking lighting effect visible from a greater distance (photo by: I. Esmund)

The effects of excessive and improper lighting, accompanied by autumn fog, are very clearly visible in Fig. 32. Moving away from the car park area allows one to notice the scale of the excessive lighting of this place. First of all, there is a glow from the parking space. It is also noticeable from more distant places than the point from which the above photograph was taken. Distinguishing each the lighting sources in it is not possible. The artificial glow comes from the entire parking space.

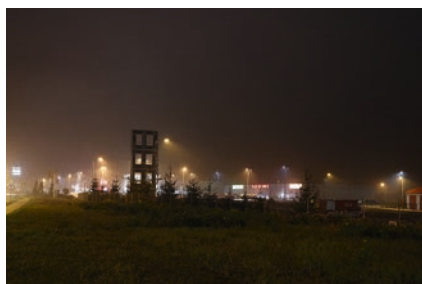
Lamps used in the car park (Fig. 33) are correctly constructed. As can be seen in the photo, the light shafts are directed to the ground. There is no visible glare effect when looking at this area from a distance. The lamps used have the correct light intensity. They light up the car park sufficiently, without the effect of lighting the neighbouring city and significant energy (and thus financial) losses.

**Fig. 33.** View of the square near the shopping space at night, Błonie St. (photo by: I. Esmund)
