# Seepage in Existing Earthen Dams in Sri Lanka

A. I. Liyanage, N. H. Priyankara and L. S. Sooriyabandara

**Keywords:** Earthen dam, Mitigation technique, Seepage, Tissa Wewa

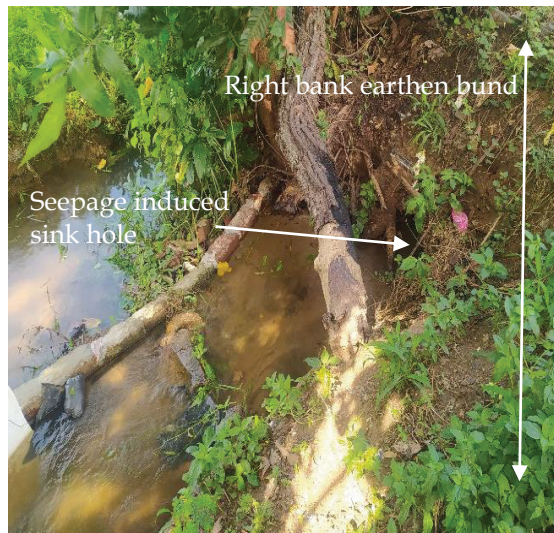
Divisional irrigation engineers take the responsibility of continuous monitoring of dam status and they have to report the condition of dams to the "Dam Safety" division in the head office of IDSL, monthly. As a result of this monitoring system, seepage of the Tissa Wewa had been observed in the year 2019 [21]. Initially, seepage had been observed at one location as shown in Figure 4, and seepage was at its lowest level. Two further seepage spots were discovered in 2020 [22].

According to the available recordings, it was found that peak seepage is observed when the tank water level reaches FSL, i.e. 4.75 m (15 feet) [22]. Table 1 presents the cumulative seepage values under different water levels [22]. According to the data presented, seepage appears when the tank water level reaches 3.96 m (13 feet). As a corrective measure to control the seepage, the tank water level must be maintained below 3.96 m (13 feet).

**Figure 4 - A Seepage Location at Tissa Wewa**

In the year 2022, the Engineering Material Branch in IDSL, introduced a thin clay cutoff wall at upstream (parallel to the seepage locations) to control the seepage. After introduction of the clay cutoff wall, seepage has been controlled and now it is maintained around 4.5 l/s. Even if the seepage is controlled at this level, Table 3 shows the possible irrigable area to be cultivated using seepage water. Based on the calculations presented in Table 3, it can be noted that about 210 acres of cultivated lands can be irrigated per year using the seepage water. These results indicate that, even now, if the seepage is maintained in existing intensity, it loses a considerable amount of water which is sufficient to commence the cultivation of around 210 acres.

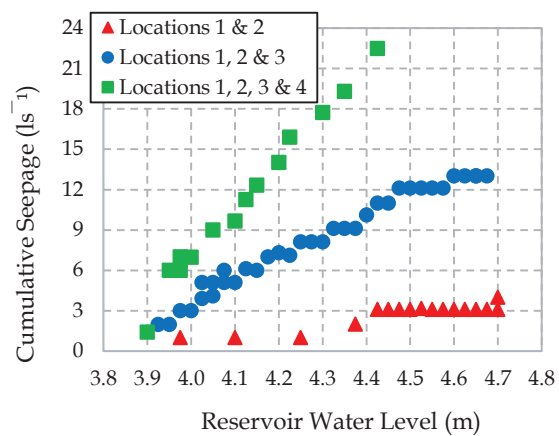
Figure 5 depicts the variation of cumulative seepage over reservoir water level at different locations, which were identified at different stages. It can be seen that under the seepage of locations 1 and 2, maximum cumulative seepage is  $3.0 \text{ ls}^{-1}$  even under the reservoir water level at FSL of 4.75 m. However, when the third seepage location was identified, cumulative seepage was increased to  $13.0 \text{ ls}^{-1}$  under the water level at FSL. Further, it can be noted that, cumulative seepage has been significantly increased upto  $22.49 \text{ ls}^{-1}$  even under the low reservoir water level of 4.43 m when the fourth seepage location was identified. This clearly indicates the importance of immediate remedial actions once the seepage locations were recognized in the field.

**Figure 5 - Variation of Cumulative Seepage Versus Reservoir Water Level**

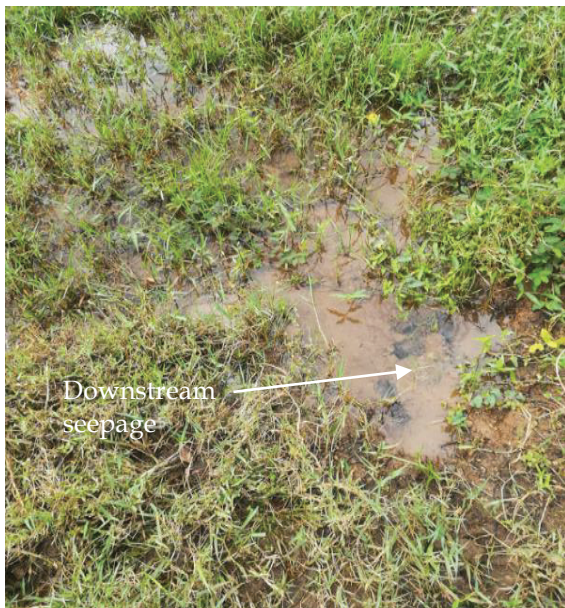
1000-2000 years ago [11] [17]. With time, at present, these reservoirs have developed seepage issues through the earthen dams. For instance, seepage problems are also present in Parakrama Samudra. In addition, there are seepage problems in major reservoirs like Girithale and Minneriya tanks. Table 4 shows few reservoirs that exhibited considerable seepage losses [26][27]. The seepage points at the Parakrama Samudra and Girithale tank are depicted in Figure 6 and Figure 7, respectively.

**Figure 6 - Seepage in Parakrama Samudra**

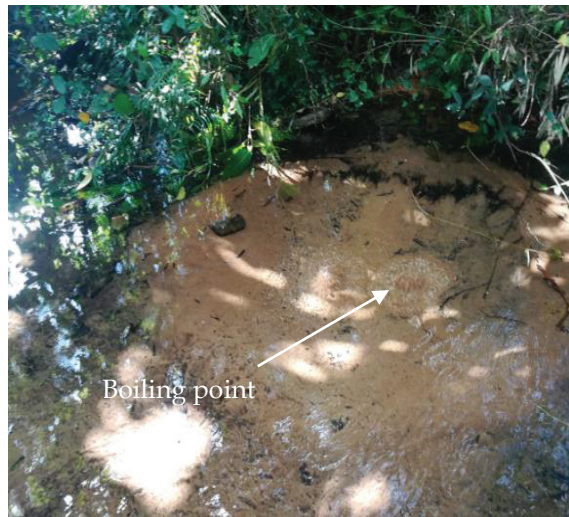
**Figure 7 - Seepage Induced Boiling point in Girithale Tank**

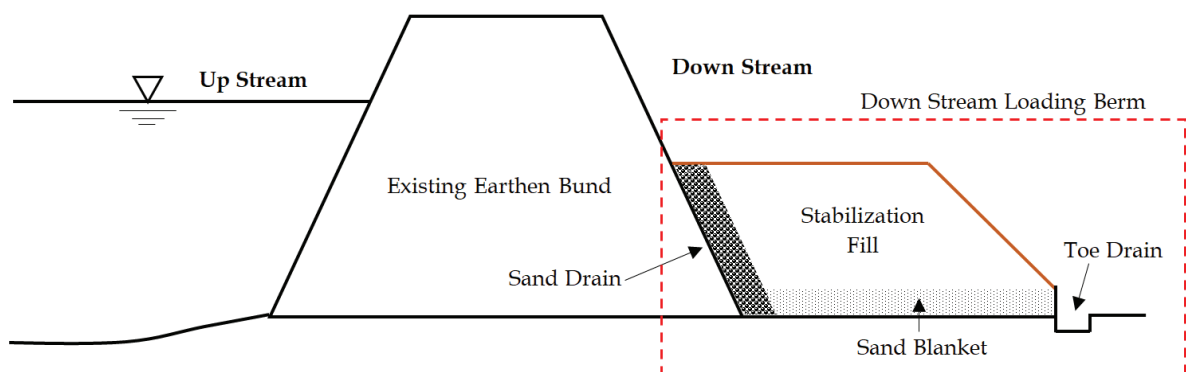
The seepage of Vendarasankulam reservoir has existed for more than 20 years and IDSL introduced a loading berm to minimize the seepage in 1989 [13]. According to available data, IDSL constructed a loading berm as shown in Figure 8. The components in loading berm are stabilization fill, a sand blanket, a network of sand drains and a toe drain. During the construction, a strip of sand blanket was merged with sand drains and placed along the downstream toe of the dam. Sand drains had been constructed underlying the sand blanket to channel the water from the sand drains to the sand blanket. A rubble-pitched toe drain had been constructed to drain out all the drain water channels from the sand drain network. About 3m high stabilization fill had been placed on top of the sand blanket to create a surcharge effect (Figure 8). After construction of the loading berm, the following observations were made through the dam body [13].

1. Sand was washed away from the sand blanket in the toe drain. As a result, existing pot holes lead to failure of the bund.
2. Seepage is continuing along the entire length of the dam.
3. A new boggy area was founded downstream of the dam.
4. Reservoir storage was limited to 10m level. This is 60% of the reservoir's full capacity.
5. In the year 2002, reservoir bund shows piping at some locations.

These observations show that loading berm technology used to control the seepage in Vendarasankulam reservoir was not successful.

Figure 8 - Schematic View of the Loading Berm

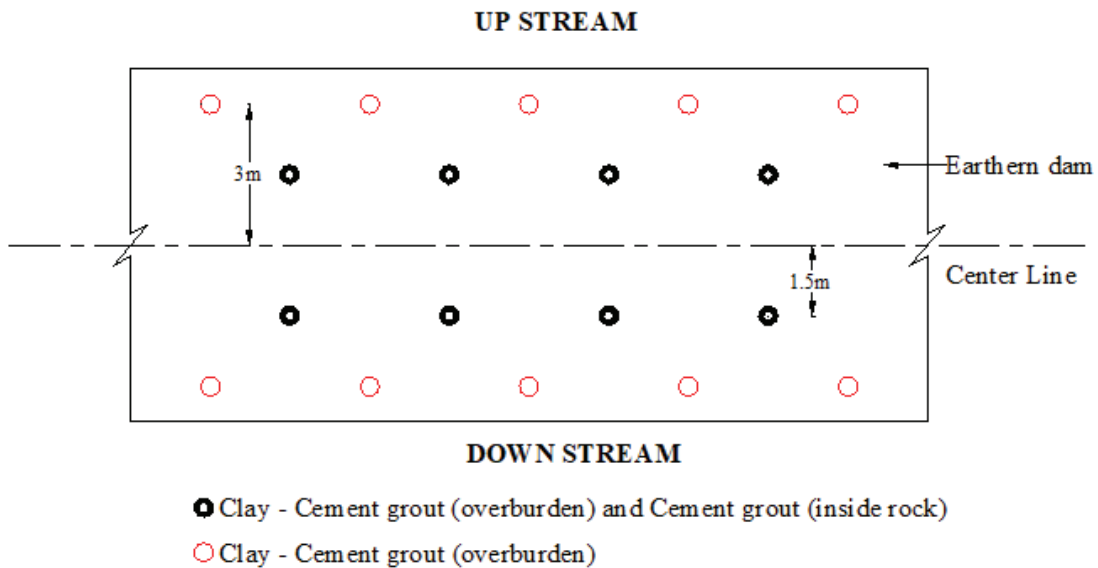
After the completion of grouting process, it was observed that seepage reduced considerably. However, with time, seepage issues again arose in Vendarasankulam reservoir (Figure 10) and IDSL gave attention to apply a new method or technology to control the seepage.

**Figure 9 - Grouting Arrangement in Vendarasankulam Reservoir**

At stage 1, 37 holes were drilled in the overburden in two rows in parallel arrangement with a 3.0m distance from the centre line of the bund top as shown in Figure 9. The grout used had the composition of water:clay:cement ratio of 20:10:1 by volume.

Stage 2 had been started 2 months after completion of stage 1 in the year 2007. Thirty-six (36) holes were drilled in two parallel axeslines, 1.5m away from the centre line of the bund top. In overburden layers, stage 1 mix ratios were adopted while rock layer was treated by cement grout only. Initially, 7:1 water:cement ratio was used. However, based on the site observations, mix ratios had been modified to 5:1 and later 3:1.

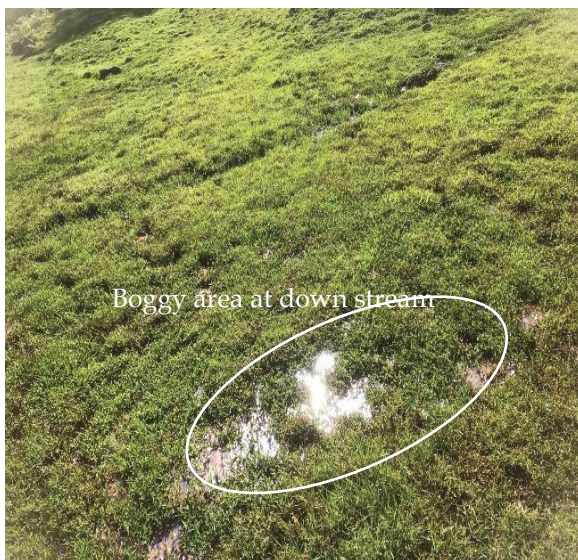
At present, seepage is controlled by limiting the storage capacity of the tank. The tank capacity on its FSL is around 22,000 acre-feet. However, due to high seepage, tank storage was limited to 16,000 acre-feet as the controlling action. Based on the above analysis, it can be clearly seen that the conventional methods adopted to control the seepage were not successful. Hence, this case study highlighted the requirement for new construction method/s for successful seepage mitigation.

**Figure 10 - Present Day Seepage at Vendarasankulam Reservoir**

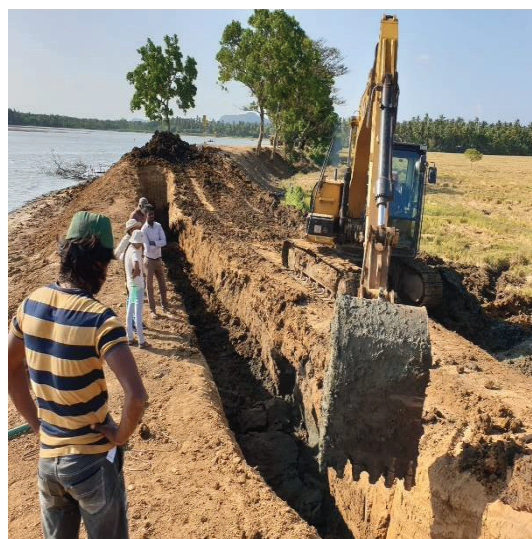
upstream and as a result of that, root systems have extended to inside the dam body. With time, one of the huge trees died and after a couple of months, seepage was observed in the downstream exactly opposite the location where the above tree was. As per site inspections and the Engineer's advice, IDSL constructed a clay cut-off wall along the existing dam body around a 50m stretch which covers the seepage locations. Clayey Sand (SC) was used as the filling material. Photo of the excavation of trench to construct the clay cutoff wall is illustrated in Figure 11 whereas clay core placement and compaction is depicted in Figure 12. It was reported that seepage has disappeared after this rectification technique [28].

Debarawewa Reservoir is a 2500 acre-feet reservoir situated in Hambantota district. The tank has exhibited seepage issues in the year 2019 [20]. Many large trees were on the

**Figure 11 - Clay Core Trench Excavation in Debarawewa Reservoir**

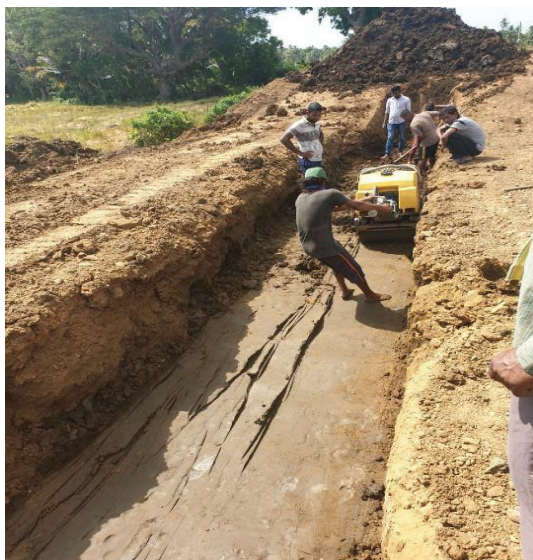
**Figure 12 - Clay Core Placement and Compaction**

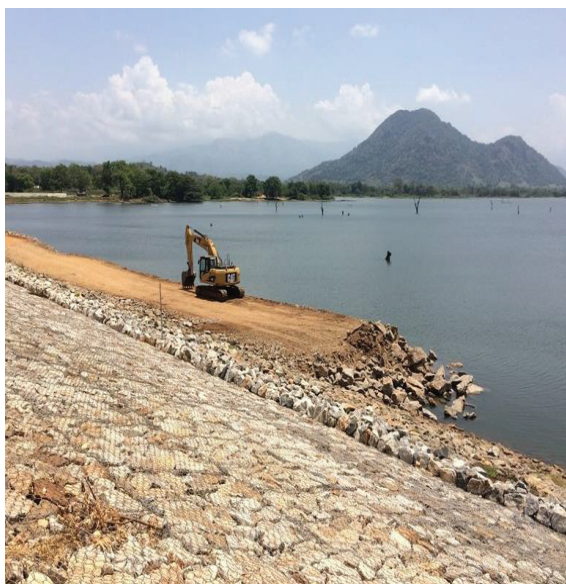
A successful implementation of upstream loading technique to control the seepage is reported in Handapanagala reservoir. Handapanagala reservoir is a 15,590 acre-feet reservoir situated in the Monaragala district. It was built in the ancient period and caters for more than 3500 acres of paddy and other crops. Initially, the reservoir was 5 m high and its capacity was 5000 acre-feet of water. Under the Uma Oya downstream development project, reservoir was developed to store 15,590 acre-feet. Subjected to reservoir development, the bund was raised to 15 m from the existing 5 m height. After completion of the reservoir bund, it had been identified that a 3.8 l/s of seepage occurred.

**Figure 13 - Upstream Loading in Handapanagala Reservoir**

Hence, as per the engineer's advice, upstream was loaded by large boulders around 10 m distance inside the tank bed along the suspected seepage origin places as shown in Figure 13. This loading was implemented in the year 2018 and seepage disappeared after completion of this upstream loading [29].
