# Analysis of Power System Failure Occurred on 09 February 2025 in Sri Lanka's Power System

N. S. Wettasinghe

**Abstract:** This paper discusses the total power system failure that occurred in Sri Lanka on 9 February 2025 and reviews the key technical aspects intended to ensure the smooth and stable operation of the power system. The study examines the performance of (a) protection relays, (b) the Under Frequency Load Shedding (UFLS) scheme, (c) frequency-controlling machines, and (d) inverter-based solar and wind power plants during the disturbance. The analysis identifies deficiencies in system response, particularly in the coordination of protection systems and the behaviour of inverter-based generation under abnormal grid conditions. Based on the findings, the paper recommends the implementation of robust, grid-friendly inverter control settings and the enactment of regulatory provisions to ensure mandatory compliance by all stakeholders. These measures are essential to enhance power system resilience and prevent similar large-scale failures in the future.

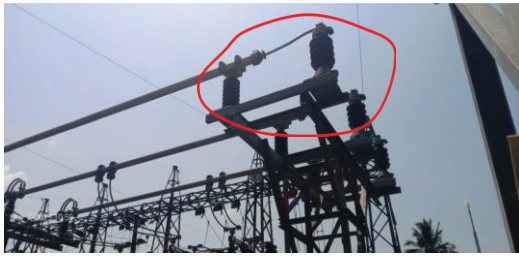
Photograph 1 - The affected bus bar section

The fault was initiated when a monkey came into contact with the 33 kV bus bar section 1 and the lightning arresters installed on the bus section near the control room. Two surge arresters corresponding to phases R and Y were completely destroyed due to an arcing flash. The surge counters of both phases were damaged,

and the arresters were likely short-circuited to ground, resulting in their failure.

Photographs 1, 2, and 3 illustrate the equipment failures and the monkey carcass found at the Panadura Grid Substation on the date of the failure.

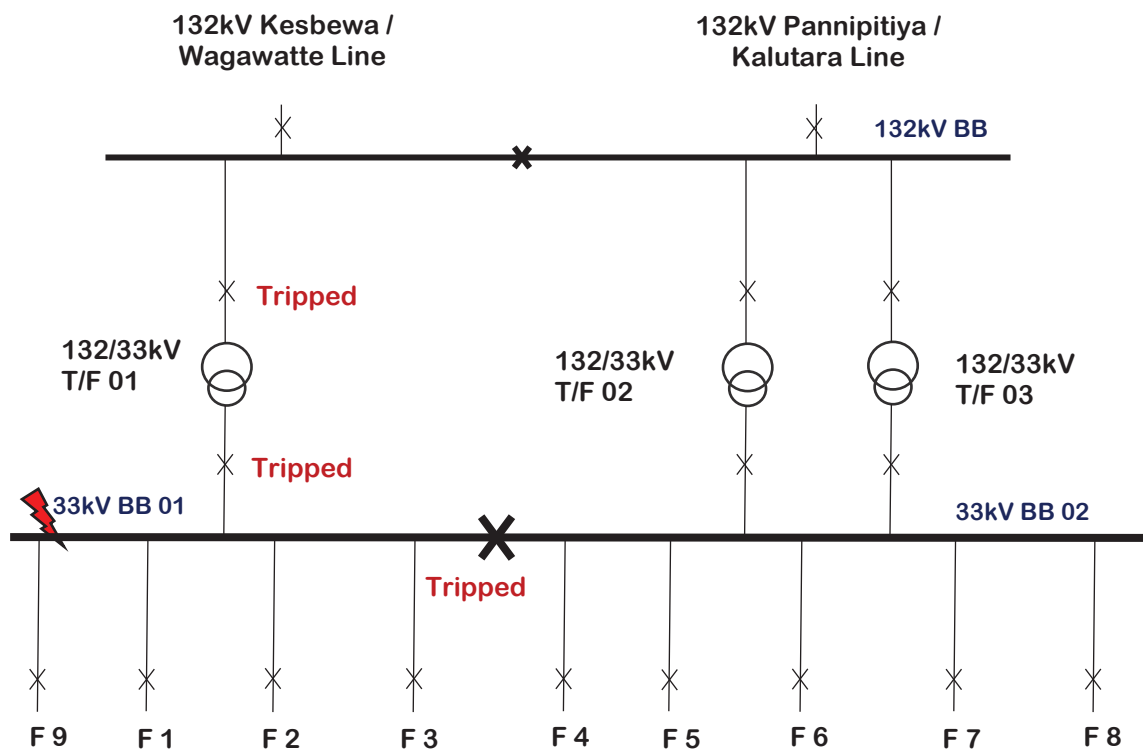
Figure 3- Single Line Diagram of Panadura GSS

1. A fault occurred in the 33 kV Bus Bar 1 of Panadura GSS at 11:13:39.520 hrs on 9 February 2025, as shown in **Figure 3**. The fault was initiated when a monkey came into contact with the energized bus bar.
2. The overcurrent function of the MiCOM P127 relay of the 33 kV bus section operated correctly and cleared the fault at 11:13:40.000 hrs.
3. Subsequently, the 132/33 kV Transformer 1 of Panadura GSS tripped due to the operation of transformer overcurrent protection at 11:13:40.580 hrs.
4. Based on DDR records of Kesbewa GSS, the 132 kV R-phase voltage dropped by 40% for approximately 450 ms, followed by a further 20% drop lasting approximately 550 ms, before recovering to nominal voltage within 1.1 seconds.

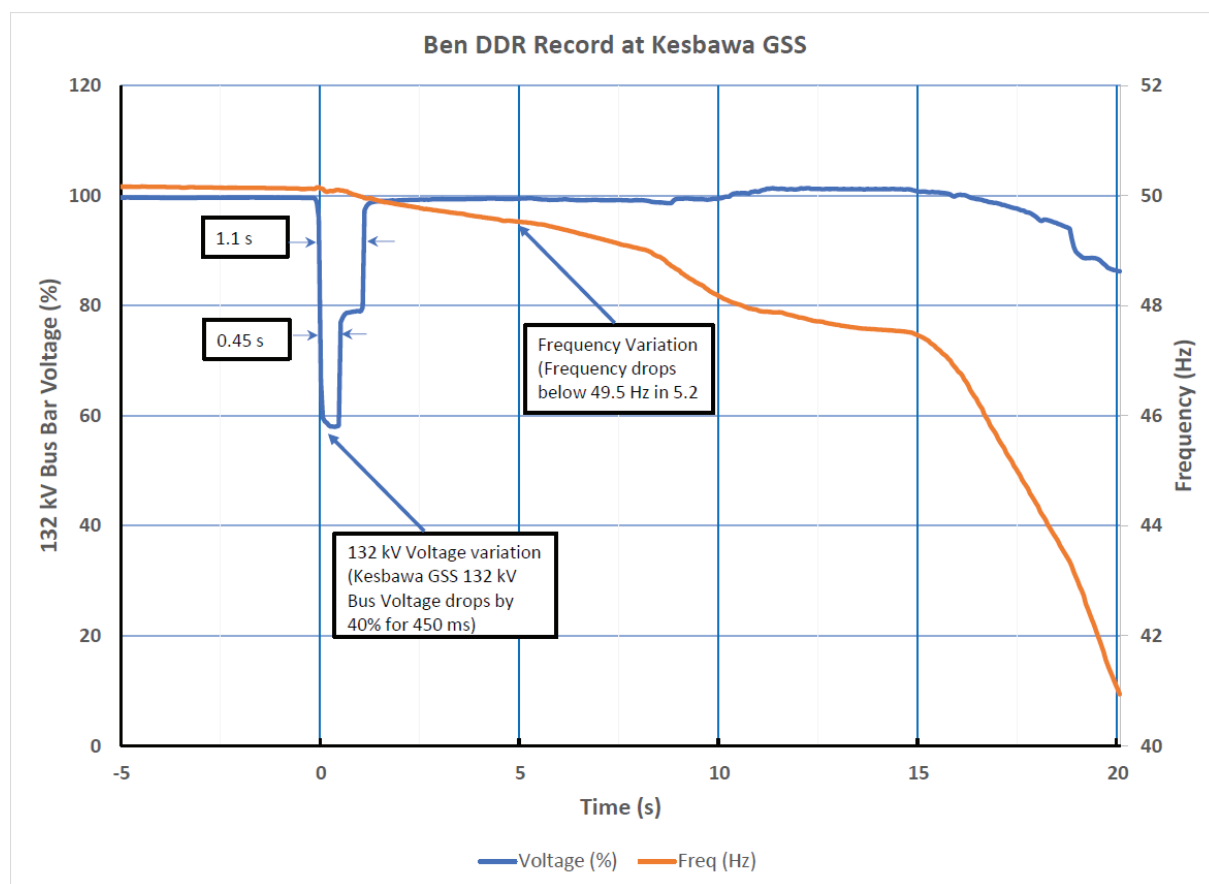
Figure 5 - Voltage and Frequency vs. Time graph

and around the Panadura Grid Substation (GSS) caused the inverters of several solar photovoltaic (PV) plants—particularly those not properly configured with adequate Low Voltage Ride-Through (LVRT) capability—to disconnect from the grid due to the operation of under-voltage protection. This loss of solar PV generation resulted in a reduction in overall system generation and a consequent decline in system frequency.

1. The system was operating with a high proportion of embedded generation (estimated at 50.4%), with rooftop solar contributing the largest share.
2. A 33 kV bus bar fault occurred at Panadura GSS and was cleared within 1.1 seconds. This fault caused a voltage drop of approximately 40% lasting about 450 ms.

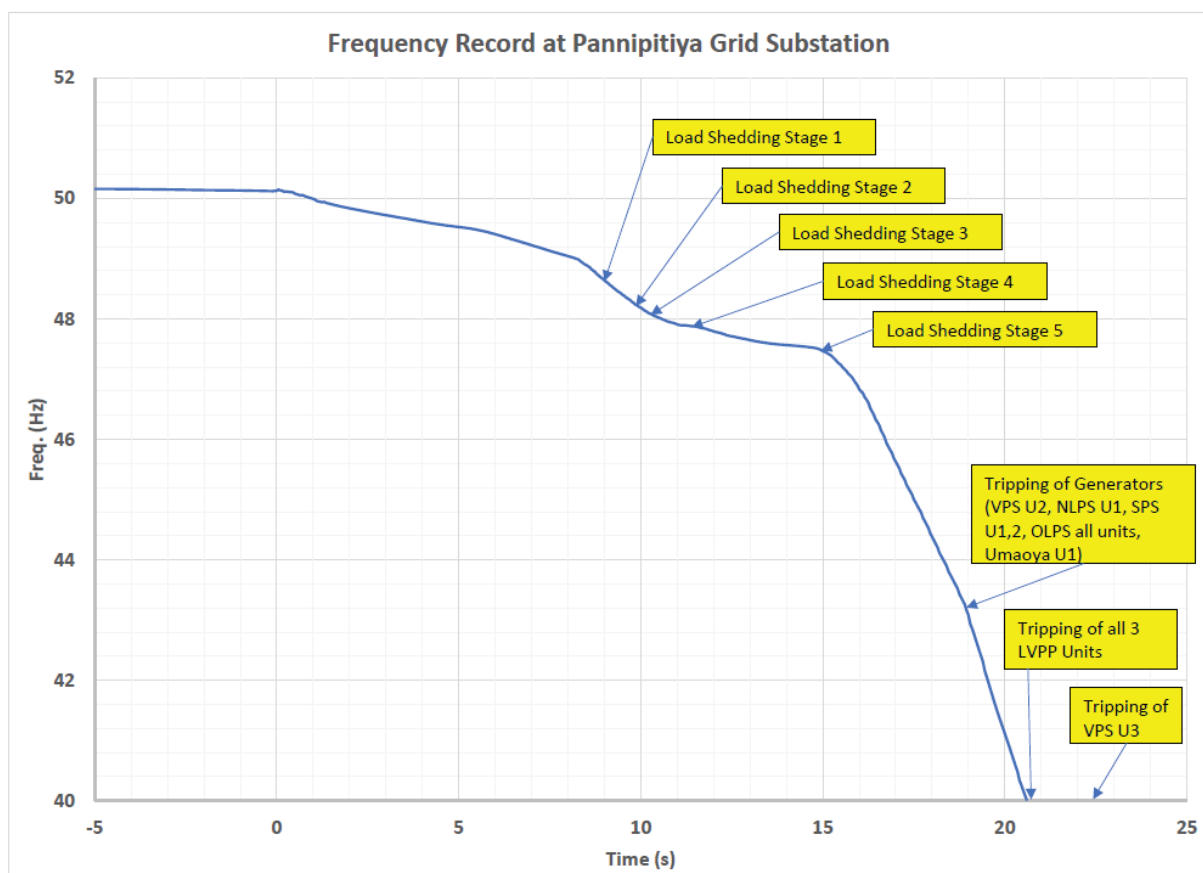
**Figure 6 - Frequency Record at Pannipitiya GSS with UFLS Operation & Generator Trippings**

Although the 33 kV bus bar fault was cleared within 1.1 seconds, a continuous decline in system frequency was observed. Consequently, all UFLS stag were activated, as summarized in Table 7.

**Figure 6** illustrates the system frequency versus time profile, covering the period from fault initiation to total system collapse, i.e., from  $t = 0$  s to  $t = 22.5$  s. When the system frequency declined to 48.75 Hz, Stage 1 of the Under-Frequency Load Shedding (UFLS) scheme was activated. Subsequently, the remaining UFLS stages were triggered at predefined frequency thresholds, with Stage 5 operating when the frequency reached 47.5 Hz. During this period, conventional large power plants remained connected to the system and were not disconnected until the system frequency further declined to approximately 43.3 Hz. [1]

According to the available records, all major conventional large generators remained in operation and connected to the system until 11:13:58.376 hrs, when the frequency had fallen to 43.3 Hz. [1]

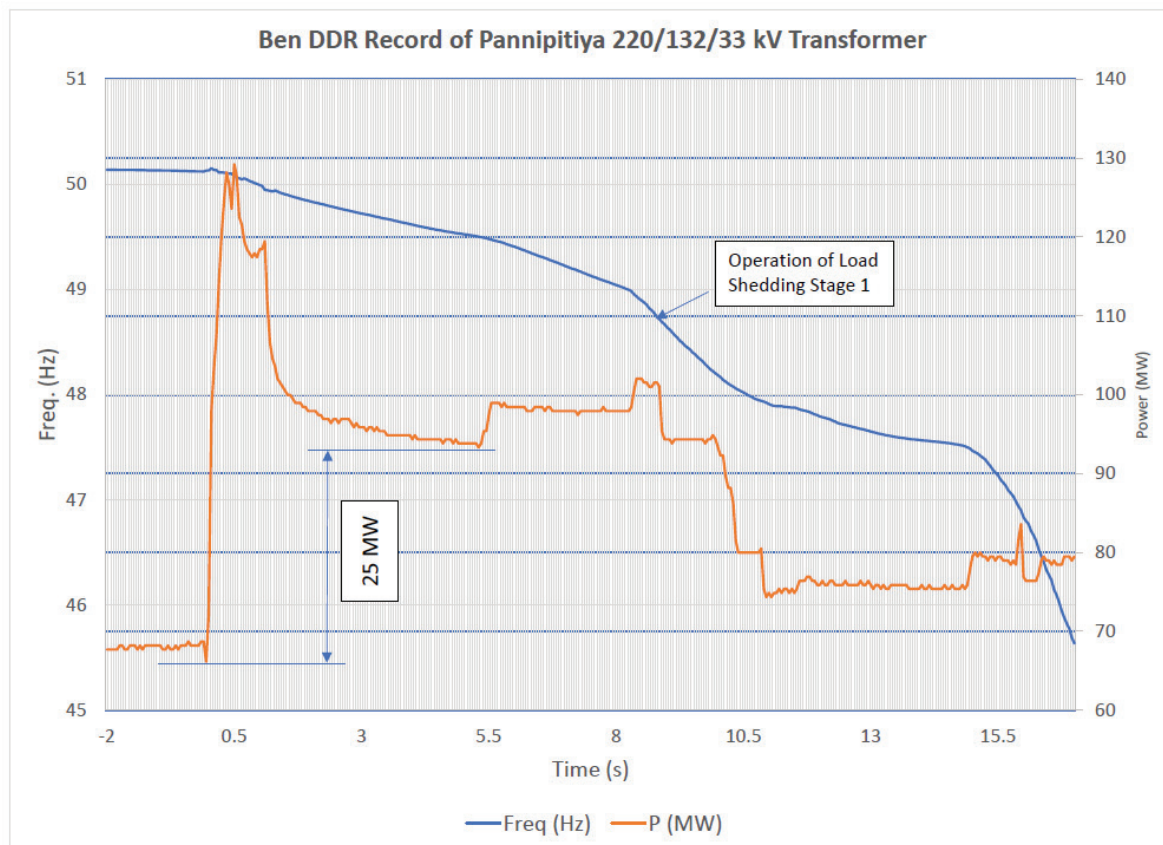
**Figure 7 - Frequency Record & Power flow in 220/132kV Transformers at Pannipitiya GSS**

**Figure 7** presents the following plots: (a) system frequency versus time, and (b) active power flow versus time for the Pannipitiya-Panadura-Horana 132 kV transmission line. The plots indicate a noticeable increase in power flow along the Pannipitiya-Panadura-Horana corridor immediately after the 33 kV busbar fault at the Panadura Grid Substation (GSS) was cleared.

A comparison of pre-fault and post-fault operating conditions shows an approximate 25 MW increase in active power flow through this transmission corridor. The Kesbewa, Panadura, Kalutara, Horana, Matugama and Ambalangoda Grid Substations are supplied through the Pannipitiya–Pananura–Horana 132 kV corridor.

3. Following fault clearance, the active power flow through the Pannipitiya-Panadura-Horana 132 kV lines increased by about 25 MW.
4. The increased power flow was attributable to the tripping of inverter-based embedded generators (mainly rooftop and ground-mounted solar PV) connected to this transmission corridor. The voltage dip initiated by the 33 kV bus bar fault triggered these inverter disconnections.
