ORIGINAL ARTICLE

# Rapid Assessment Survey Using Side Scan Sonar: International Obligations and Role of Hydrography in Ensuring Safety of Navigation – Case Study of the Aftermath of MV X-Press Pearl Incident

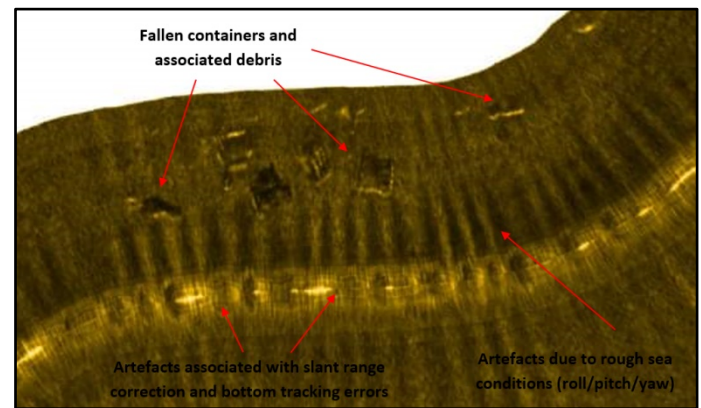
No targets were detected in Zone A. However, a total of 24 objects were identified in Zone B, which included several fallen containers (Fig. 4) and other debris laying on the seabed about 8 km towards North from the end of the channel where the MV X-Press Pearl was grounded. These debris might be from the damaged containers or parts of the ship's super structure. However, the pitch and roll effects were prominent along the middle section of the SSS data due to the rough sea conditions.

**Fig. 4:** Some of the fallen containers and debris from the MV X- Press Pearl captured by SSS imagery

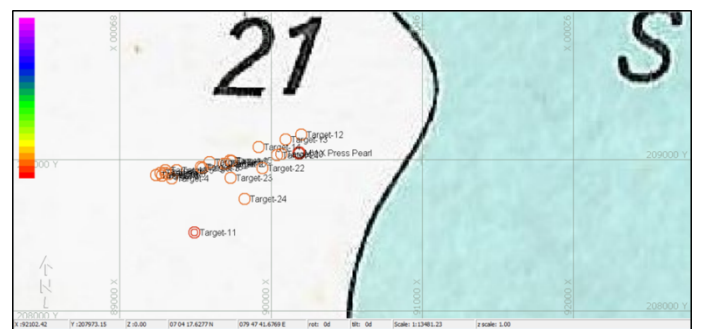
Most of the objects found showed to be having a rectangular/linear shape of about from 9 m to 12 m in length, spread out within a 900 m stretch towards West from the MV X-Press Pearl shipwreck (Fig. 5). The identified objects were overlaid on the nautical chart of Approaches to Colombo Harbor (INT 7 383).

**Fig. 5:** Higher density of objects observed near the MV X-Press Pearl shipwreck location; overlaid on the nautical chart of Approaches to Colombo Harbor (INT 7 383).

However, it was found that all the objects detected were scattered within 900 m adjacent to the MV X-Press Pearl shipwreck. This result was further supported to validate the current enforced Navarea VIII warning, stating that the "MV X-Press pearl shipwreck in position 70° 04.87' N, 79° 46.77'E following a fire onboard, and vessels are advised to keep well clear and exercise caution. Affected charts are INT 32 263 and INT 7 383". Therefore, this action ensures the safety of navigation of the ships visiting Colombo Port.

Finally, the rapid hazard investigation survey conducted using the SSS technique in the ports limit confirmed that it was safe for day to day operations. However, it is suggested to survey the entire coastal area, including the port anchorage, in a systematic manner for a full detailed investigation. This way, any future threats, for example dragging debris subjected to sea currents, can be detected. The located debris can be recovered and stored at a salvage yard if necessary, to minimize adverse environmental impact. Therefore it is possible to ensure that the area is clear for any ships anchoring and also for local fishing activities. This operation has already been started by the National Hydrographic Office (NHO) of the National Aquatic Resources Research & Development Agency (NARA) and Sri Lanka Navy (SLN), collaborating with other relevant maritime administrative authorities of Sri Lanka. These activities may take a few more months to complete and update the relevant nautical charts accordingly. These findings were shared with the working group appointed by the government of Sri Lanka for further actions and necessary investigations.
