# MECHANISM OF SLOW-MOVING SLOPE FAILURE IN KAHAGOLLA, SRI LANKA

UDENI B. AMARASINGHE

*Department of Geology, University of Peradeniya, Peradeniya, Sri Lanka*

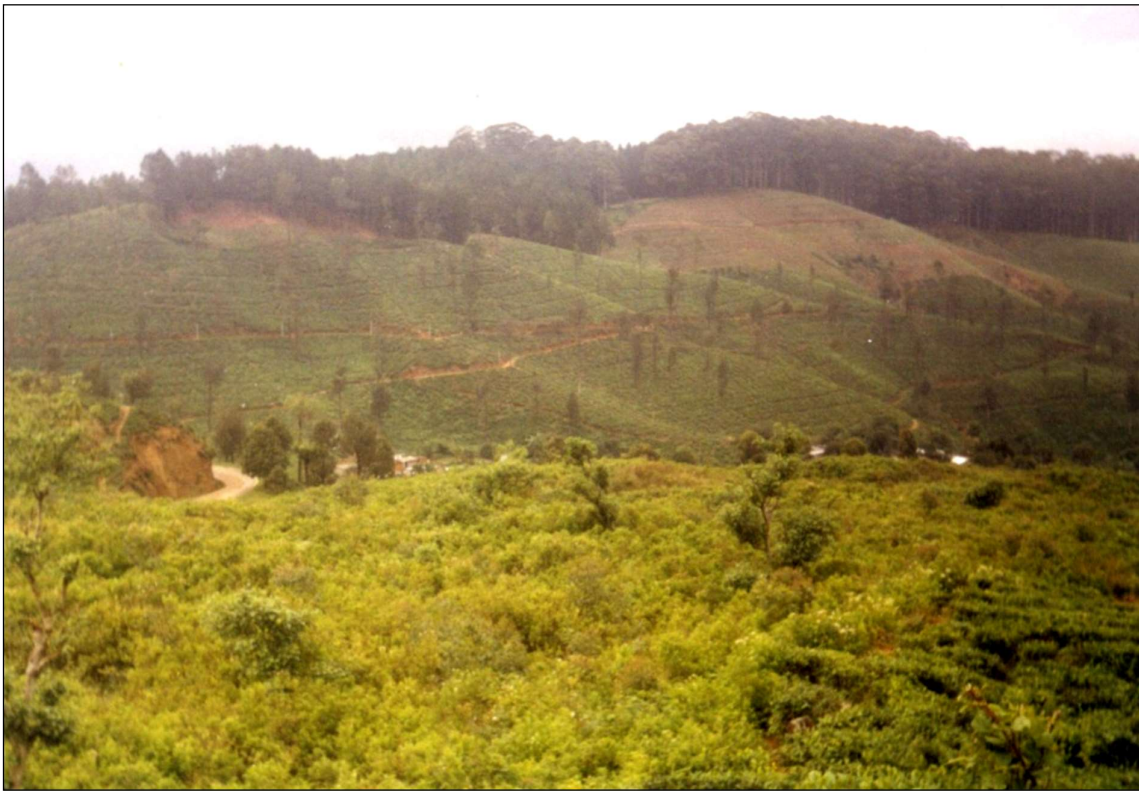
The Kahagolla slope failure is found on the mid-slope region of the North East – South West trending ridge extending from Haputale area (Figure 1). The slope is covered with a colluvial soil layer of variable thickness. The low-lying layer is found to be completely weathered bed rock. It was found that the IC horizon of the residual weathering profile of the Kahagolla landslide had formed through three different rock types, marble/calc gneiss, quartzite, and garnet hornblende biotite gneiss under scarp slope condition (Figure 2). These three rock types have different weathering resistance and as a result of that the slip surface has become undulatory with culminations and troughs. This has caused the sliding material and the surface to experience both land subsidence and upheaval. Subsided upper depression is underlain by the marble bed rock. There is a pool of surface water in the upper mid slope part of the landslide. This area is underlain by marble/calc gneiss bed rock mass with solution cavities. This rock layer is highly permeable and a constant groundwater flow takes place towards the lower slope from this surface water body.

**Figure 2:** The mid slope bench slope with marshy condition in the Kahagolla Landslide

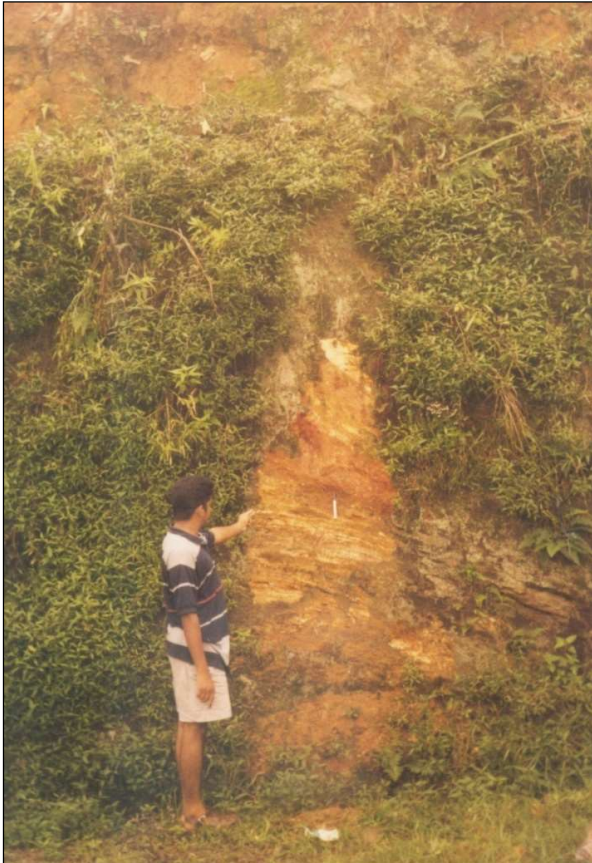
**Figure 2:** The head/back scarp of the Kahagolla landslide showing the residual weathering profile

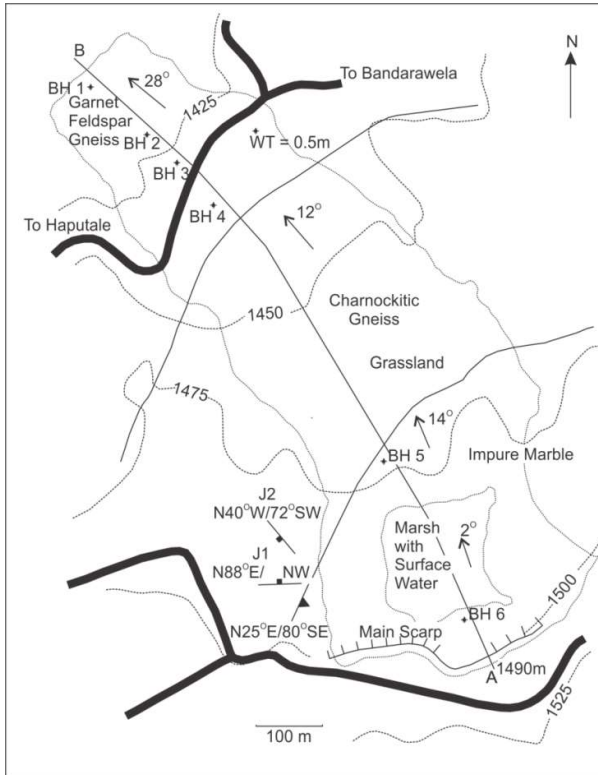
Scarp slope condition is exposed, garnet hornblende gneiss, quartzite and calc gneiss/ impure marble and garnet granulitic gneiss are found as the bed rock layers as shown in the Figure 3.

**Figure 3:** The Engineering Geological Map of the Kahagolla Landslide area

It is observed that there are three main discontinuities in the underlying bed rock (Figure 3). They include the foliation plane, first joint set (J-1), and the second joint set (J-2). The strike and dip of the J-1 plane is 60 NE and 680 NW respectively. The J-1 discontinuity is very prominent and runs through the completely weathered soil mass as a weak relict structure, which is parallel to the head/back scarp of the sliding mass. The J-2 discontinuity is parallel to the lateral boundary/minor scarp of the slide and its strike and dip were found to be 10 NE and 80 SE respectively.

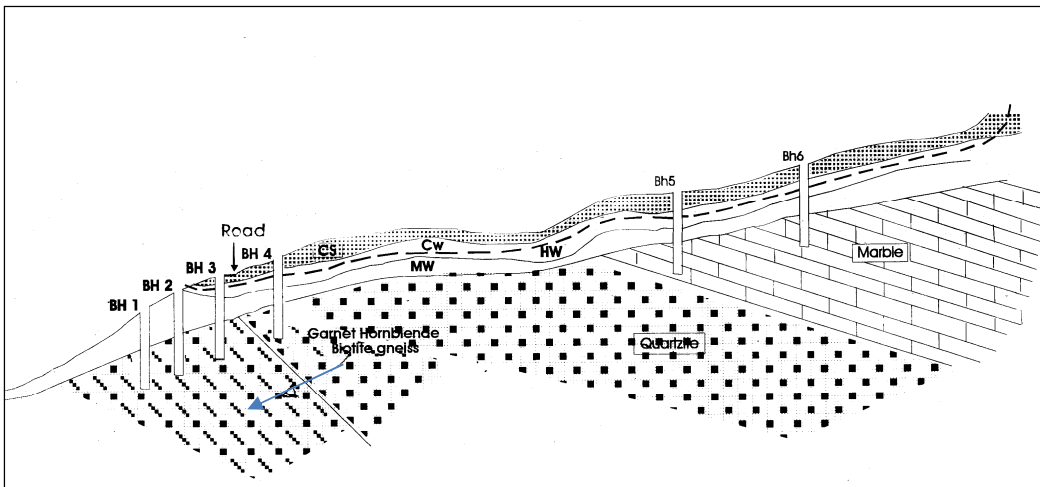
**Figure 4:** The Engineering Geological Profile /longitudinal section of the Kahagolla Landslide based on rotary core drilling (Scale: 1: 200)

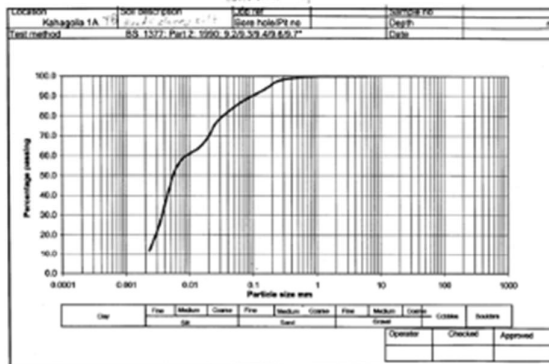
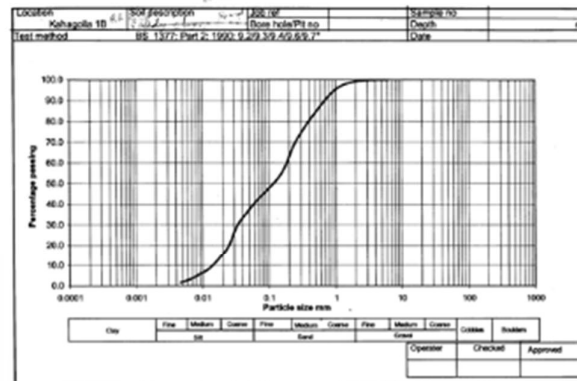
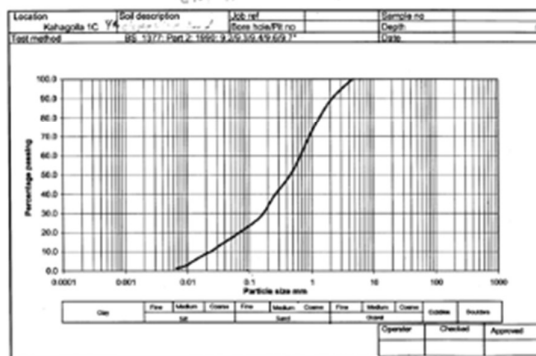
On the basis of two test pits two weathering profile sections were studied. The test pit 1 (TP1) shows that the slope soil overburden consists of four different layers as shown in the soil profile, Figure 5. The top layer is the 1 A and the soil is yellowish brown sandy clayey silt. The top layer is found with embedded boulders and it is The soil profile of the second test pit was also studied. The first layer, 2 A is the Brownish sandy clayey silt and which is the colluvium. The second layer, 2 B is the Brownish to reddish brown sandy clayey silt and which is recognized as the residual soil layer. The third layer, 2 C is the yellowish sandy clayey silt layer and which is found as the

recognized as the colluvium. The second layer, 1 B is the reddish brown to Yellowish brown sandy clayey silt and which is found as the residual soil layer. The third layer, 1 C is the Yellowish-brown silty sand is found as the upper layer of the completely weathered bed rock as indicated by relict structural features. The fourth layer, 1 D is the Yellowish sandy clayey silt and which is found as the lower layer of the completely weathered bed rock. The fourth layer is recognized as the slip surface material with polished and slickensided surfaces.

Figure 5: The grain size distribution of different horizons of Kahagalla landslide (a) 1A, (b) 1B, (c) 1C

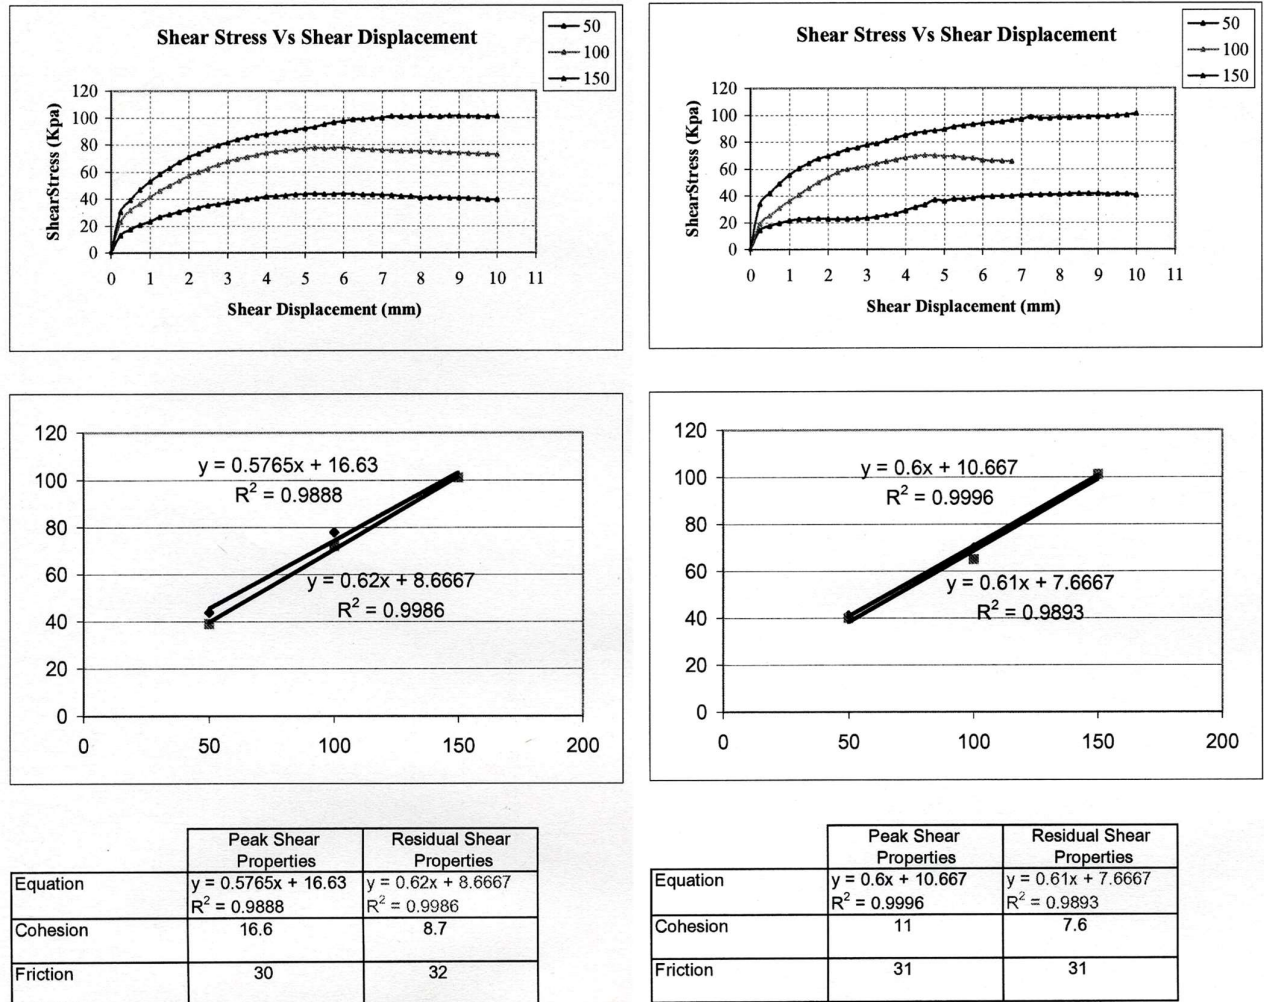
**Figure 6:** Shear strength of slip surface material encountered at the test pit-1 and test pit -2

The sample BSI from the test pit-1 shows cohesion and angle of friction under peak shear strength condition 16.6 and 30 Kpa respectively. The same sample shows the cohesion and the angle of friction under residual strength condition 8.7 and 32 Kpa respectively. The sample BS2 from the test pit-2 shows cohesion and angle of friction under peak shear strength condition 11 and 31 Kpa respectively. The same sample shows the cohesion and the angle of friction under residual strength condition 7.6 and 31 Kpa respectively. Undisturbed box samples of slip surface materials were obtained from two test pits, TP1 and TP2 as shown in the Figure 6 for laboratory direct shear testing.

The peak shear strength values of the Box sample 2 (BS2) were found to be  $C=16.6$  kpa and  $O=30$  respectively. The residual shear strength values of the Box sample 2 (BS2) were found to be  $C=8.7$  and  $O=32$  respectively. The peak shear strength values of the box sample 3 (BS3) were found to be  $C=11$  kpa and  $O=31$  respectively. The residual shear strength values of the Box sample 3 (BS3) were found to be  $C=7.6$  kpa and  $O=31$  respectively. The low cohesion values are attributed to high silt content in the slip surface material and the angle of friction value of 31 is attributed to sand particles in the slip surface material. The completely weathered rock as the slip surface material exhibits low shear strength

values under saturated condition. So subsequent to a tensional failure of the surface materials, a slow shear movement is understood to have occurred through the weakest completely weathered rock material to form the slip surface.
