# STATIC ANALYSIS OF SELECTED TYPES OF ROOF TRUSSES CONSIDERING THE WEAKENING OF THE STRUCTURAL ELEMENTS

Silvia MARTINKOVIČOVÁ<sup>1\*</sup>, Jaroslav SANDANUS<sup>1</sup>, Ján BRODNIANSKY<sup>1</sup>, Lucia ONDRAŠINOVÁ<sup>1</sup>

<sup>1</sup> Dept. of Steel and Timber Structures, Slovak University of Technology in Bratislava, Slovakia

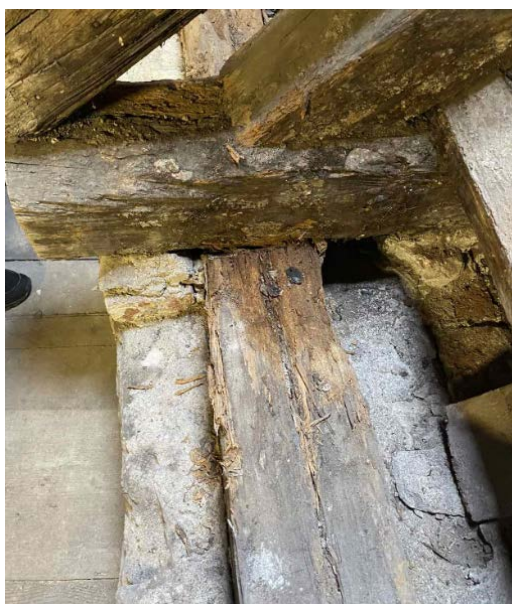
**Fig. 1** Impact of moisture on a beam in a roof truss structure

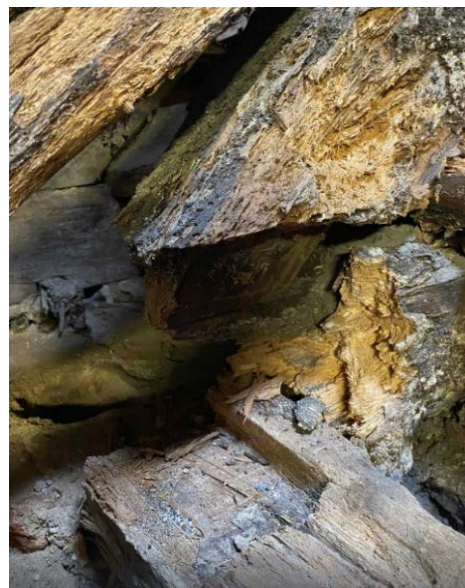
**Fig. 2** Damage to a Rafter's is Foot and Beam Due to Moisture and Wood-Decaying Fungi.

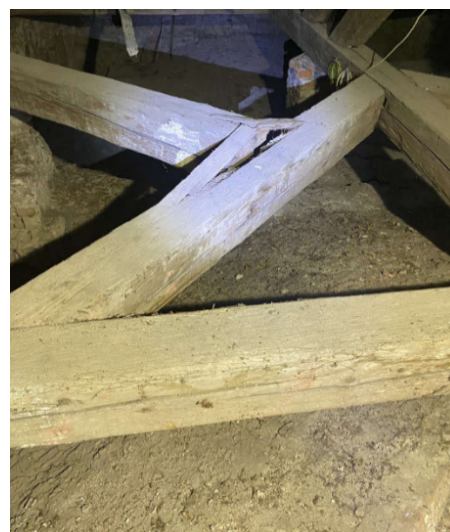
**Fig. 3** Element Tear-Out Due to Improperly Constructed Joint.

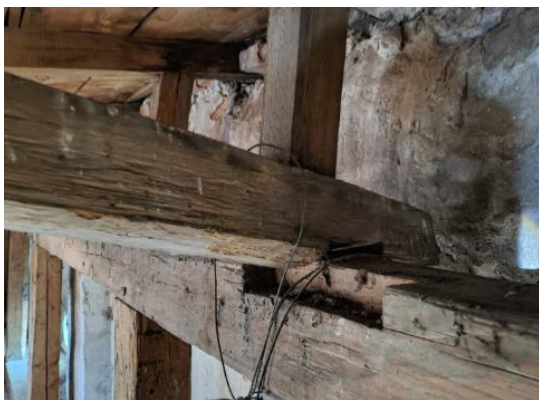
**Fig. 4** *Twisting of a Rafter's Cross-Section*

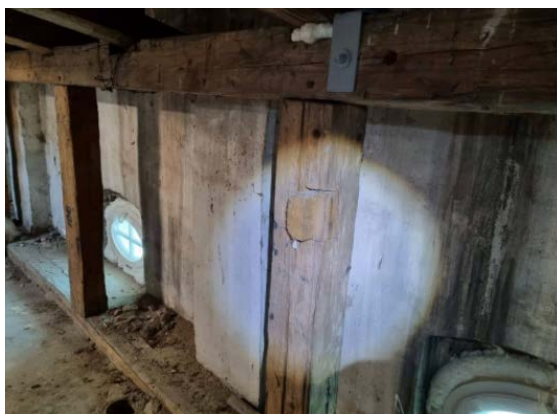
**Fig. 5** *Removal of an Original Structural Element*

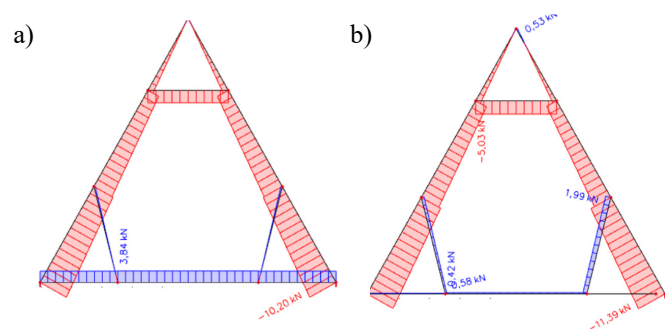
The decay of the tie beam was subjected to a structural analysis, including the self-weight and permanent roofing load (clay tiles). Figs. 10-12 represent the diagrams of the internal forces, which include the axial forces  $N$  (kN), bending moments  $M_y$  (kNm), deformations (mm), and nodal displacements (mm) at the location of the failure caused by the decay. The images from the parametric study include only the diagrams of the original intact truss and the truss with the full decay of the tie beam element. The analysis revealed a significant change in the redistribution of the internal forces, with the largest change occurring at the damaged location of the tie beam, which is the key load-bearing element of the entire roof truss system. The change in the distribution of the internal forces is particularly evident in the bending moments (Fig. 11), while the change in the distribution of the axial forces is shown in Fig. 10.

**Fig. 10** Axial forces on a) the intact construction (Tie beam  $N=3.84$  kN, Rafter  $N=10.20$  kN), b) damaged construction (Tie beam  $N=0.85$  kN, Rafter  $N=11.39$  kN).

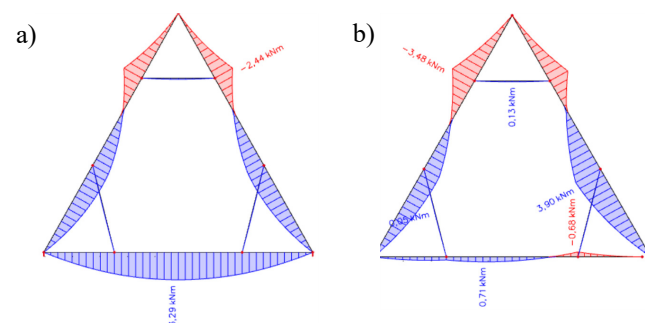
The diagram of the bending moment in the roof truss changes under the effect of decay. Previously, the maximum bending moment occurred at the centre of the tie beam, but after the damage, the maximum moment shifts position and

is found further from the point of failure, in a smaller single element, i.e., a rafter is a more subtle element than a truss which becomes overloaded. This leads to a change in the distribution of the forces within the entire main truss. This phenomenon indicates that the roof is no longer loaded uniformly but symmetrically (the load considered causes a symmetrical distribution of the internal forces in the construction). Additionally, the analysis of the nodal displacements showed that due to the decay of the tie beam and its detachment from the truss connection with the rafter, the tie beam experienced a vertical displacement of 11.2 mm (Fig. 12). As expected, the rafter stayed in its original location at that specific point.

**Fig. 11** Bending moments on a) the intact construction (Tie beam  $M_y=3.29$  kNm, Rafter  $M_y=2.44$  kNm), b) the damaged construction (tie beam  $M_y=0.71$  kNm, Rafter  $M_y=3.90$  kNm).

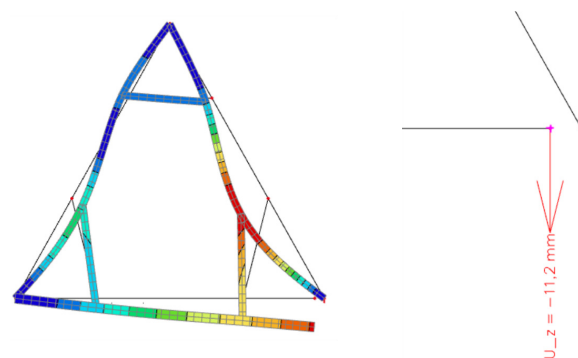
**Fig. 12** Total deformation of the tie beam with the damage and nodal displacement at the support location.

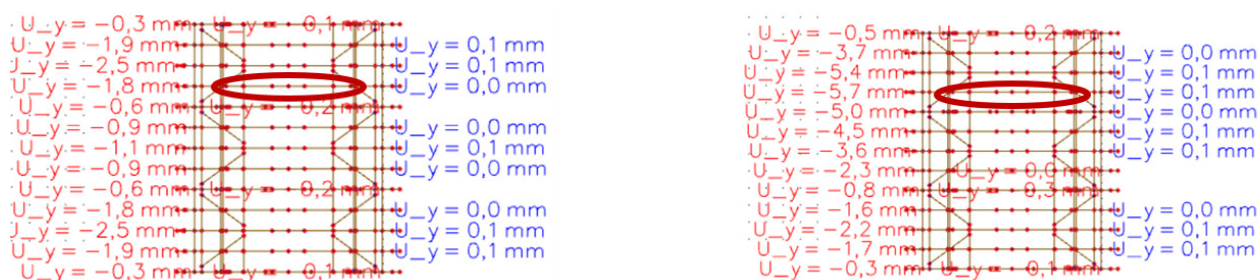
**Fig. 18** Horizontal displacement in the roof structure: a) intact structure b) damaged structure, with the location of the damage marked.

The effect of the removal of the tie beam can also be noticed within the horizontally deformed structures with a damaged tie beam. Figure 18 shows a comparison of the horizontal displacement between the intact and damaged structures.

The analysis shows that in the case of the damaged complete truss bay, the largest deformations specifically occurred on the horizontal posts and rafters, that ensure the load-bearing capacity of this type of roof structure. Moreover, when comparing the horizontal node displacements between the intact and damaged truss bays, a significant difference is evident. The node displacement in the damaged complete truss bay increased from 1.8 mm to 5.7 mm due to the unprofessional intervention, thereby indicating a significant change in the behaviour of the entire structure. The most prominent change, which could lead to a critical failure of the roof, is the overloading of the adjacent empty bays in the damaged structure.
