## REVITALISATION OF THE 14TH-CENTURY ARCHCATHEDRAL BASILICA IN FROMBORK (POLAND) – AN EXAMPLE OF THE ADAPTATION OF A MEDIEVAL STRUCTURE FOR MUSEUM AND EXHIBITION PURPOSES

The subject of this paper is a case study of the revitalization of the roof truss and attic of the Archcathedral Basilica in Frombork. This study presents an innovative integration of diagnostic approaches, combining traditional building diagnostics – focused on assessing the technical condition – with principles derived from sustainable develop-

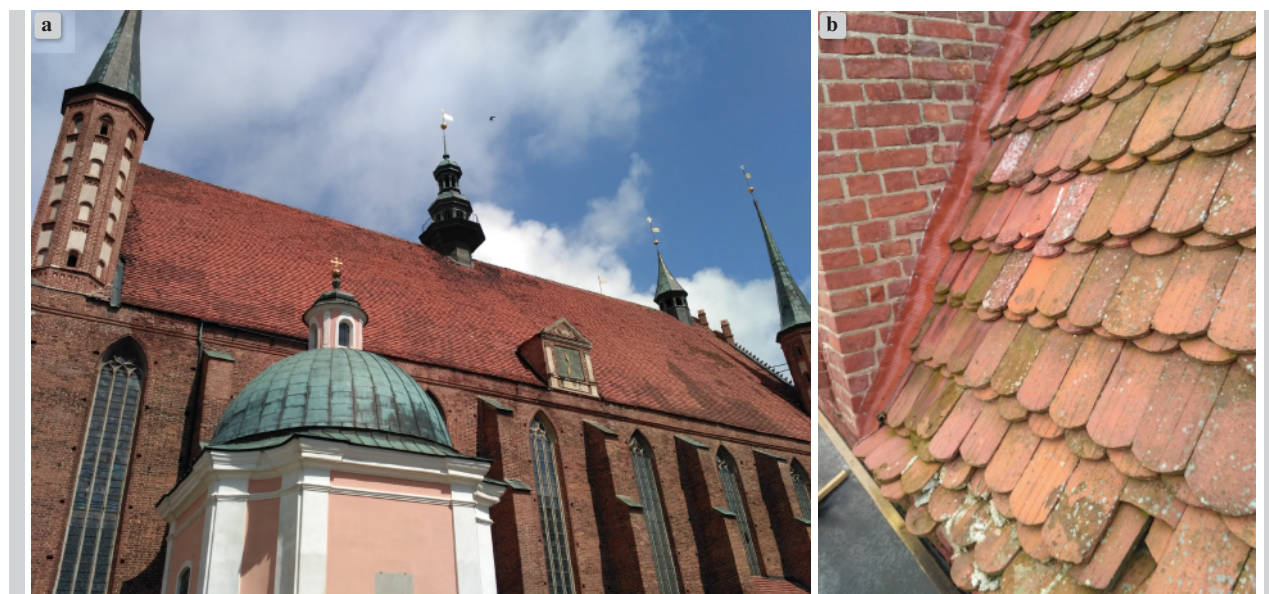
**Figure 2.**  
Condition of preservation of the south nave roof slope a) overall view b) zoomed area (visible broken and destroyed roof tiles)

**Stage II** involved the preparation of technical assessments [27, 28], which revealed that the condition of the roof covering was poor, with numerous leaks roof tiles of various formats, degraded due to long use. However, the technical condition of the wooden elements of the roof truss was described as good. The most significant deterioration was identified in the zones where the ceiling beams interfaced with the masonry walls. The greatest damage to the perimeter walls was also noticed in this area. Moisture in the cresting area was caused by the incorrect execution of the eaves of the sheathing and the lack of roof flashing. As a result of these deficiencies, rainwater that got under the roof tiles along the entire height of the roof surface was not discharged outside into the eaves but dripped onto the wall crown, subsequently infiltrating the masonry or flowing down onto the vault surfaces. Moreover, observations during heavy rainfall revealed that the significant volume of rainwater flowing from the large roof area, combined with the minimal extension of the eaves beyond the wall edge, caused water to accumulate at the base of the structure, flooding the walls near the ground (plinth area). Several months of monitoring allowed for assessment of the impact of wind-driven rain on the cathedral's façades. Strong gusts of wind, related

- complete replacement of the roof covering,
- supplementation of the board sheathing,
- replacement of flashing elements,
- local repairs of the roof truss structural components using traditional carpentry techniques and carefully selected wood species and cross-sections.

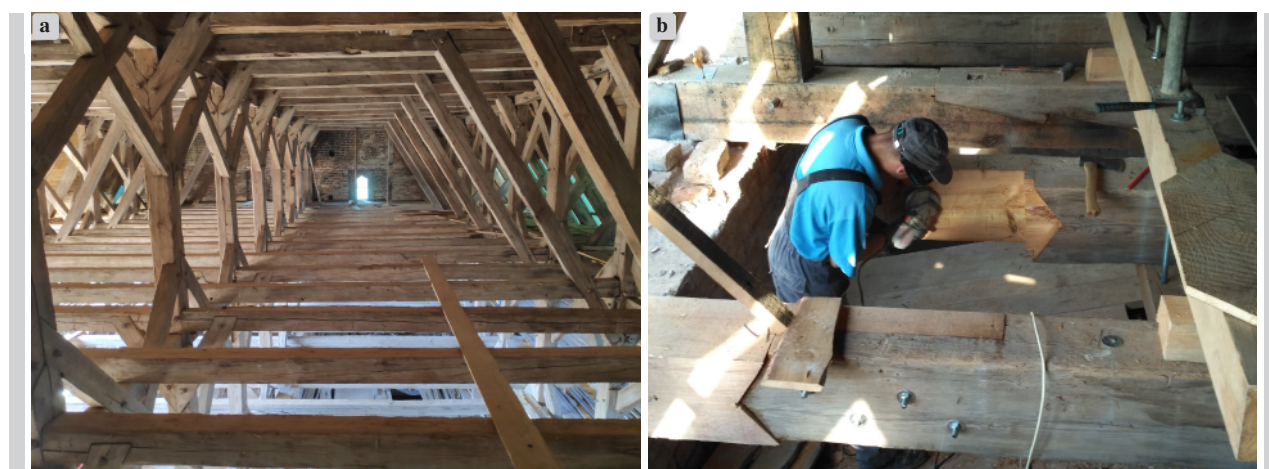
**Figure 3.**  
The internal part of roof truss a), structural elements, b) work on replacing the beam

**Stage IV** involved the implementation of previously planned renovation works. Despite an earlier, detailed assessment of the technical condition of the roof truss, the limited accessibility and lack of lighting in the attic space significantly hindered the full identification of all elements requiring intervention in the form of repairs or supplementary work. Nevertheless, during the course of the renovation, it was determined that the vast majority of the structural elements could be preserved in their existing state without the need for replacement (Figure 3).

However, local repairs were necessary in the form of fleeces and filling in missing beam fragments. Moreover, loose carpentry joint repairs were necessary in many places. The rafters and the ends of the parts of ceiling beams bearing on the wall (maintaining the existing cross-sections) were partially replaced (Figure 4b). Roof sheathing made in the 1980s was replaced with new ones made of overlapping boards. In order to reduce the effects of wetting the walls, it was essential to correct roof flashings and extend the eaves overhang that involved the introduction to the roof structural system of chantlates (Figure 4c). In consultation with the conservation services, it was recognised that the proposed solution would not change the roof geometry visibly and would significantly reduce the moisture of walls, both in the eaves and plinth area.

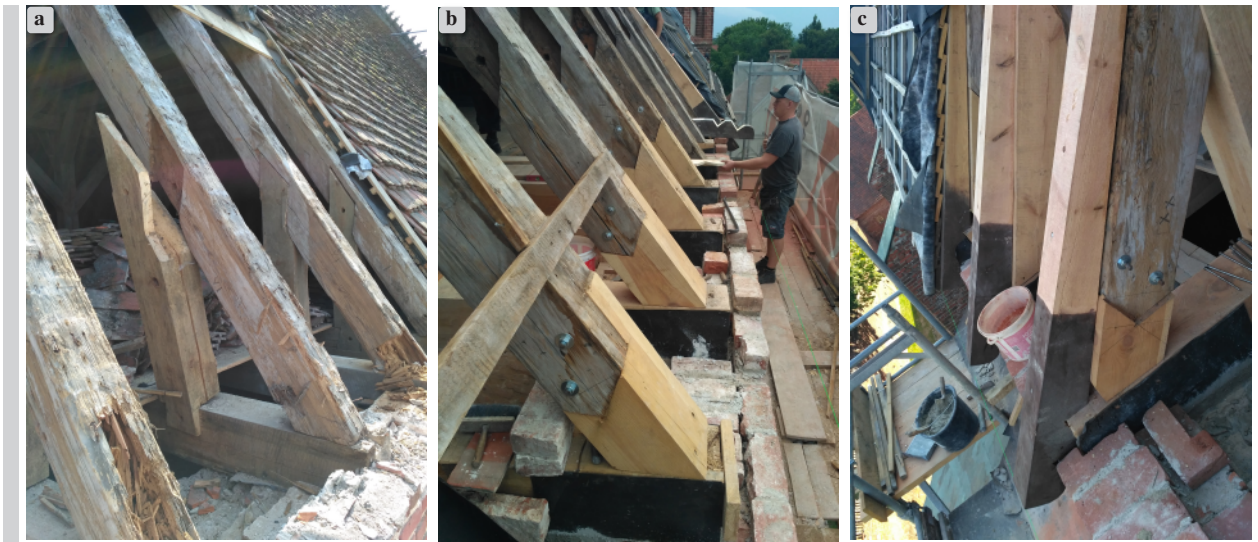
**Figure 4.**  
The eaves zone of the roof a) damaged ends of rafters and floor beams; b) repaired rafter ends; c) correction of the eaves' length by the use of chantlates

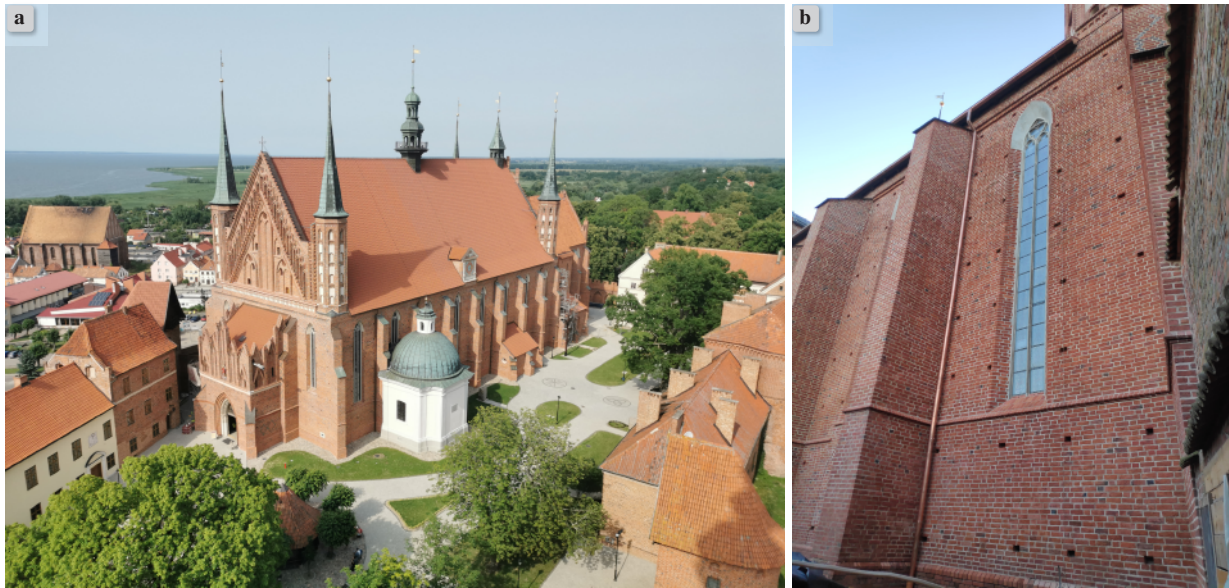
Figure 5.

a) the Archcathedral after renovation works with new roofing, b) the rainwater drainage system

The next step involved the introduction of solutions not previously applied in the building, aimed at extending the durability of both the roof and the façades. The greatest challenge was to reach a compromise between the conservation authorities' requirements and the engineering team's proposals. Ultimately, the overriding goal was to ensure the long-term protection of the structure, which led to the acceptance of modern technical solutions as a necessary measure against ongoing degradation. As a result of these agreements, it was decided to modify the original historic solutions by installing a rainwater drainage system – gutters and downspouts

(Figure 5b) – which were absent in medieval architecture. An additional compromise involved the implementation of dampers, which facilitate effective and safe water drainage from the historic structure.

The final stage of the roof renovation was a covering made of plain tiles arranged in a lace pattern. However, during repair works on ceiling beams, roof tiles, probably from the period of roof renovation and replacement of its covering, were found in the haunches. During archaeological research conducted at the same time on the cathedral hill, fragments of roof tiles were found that clearly indicated the original method of covering the roof of the cathedral. In consultation with the conservation services, it was decided to recreate the covering in its original form using monk-nun roof tiles, thus restoring the historic appearance of the roof (Figure 5a).

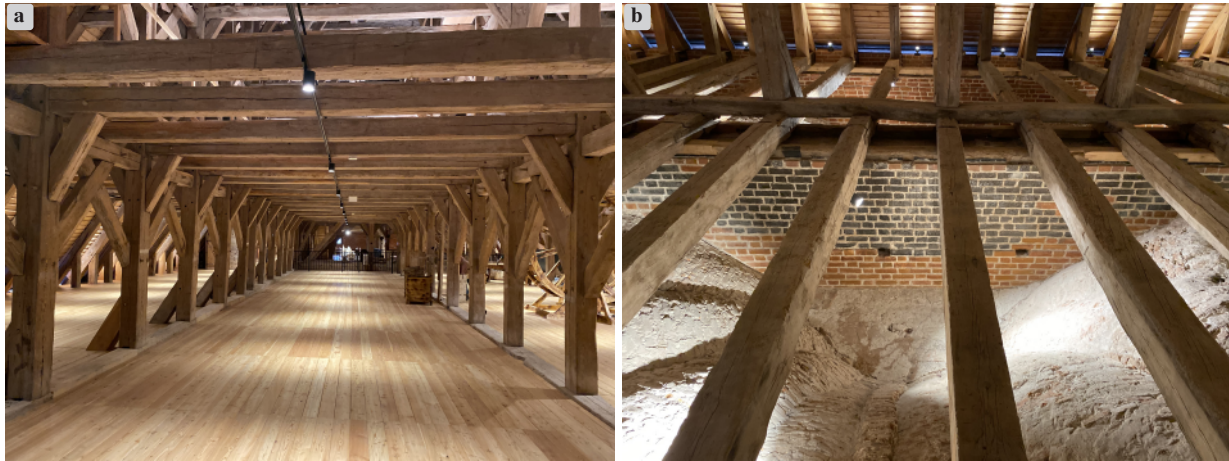
**Figure 7.**  
The attic space after renovation a), roof truss and wooden floor; b) vaults over the nave

Beyond ensuring visitor safety, the scope of intervention was deliberately restricted to the absolute minimum, in line with internationally recognized principles of heritage conservation, which emphasize the maximal preservation of original fabric and advocate intervention only when deemed necessary to ensure structural integrity or functional viability. The primary technical measures focused on correcting the existing wooden floors, which, due to significant deformation of the ceiling beams, were unsuitable for further use. To restore the functionality of the flooring, the beams were levelled by screwing square beams to their side surfaces that were also a supporting structure for the new wooden floor (Figure 7a). This approach was selected for its reversibility and the ability to control the extent of intervention in the original structure. Demolition work of the existing floor provided access to the crystal vaults above the nave. Interesting elements of the cathedral's architecture were exposed (Figure 7b). One of the interesting elements of the building was a clock mechanism, which owing to its technical and historical value was

exposed by making a glass casing, combining protective and educational functions. Other works included the implementation of security measures in the form of balustrades.
