## CAVEAT COMMUNIQUE

### AN UNFORTUNATE INCIDENT

Stanley G. Jacobs

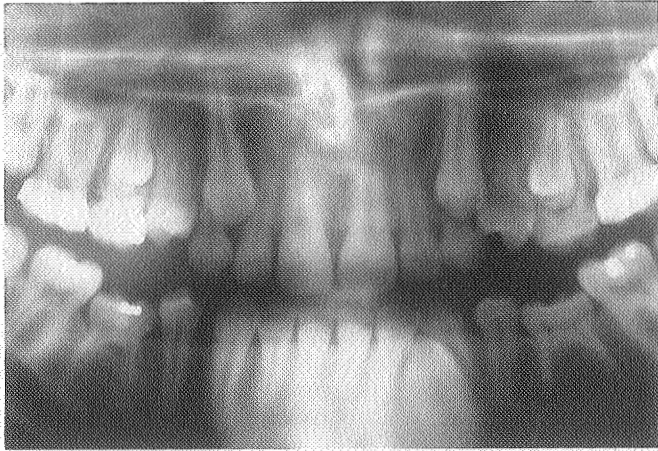
Figure 4. Initial OPG

The explanation was that the patient had been transferred to me during treatment\*. His previous orthodontist, before commencing treatment, had requested the removal of the seven remaining deciduous teeth and two maxillary first premolars present in *Figure 4* but did not notice subsequently that 73 had not been extracted. The orthodontist had banded 73 as well as the other nineteen permanent teeth. The patient was transferred thirteen months after fixed appliances were cemented.

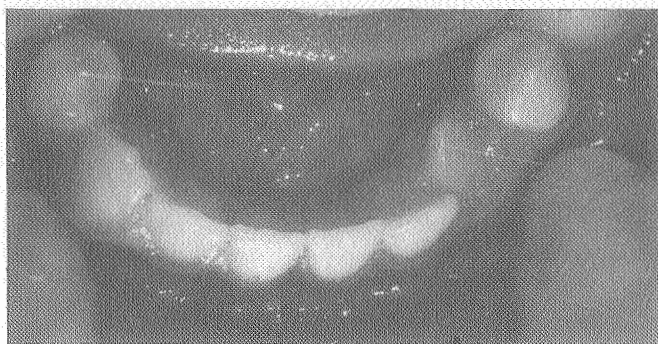
Figure 5. 33 erupting fifteen weeks after debanding

Fortunately, 33 could be seen erupting at the next visit five weeks later.

*Figure 5* shows 33 fifteen weeks after debanding.
