# STUDIES AND PERSPECTIVES ON THE TYPES OF CORROSION OCCURRING IN CONTINUOUS CHROMIUM PLATING PLANTS

The aim of this study is based on an analysis of the effect of electrochemical processes in the chromium plating solution on the copper anode bar in continuous chromium plating plants. Initially the forms of corrosion damage to the metal material were identified and then attempts were made to develop methods to reduce and avoid their destruction.

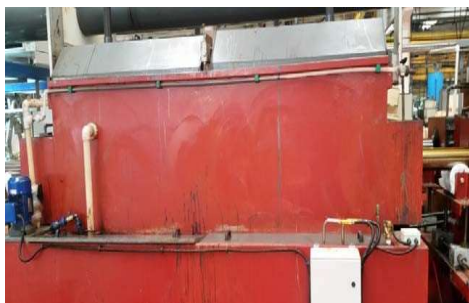
**Figure 2. Electrolytic tank in which chromium plating takes place**

The chromium plating cell consists of a metal tank, equipped with anodes, buffer tank (equipped with feed

pumps, resistance pump, temperature probe, suction filter), vertical pressure pump necessary for continuous mixing of the electrolyte, suction tubing, accessories for temperature control and the minimum and maximum levels of the electrolyte solution, as well as rollers for supporting and guiding the bar.

Figure 2 shows an overview of the chromium plating cell [1,2,31].

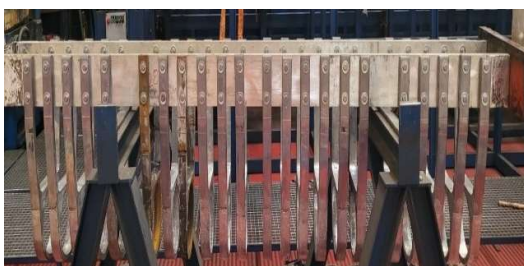
**Figure 3. Mounting the anodes**

Inside the electrolytic chromium plating tank, circular anodes are mounted equidistantly, through which the cathode-bound bar moves automatically, on which the chromium layer is to be deposited [32]. The anodes are clamped to the copper bar by means of removable bolt-nut assemblies (figure 3). Several groups of contacts are positioned between the basins (these are electrolyte tanks) to ensure the passage of current, thus allowing the deposition process to take place.

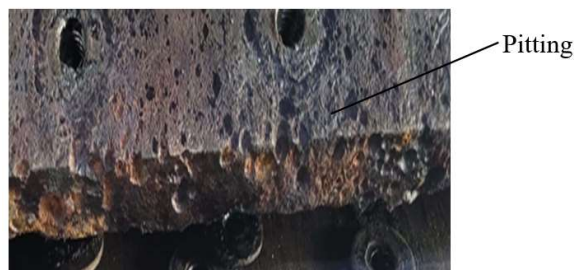
Figure 10. Spot corrosion of electrolytic copper bar

Another form of corrosion found in both electrolytic copper rods and anode supporting rods is *pitting or spot corrosion*. This is one of the most destructive and intense forms of corrosion and is deemed the most dangerous form of corrosion because it is harder to detect.

The manifestation form is a small area spot that takes the shape of a cavity and has a width to depth ratio of 2/3.

Figure 10 shows such a corrosion at the anode clamping bar.

In order to avoid spot corrosion and its effects, it was decided to control weekly the value of aggressive polyatomic  $\text{SO}_4^{2-}$  sulphate anions responsible for this type of corrosion.

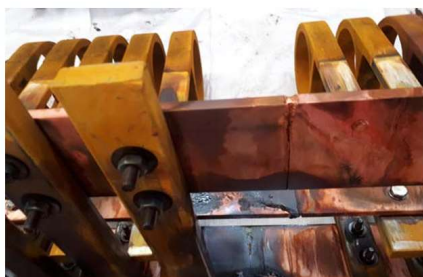
Figure 11. Copper bar breakage in crevice corrosion

Another form of damage to electrolytic, anode-clamping copper bars, similar to pitting corrosion, was *crevice corrosion*, also called concentration cell. The localization of this type of corrosion was found in the areas where the anode rods were clamped to the supporting brackets (Fig. 11, Fig. 12), and cracking of the rod material was also observed in this area.

The mechanism of this type of corrosion is similar to galvanic corrosion except that it is generated by differences in the concentration of the medium in contact with a material which can lead to different electrochemical activities. Crevice corrosion is based on poor aeration with the occurrence of anode reaction in this area and cathode reaction on the well-aerated free surface, at the same time the passive oxide film disappears into the crevice.

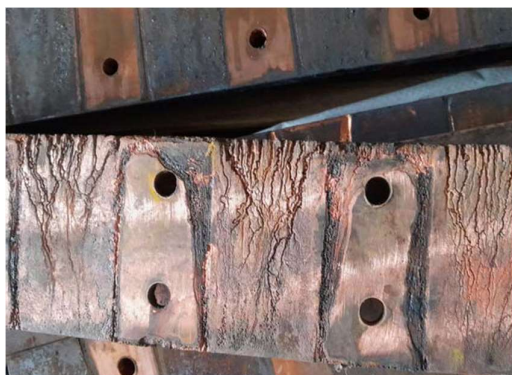
**Figure 15. Galvanic corrosion of the copper bar**

Studies and analyses carried out during repairs of chromium plating plants have led to the conclusion that the passage of electric current through the anode clamping bolts on the electrolytic copper bars leads to *galvanic corrosion* of the clamping system.

This is due to the different electrochemical potential of the material of the clamping bolts and washers (originally

galvanised steel) between the electrolytic copper bar and the anode rods (figure 15).

Figure 15 illustrates a strong corrosion in the area of the anode bolt clamping area of the copper bar and figure 16 shows the corrosion of the clamping bolts.

- replacement of galvanised steel bolts, nuts and washers with similar titanium ones;
- for better electrical contact it was decided to replace the copper bars as follows: for lead/tin/antimony alloy anodes duralumin bars will be used and for titanium anodes copper or tinned copper bars will be used;
- controlled tightening of the threaded assembly, using a torque wrench, so as not to create unnecessarily high tightening tensions.

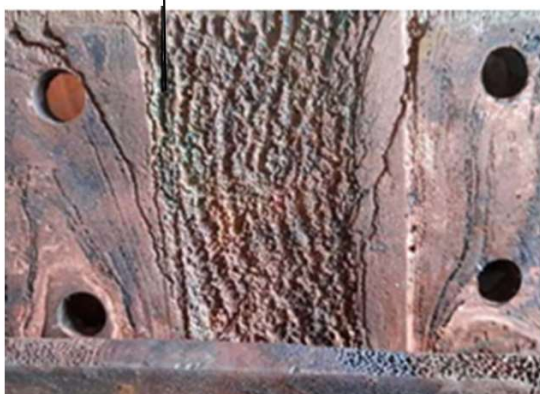
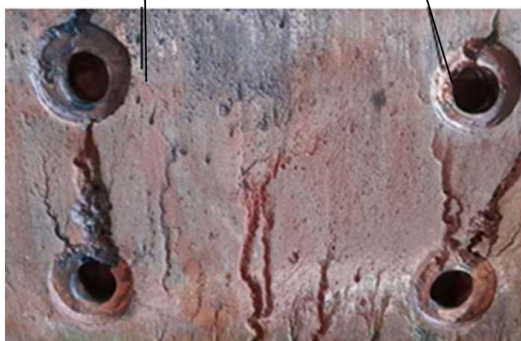
**Figure 16. Galvanic corrosion in the area where the anodes are clamped with bolts**

Bolt sheared off due to galvanic corrosion

The trace left by the safety washers upon the assembly of the anode bolts

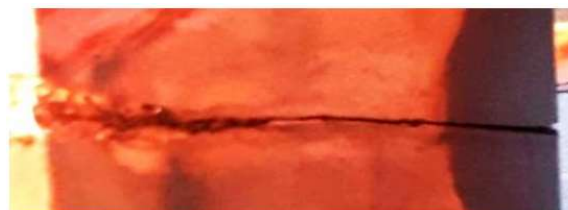
**Figure 18. Copper bar breakage due to fatigue corrosion**

The effect of internal stresses in the material and external stresses produced by the clamping of various mechanical elements in combination with the corrosive environment can generate fatigue corrosion. Cracks in the electrolytic copper bar are due to the decrease in the strength limit of the material under the action of these two factors. The cyclicity of the process and the corrosive environment cause disturbances to occur in the atomic lattices of the metal after a certain number of cycles, leading to cracks. Crack surfaces caused by fatigue corrosion look similar to those caused by stress corrosion (figure18).

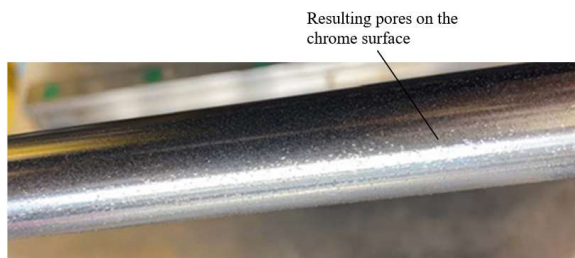
Figure 19. Defects in chrome plating bars

The defective way of stirring and filtering the electrolyte or the concentration of salts or hydrogen ions in the chromium plating bath leads to residue deposits which, when engaged into the electrolysis process, cause the technological process to be defective and numerous defects to appear on the surface of the bars (figure19 ).

- replacement of the filter pump with a higher power one in order to improve suction and circulation of the electrolyte solution to avoid oxide deposits on the surface of the bar.

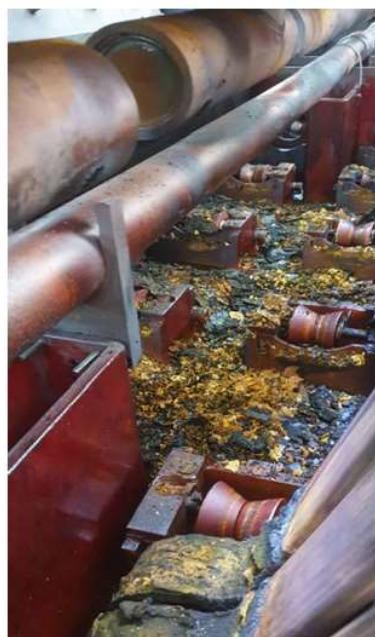
Figure 20. Residues resulting from the chromium plating technological process

Figure 20 shows the residues resulting from the chromium plating technological process.

In order to have a better circulation of the electrolyte solution, with intense stirring, the filter pumps were replaced with ones of higher capacity. The better filtration resulted in better retention of mechanical impurities or residual particles in the solution.
