# Cable-stayed bridges, diagnostic survey of stays

Civil and Environmental Engineering  
Journal of the Faculty of Civil Engineering | University of Žilina

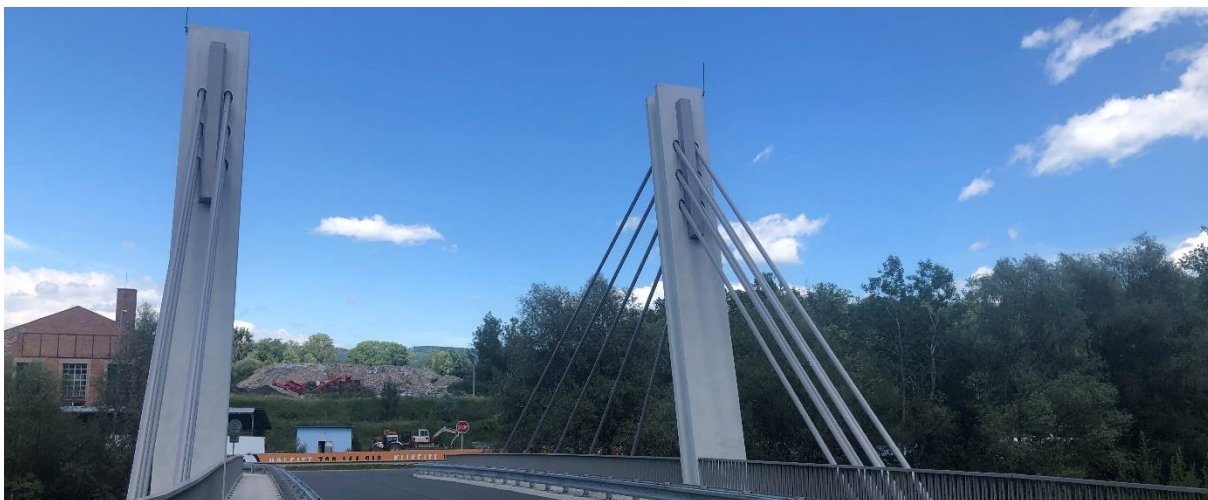
The first diagnosed construction is a bridge structure located in the Zlín region (Vsetín district) near the village of Hrachovec (Figure 1). It is a single-span cable-stayed bridge with a span of 40 m crossing a 3rd class road over the Rožnovská Bečva River. The bridge deck consists of prefabricated prestressed segments (modified KA-girders) supported on a pair of prestressed T-beams. These beams are suspended by stayes from two 10-meter-high prefabricated prestressed pylons. The substructure consists of massive monolithic reinforced-concrete abutments with reinforced-concrete bearing thresholds. The bridge was built in 1992 based on a design by the engineering office Dopravní stavby Olomouc.

**Figure 1:** Cable-stayed bridge over the Rožnovská Bečva near Hrachovec

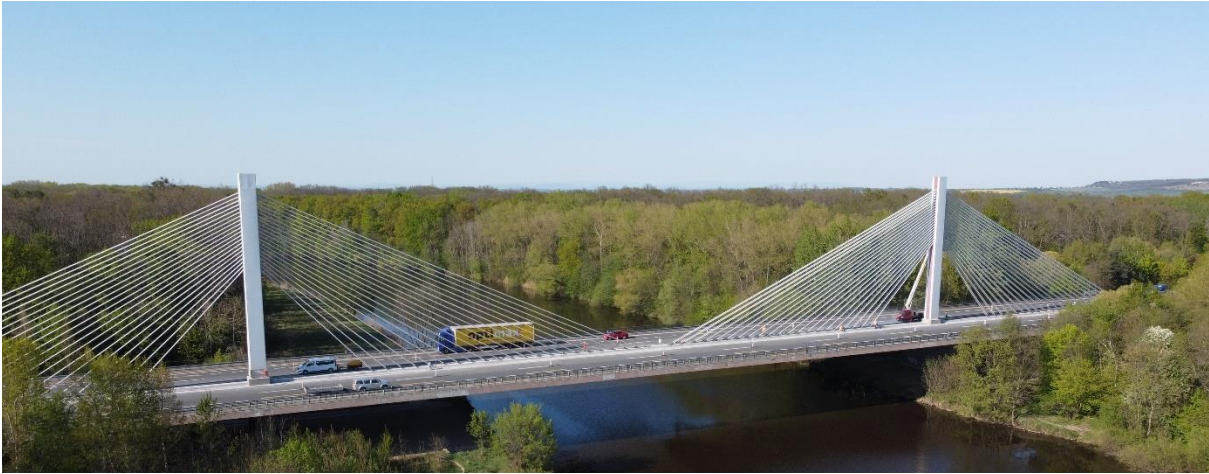
The second structure is a bridge construction located in the Middle Bohemia region (Nymburk district) near the town of Poděbrady (Figure 2). The bridge is a three-span cable-stayed bridge with spans of 61 × 123 × 61 m, crossing the D11 motorway over the Elbe River. The bridge consists of a precast segmental box-girder structure assembled using the balanced cantilever method. The cable-stayed system is of the harp type, with stays anchored to two pylons positioned above the inner piers and rising to a height of 28 m. The structure is suspended in a single plane along the bridge axis. The bridge was built in 1990 based on a design by the same engineering company.

**Figure 2:** Cable-stayed bridge over the Elbe River near Poděbrady

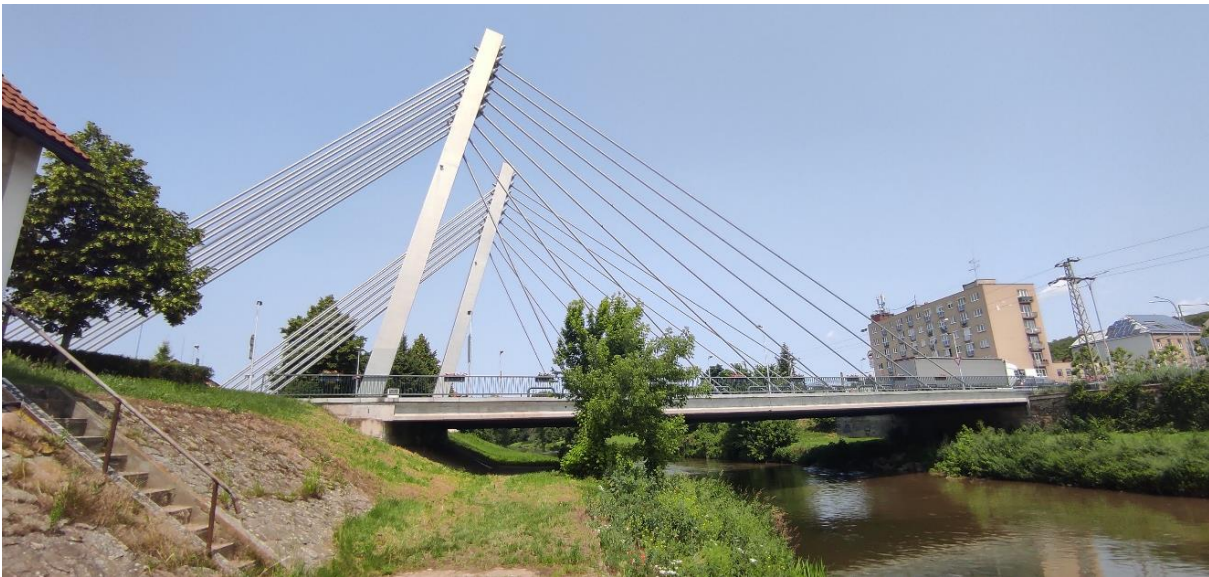
The last structure is a single-span cable-stayed bridge, 50 meters in length, crossing road II/416 over the permanent watercourse of the Svratka River (Figure 3). The bridge deck is composed of prefabricated, prestressed segments (modified KA-girders, like those used in the first structure near Hrachovec), supported by a pair of prestressed T-beams. These are suspended by stayes from a pair of inclined composite pylons made of steel and concrete, each 23 meters tall. The main girders are rigidly connected to the abutments. The rear anchor stayes are fixed to an anchorage chamber located in a shaft beneath the sidewalks. The bridge was completed in 1993, based on a design by the engineering office Dopravoprojekt Brno.

**Figure 3:** Cable-stayed bridge over the Svatka River in Židlochovice

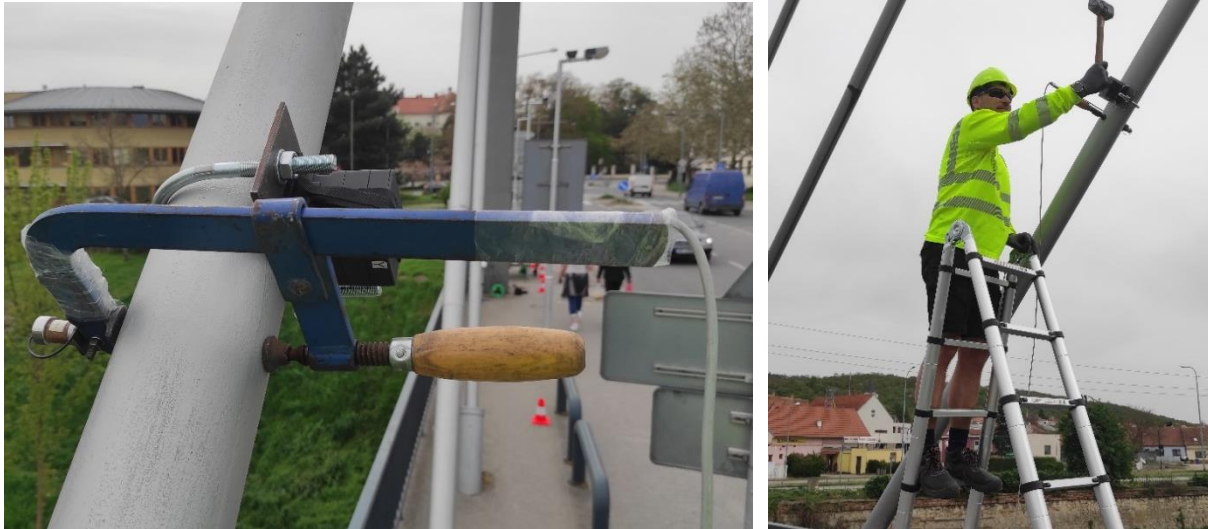
For easy handling and secure attachment of the accelerometer to the outer diameter of the stayes (without damaging their surface), a simple fixture in the form of a clamp with a welded pad for sensor mounting can be used (Figure 7a). Vibrations are induced by striking the stay cable horizontally with a hammer fitted with a rubber head (Figure 6b) at a point sufficiently distant from the stay cable end (either the bridge deck surface or the arch anchorage). This method is effective for generating lower vibration modes. The recording length is typically set to at least 90 seconds. Measurements should be carried out in calm weather, with the ambient air temperature recorded, and preferably with no traffic on the bridge. In the case of uninterrupted traffic, minor interference in the recorded data may occur.

**Figure 7:** Conducting dynamic measurement: a) measuring fixture with mounted accelerometer, b) excitation by striking with a hammer fitted with a rubber head

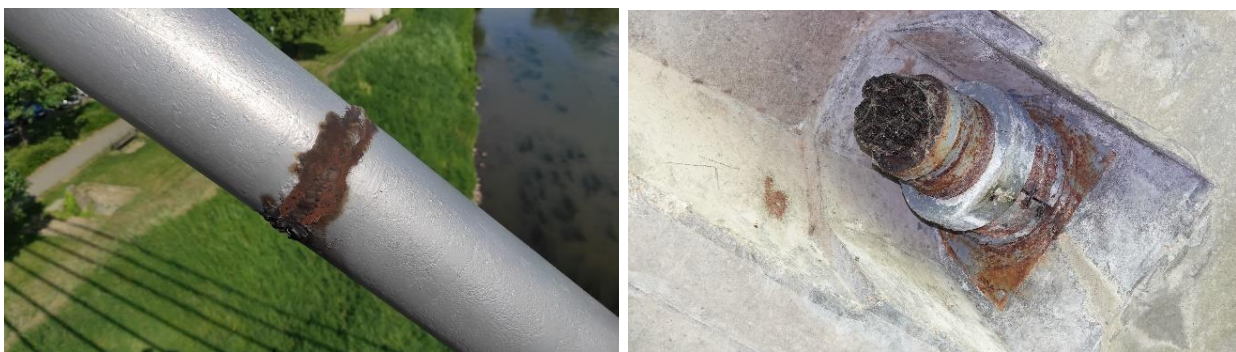
The visual inspection began with an examination of the entire length of the external stay cable sheath, which, for all inspected bridges, consisted of a steel pipe. Any damage identified was documented photographically. Common defects included abrasions, localized thinning of the coating, and corrosion, particularly at the welded joints of the steel pipes (Figure 8a). In these areas, where the base material of the stay cable sheath had been chemically altered by the welding process, the protective coating had reached the end of its service life, resulting in progressive corrosion and flaking of the topcoat. Additional issues observed included areas with incomplete coating, dents, bends, and contamination, most of which likely originated during the construction phase.

During the diagnostic investigations, a visual inspection of all stay cable anchorages was carried out. In most cases, corrosion of the surface protective coating (topcoat) was visible, and in some instances, flaking was also observed (Figure 8b). These findings were consistent regardless of whether the anchorages were located beneath the bridge deck or in anchorage chambers — as with the bridges in Židlochovice and near the village of Hrachovec — or inside the bridge box girder, as in the case of the Poděbrady bridge. Wherever rainwater could penetrate — for example, due to failed deck waterproofing or water ingress between the steel pipe and the protective sleeve at the deck penetration — the protective coating on the anchorages had deteriorated.

**Figure 8:** Results of visual inspection: a) corrosion of external sheath joints, b) corrosion damage to the protective coating system of the anchorage and missing anchorage cover

The visual inspection identified the need for a complete renewal of the anti-corrosion coating on all stay cable sheaths. Remedial works should include refurbishment of exposed anchor surfaces and restoration of corrosion protection systems (PC) for anchorages on pylons, within anchorage chambers, and in the bridge deck — including protective covers, nuts, and washers. In addition, it was recommended to redesign the protective covers to allow for pressure-injection replenishment of lubricants containing corrosion inhibitors.

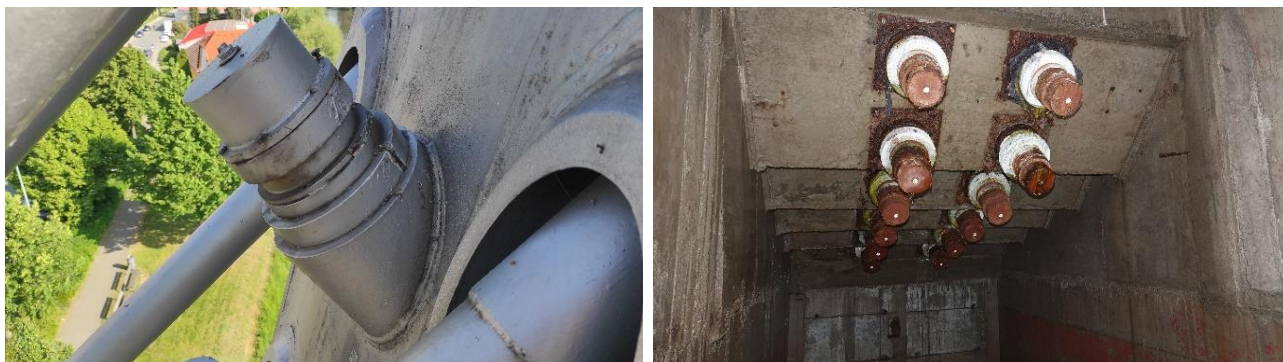
For anchorages located inside chambers (Figure 9b), although sheltered from direct weathering, significant water intrusion evidently occurred during rain events. These chambers lacked both ventilation and accessible inspection openings, which significantly accelerated the corrosion process. The damage affected not only the anchorage housings but also the adjustment nuts and washers.

The condition of the pylon anchorages varied slightly depending on their exposure to the outdoor environment. At the bridges in Židlochovice (Figure 9a) and near Hrachovec, the anchorages were exposed to weathering, whereas at the Poděbrady bridge they were located inside the pylon, where they were better protected.

**Figure 9:** Condition of anchorages: a) on the pylon, b) in the anchorage chamber of the bridge over the Svatka River in Židlochovice

Acoustic tracing of the grouting in all stays primarily revealed areas with a resonant or hollow response, indicating potential voids or cavities. These defects were detected mainly on the Poděbrady bridge, in the upper sections of the stays near the pylons (red section in Figure 11). The most likely cause was settlement of the grouting compound, leading to the formation of cavities, particularly beneath the anchorages. No such cavities were found on the bridges in Židlochovice and near Hrachovec; however, it should be noted that on these bridges the area directly beneath the anchorage—where grout settlement could occur—is located inside the pylon (Figure 9a).

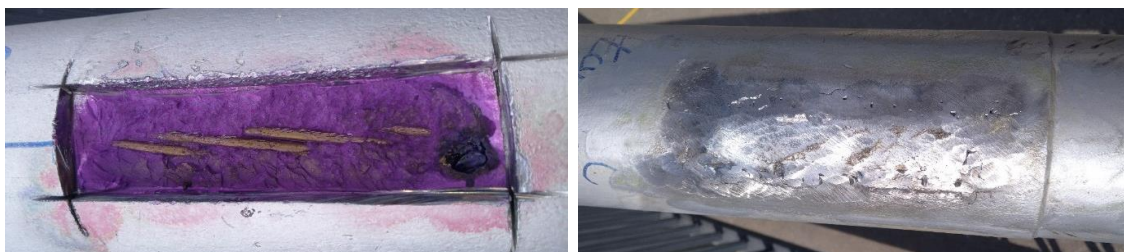
In-situ pH testing using a Rainbow indicator (Figure 12a) and laboratory analysis confirmed that the pH values of the grout were consistently high (greater than 12.00). Such a strongly alkaline environment ensures that the grout effectively maintains the passivation of the prestressing strands.

**Figure 12:** Cut-through probe through the stay cable sheath on the bridge in Židlochovice: a) indicative pH test, b) sealing with a welded steel patch

Finally, the cut inspection ports were reinstated by filling them with Groutex Fill In, a thixotropic, non-shrink structural repair grout, and resealing them with the original steel cover plate, hermetically welded along the entire perimeter (Figure 12b). The surrounding surface was subsequently overcoated with a protective anti-corrosion coating system to ensure long-term structural durability.

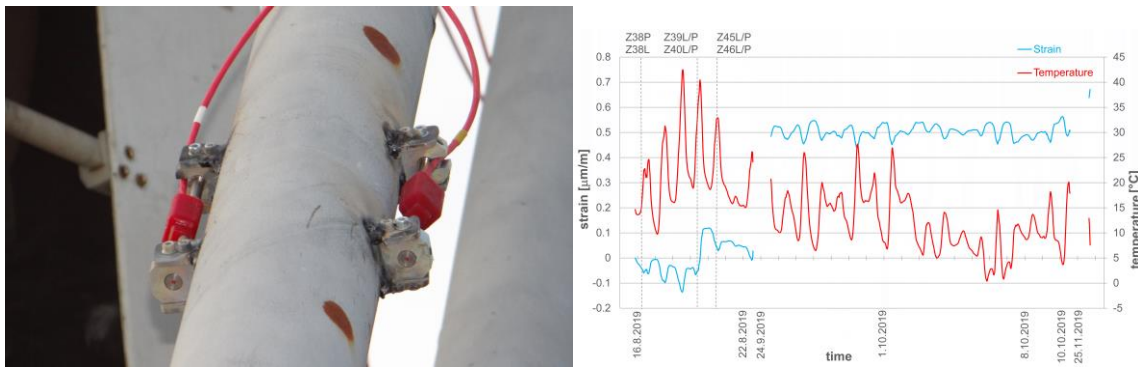
Strain-gauge measurements of the stays were carried out only on the bridge near Hrachovec and served as a verification method for the dynamic analysis. A closed-loop strain-monitoring system was installed to record variations in strain and stress in the stays. The instrumentation consisted of surface-mounted vibrating-wire strain gauges with weldable end blocks (Figure 14a).

While strain gauging alone cannot determine the initial prestress level or the absolute axial force in the stay cable, it allows continuous monitoring of tension changes, making it possible to detect any increase or decrease in axial force during the measurement period (Figure 14b).

**Figure 14:** Strain-gauge measurement: a) installed vibrating-wire strain gauge, b) deformation and temperature record from a selected gauge
