# Experience in Monitoring the State of the Load-Bearing Structure of Prestressed Concrete Bridge to Extend Its Operation

Civil and Environmental Engineering  
Journal of the Faculty of Civil Engineering | University of Žilina

## 2. The Bridge on Bojnicka Street in Bratislava

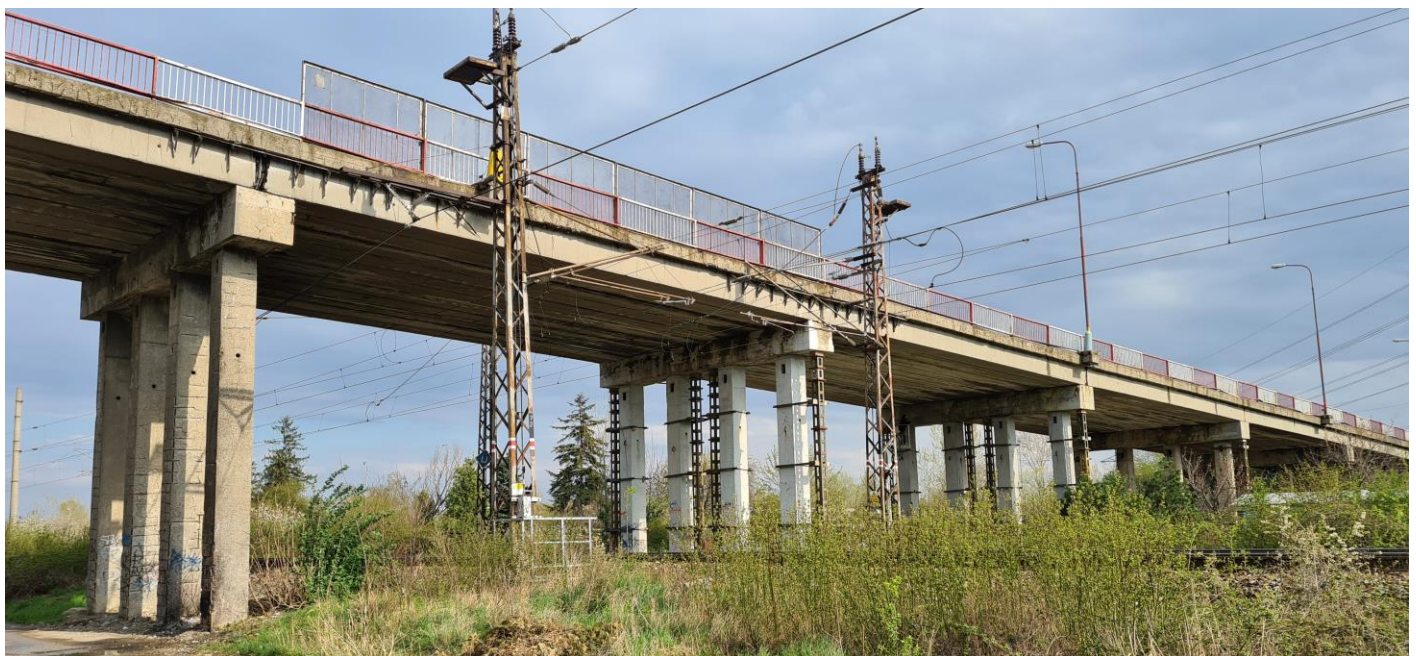
**Figure 3:** View of the bridge on Bojnicka Street

The bridge on Bojnicka Street was designed as a temporary road overpass, which served as access to the industrial area, see Figure 3. The bridge crosses the double-track railway line and another 2 sidings, see Figure 4. It was built in 1977. The bridge has 6 spans with a total length of 106.8 m. The deck consists of 18 m long post-tensioned precast girders KA-67. There is no bending connection in the intermediate supports; therefore, the bridge behaves as a sequence of 6 simply supported spans. There are 11 beams in the cross-section. The depth of the beams is 0.85 m. The total width of the bridge deck is 11.5 m, see Figure 5. The connection between the beams in the transverse direction is made with cast-in-situ concrete joints. The beams are made of concrete class B500 (C35/45) with a mean cube strength of 50 MPa.

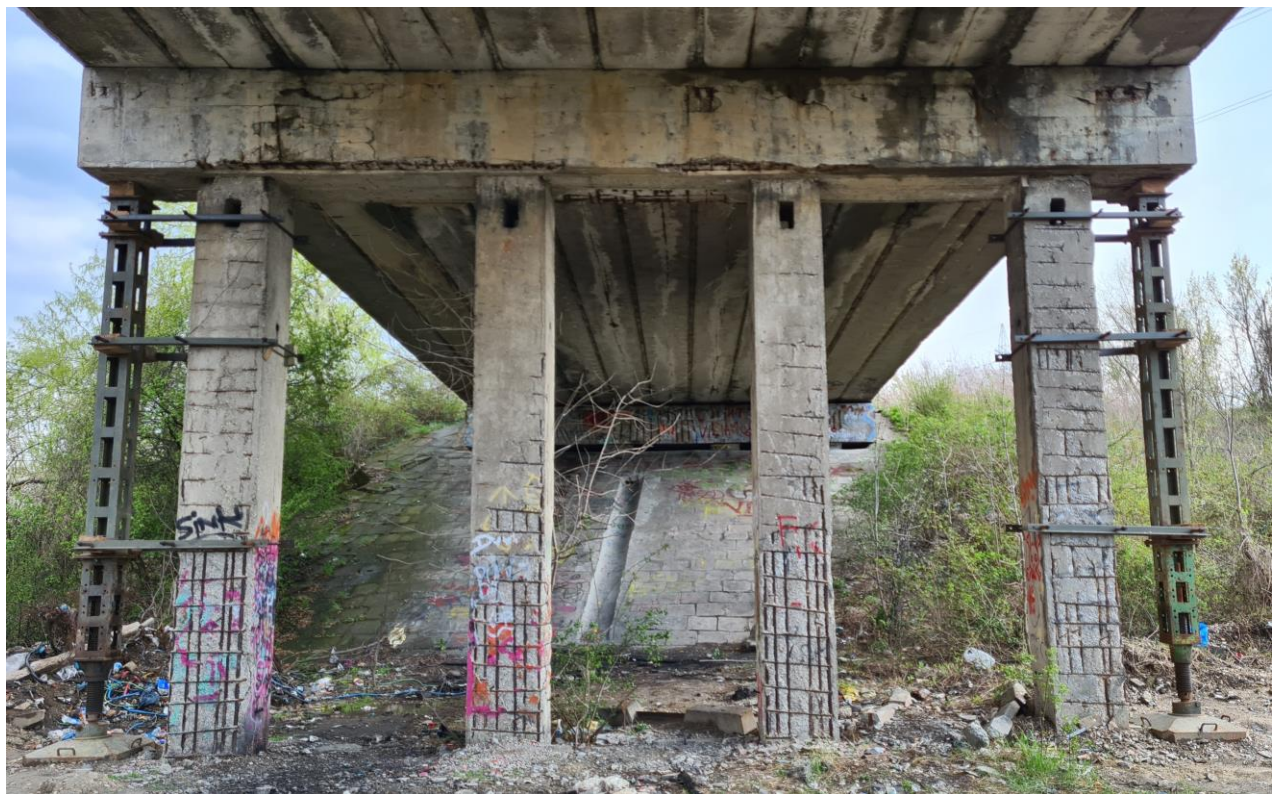
There was a full-surface delamination of the concrete cover layer on the bottom part of the columns and the crossbeams (Figure 6). Thus, there was a significant reduction in the bond between the reinforcement and the concrete. The covering layer is delaminated on approximately 80 % of the area of the columns, and even if it is not visually obvious at first sight, the concrete cover falls off after tapping with a hammer. The reinforcement under the cover layer was significantly corroded. The reductions in the cross-sectional area of the reinforcement were as follows:

- Column, longitudinal bars: 10 to 20%.
- Column, stirrups: 50 to 80%.
- Crossbeam, longitudinal bars in bottom surface: 50 to 100%.
- Crossbeam, stirrups: 50 to 100%.

High concentrations of chlorides were measured in the vicinity of the reinforcement in the range of 1 to 10 % of the estimated weight of the cement, both on the columns and on the crossbeam.

**Figure 6:** View on the substructure with temporary support of the crossbeam

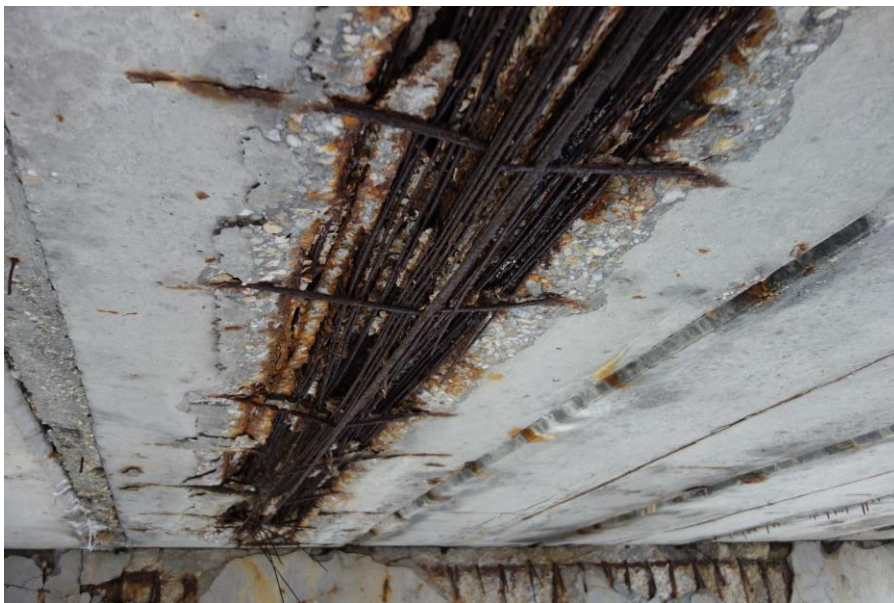
The bridge deck leaks over approximately 40 % of the area, which is already visible at first sight from below at all the spans. Moreover, steel bars were used to support transverse reinforcement, and therefore, they were placed directly on the formwork in the longitudinal direction. Their corrosion has gradually affected the integrity of the concrete cover at the bottom surface of the beams. Corrosion of the prestressing tendons occurs locally. It is estimated that the prestressing tendons corrode in at least 20 % of the beams. In some places, the concrete cover layer of the prestressing units has spalled off, and the corrosion has become visible. Some beams show longitudinal cracks at the bottom surface, which are caused by corrosion of the prestressing ducts. The worst corrosion of prestressing wires is presented in Figure 7. It has completely corroded several tendons along a length of approximately 5 m. The significant corrosion advancement is caused by the high chloride content in their vicinity, which was detected in the laboratory on samples of the cover layer and injection mortar. Chloride concentrations determined based on laboratory analysis showed values ranging from 3 to 23 % of the estimated weight of cement.

Figure 7: View of corroded prestressing wires

When there are doubts about the intensity of structural damage or inaccuracies in determining the prestress level of a bridge, the procedure for determining its load-carrying capacity can be supported by a proof-load test. This test serves to validate the assumptions made during the structural analysis (Moravcik, et al. 2025). Therefore, load test aimed to verify the structural behaviour of the bridge considered by the design model that was used for the assessment of the bridge load capacity. This mainly concerns the transverse distribution of the load, i.e. the mutual interaction of the beams in the transverse direction. Furthermore, to determine the impact of significant damage to the prestressing tendons of the beam in the 3rd span (Figure 7) on the overall performance of the bridge.

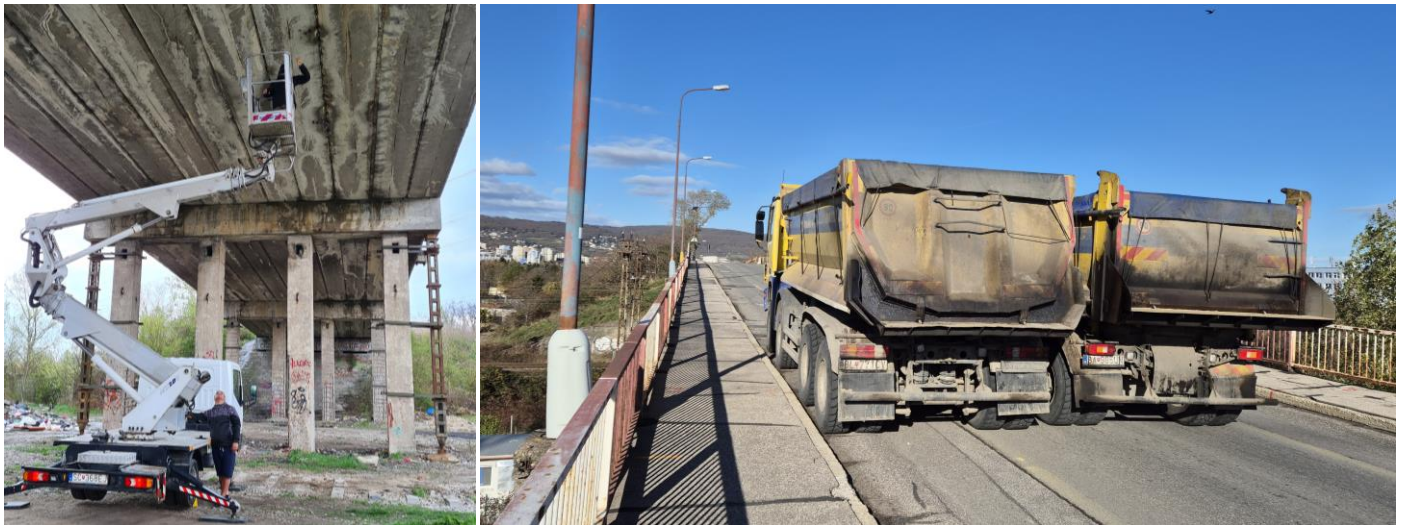
To keep the bridge in service, detailed visual inspections of critical sections have been prescribed at least 2 times a year. The aim is to visually monitor the possible degradation of critical parts of the bridge (Figure 11a). In order to detect possible hidden damages, measurements of the dynamic properties of the bridge are also carried out. Load tests are repeated every two years, comparing the response to the same loads, including the most unfavourable vehicle position, see Figure 11b.

**Figure 11:** a) Detailed inspection of critical sections, b) the most unfavourable position of the load during the load test

The test load was carried out by two 4-axle Mercedes Actros vehicles, see Fig.11b. The vehicles had a weight of 40 t. For the theoretical calculation of the bridge response to loading, the same grid finite element model was used as for the assessment of the load capacity. The calculation of deflections was performed with two flexural stiffnesses. The first flexural stiffness  $(EI)_1$  was determined only with the cross-sectional properties of the prestressed beams, and the second increased bending stiffness  $(EI)_2$  was determined with the cross-sectional properties of the beams, including the sloped plain concrete placed on the top surface of the beams. The values of bending stiffness for representative individual girders are given in Table 2 for both cases.
