Diagnostic Survey of prestressed concrete bridges in Prague

The article focuses on a comprehensive analysis of prestressed road bridges in the administration of the Technical Administration of Communications of the Capital City of Prague. Prague (TSK) in the Czech Republic. Most of the structures were mainly built between the 1960s and 1980s, mainly various types of prefabricated structures. The project evaluated the diagnostic surveys and load capacity calculations carried out so far on several dozen constructions. Detailed diagnostic surveys, which are carried out according to methodological standards and include visual inspections, laboratory and chemical analyses of the concrete, carbonation measurements, chloride concentration determinations, as well as direct inspection of the condition of the prestressing reinforcement, including endoscopy of the tendon ducts, play an essential role in the evaluation process. The paper summarizes and statistically evaluates the findings obtained from the analysis of superstructure made of I-73 Girders and gives an overall view of the condition of these bridges, with emphasis on the estimation of the residual service life and possible rehabi

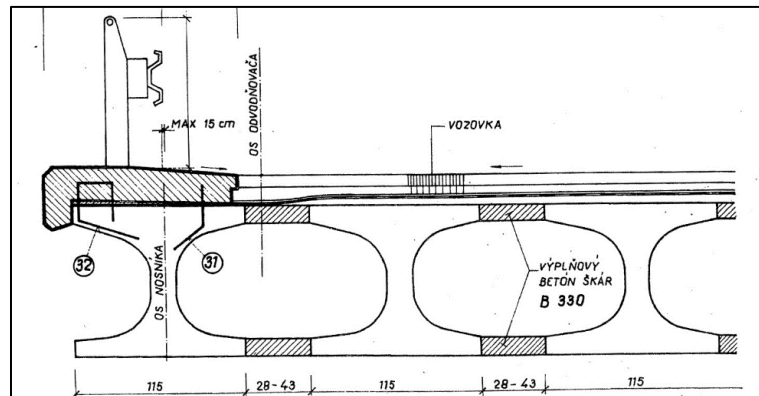
Figure 1: Cross-section of a bridge, where the superstructures consist of I-73 girders (Dopravoprojekt, 1973)

streams, and other motorways. The superstructures are built from standardized I-73 girders with clear spans ranging from 21 to 30 meters. The substructures are made either of reinforced concrete or of a combination of plain and reinforced concrete. Figure 1 presents a typical bridge cross-section with I-73 girders in the superstructure, while Figure 2 illustrates the reinforcement of the 21-meter-long I-73 girder with prestressing tendons.

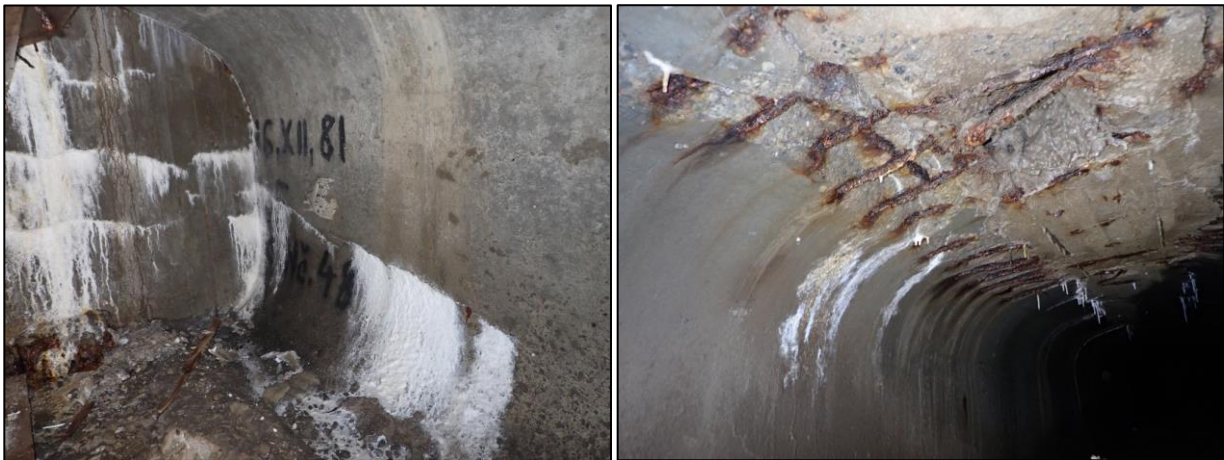
Figure 4: Significant active water leakage into the cells between the I-73 girders. Visible surface degradation of the concrete and exposed reinforcement. Observable paths of prestressing reinforcement (cracks and leachates)

A complete renewal of the waterproofing system is the only effective measure to mitigate the identified superstructure defects and prevent further loss of water. Advanced strengthening approaches, such as UHPC application, can help enhance the bridge deck and increase its service life. During reconstruction works, careful evaluation of the prestressing anchors and verification of the grout quality in the ducts are necessary. However, given the difficulty of inspecting the anchorage zones of the inner girders and the presence of active leakage, it is unlikely that these superstructures will achieve the intended service life of 100 years (Vičan et al., 2023; Kralovanec et al., 2024).

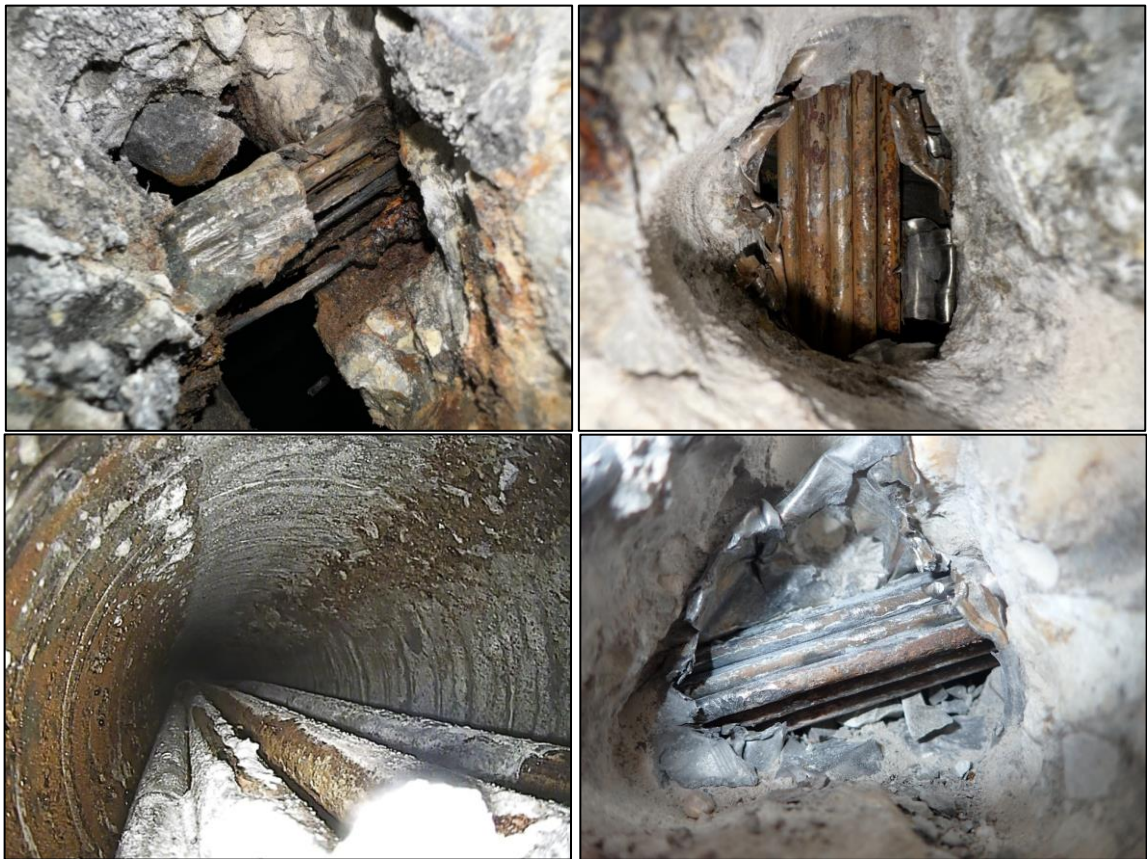
Figure 5: Presence of non-grouted tendon ducts and corrosion of prestressing strands and wires

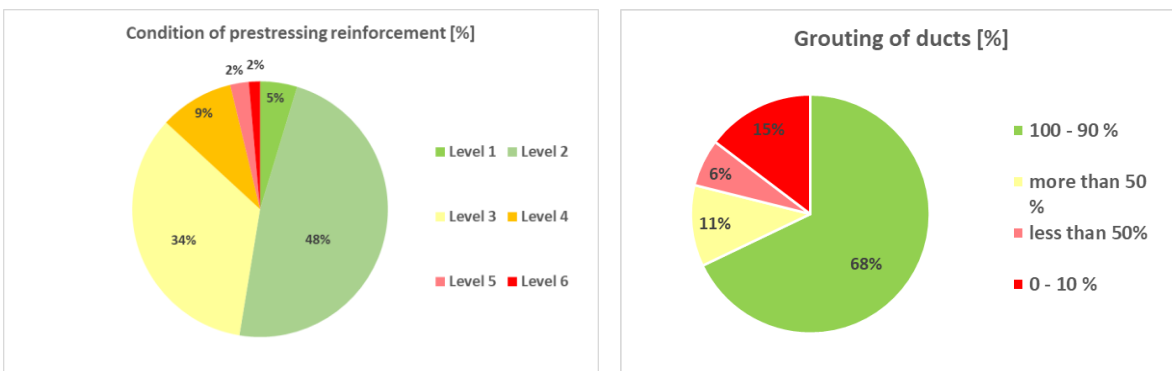
- As seen in Fig. 6, 5% of the total 213 boreholes across 8 bridges were classified as Level 1, 48% as Level 2, 34% as Level 3, 9% as Level 4, and only 4% as Level 5 or below.

- As seen in Fig. 6, the ducts were filled to the specified level of 90–100% of their capacity in 68% of the 213 boreholes, 50–90% in 11%, 10–50% in 6%, and 15% were non-grouted.

Figure 6: Presence of ungrouted tendon ducts and corrosion affecting the prestressing strands

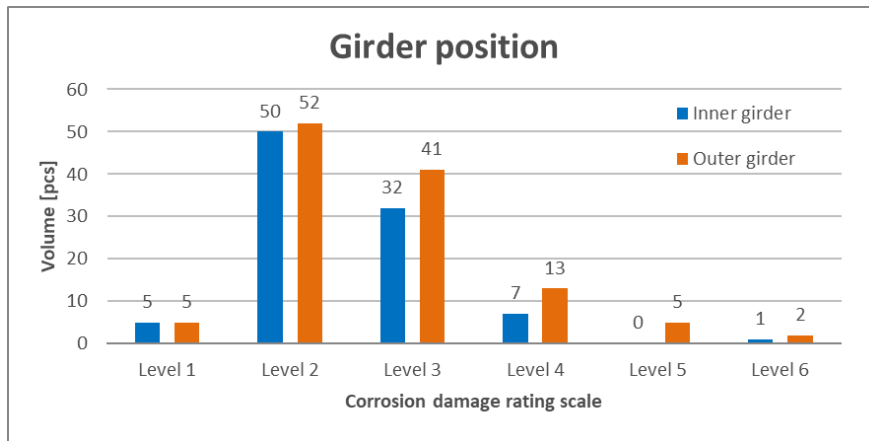
- The most critical areas were identified as the outer girders and, in some cases, the longitudinal joints between girders, where prestressing reinforcement is especially susceptible to corrosion due to degradation of joint materials and leakage caused by defective bridge deck waterproofing.

Figure 7: Prestressing Reinforcement Condition Evaluated by Girder Location
