# Qualitative Seismic Evaluation of the Existing UR Masonry Shear Walls – Reinforced Concrete Frames System

## 2 Preliminary data regarding the analyzed building

The analyzed building is located in Romania, Suceava County, and falls into importance category C and earthquake importance and exposure class III in accordance with HG. 766/1997 [12] and P100-1/2013 [13] norms.

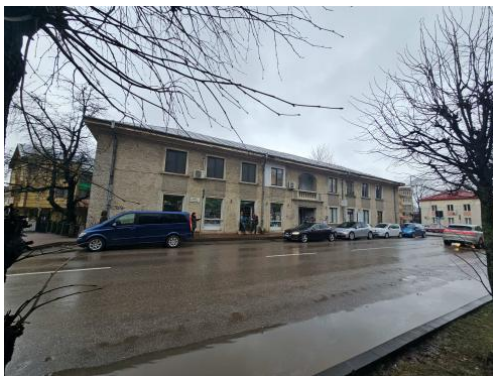
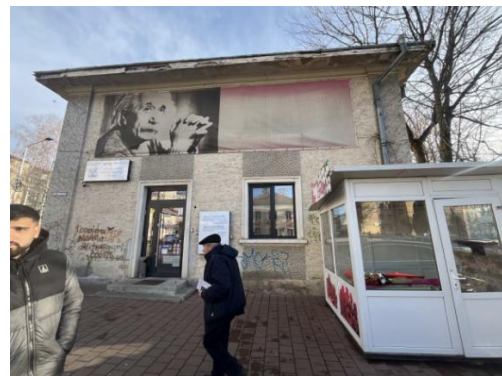
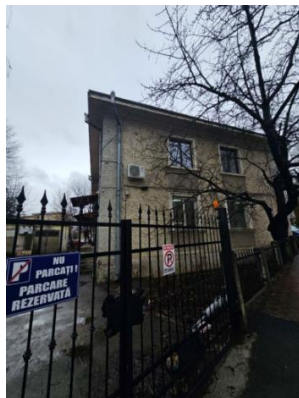
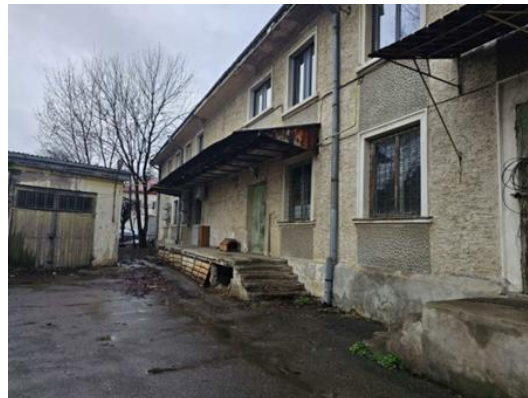
Figure 1: Representation of the: (a) main facade of the analyzed building; (b) right side facade; (c) left side facade; (d) rear facade

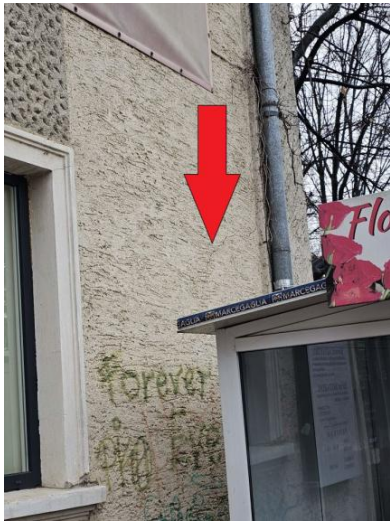
- SD.1 - structural degradation and micro/ macro-cracks of the external masonry shear walls (see Figure 3 (a); Table 4, Table 5);
- SD.2 - horizontal cracks in the masonry shear walls (between the gaps) caused by tensile stresses from bending moments resulting from seismic or non-seismic actions (see Figure 3 (b), (c); Table 4, Table 5);

Figure 3: Representation of the structural degradations: (a) degradation and micro/ macro-cracks of the external masonry shear walls; (b), (c) horizontal cracks in the masonry jamb between the gaps; (d), (e) inclined ( $45^\circ$ ) cracks above the masonry coupling beams; (f) cracks under the support of the beams (the crushing effect of the local area); (g) local separation cracks between RC floor and masonry shear wall; (h), (j), (k) inclined ( $45^\circ$ ) macro-cracks in the field (plain) of masonry shear walls; (i) multiple cracks in the RC slab above the ground floor

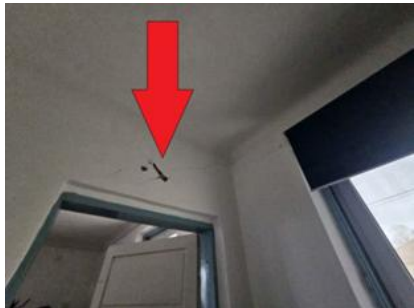
- SD.3 - inclined cracks (at 45°) above the masonry coupling beams caused by "vault" action of the masonry in that area (see Figure 3 (d), (e); Table 4, Table 5);

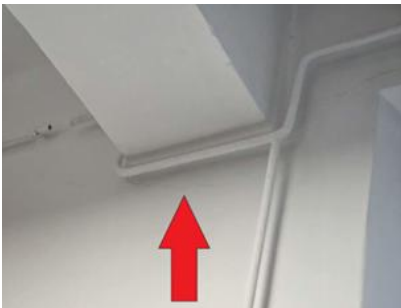
(f)

- SD.4 - cracks under the support of the beams (the crushing effect of the local area) caused by compression stress (see Figure 3 (f); Table 4, Table 5);
