Tadeusz Majcherczyk

AGH University of Science and Technology, Faculty of Mining and Geoengineering,
Cracow, Poland

MINING INFLUENCE IN THE AREA OF THE PSZCZYNKA RIVER AND THE METHOD OF RIVERBED RESTORATION

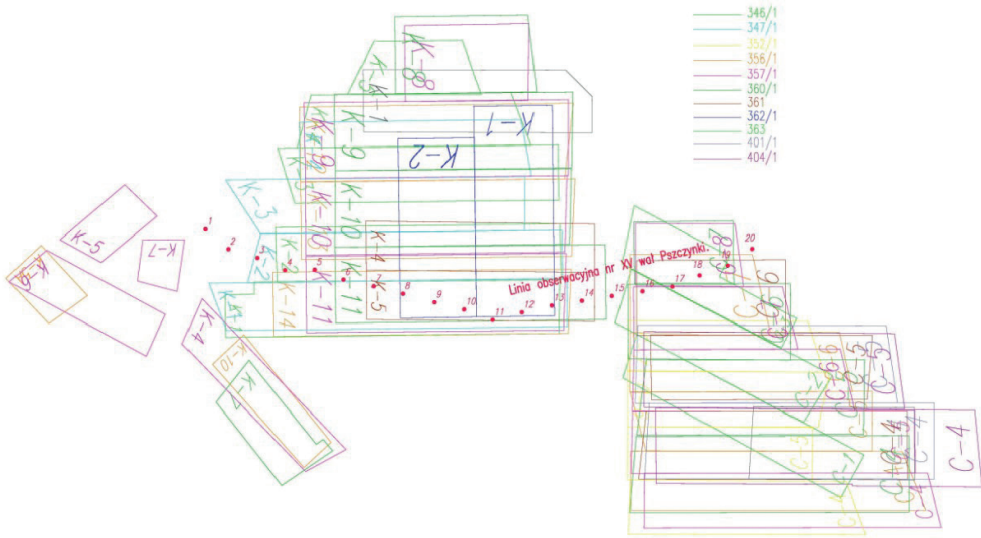
Fig. 1. Excavation in the area of the Pszczynka river and the positioning of the observation line

Fig. 1 presents the distribution and shape of particular walls and the positioning of the measurement line where the measurements were performed from 2005.

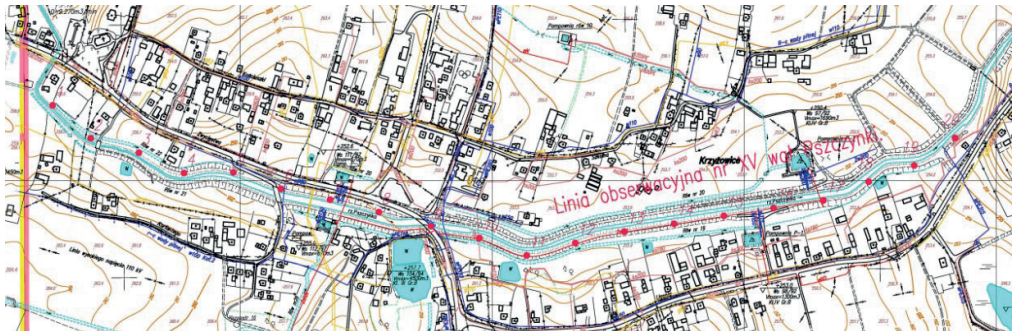
Fig. 2. Map of the analysed area and positioning of the measurement line

The process of subsidence trough formation, enhanced by mining exploitation in the discussed area, is documented by the results of geodesic measurements from the period June 2005 to June 2018, taken on the observation line running along the riverbed. The 2,000-metre long line consists of 20 geodesic points fixed at every 100 meters on both sides of the river,

relatively close to the riverbed. A map showing the distribution of the measurement points in the area of the bed of the Pszczynka river is presented in Fig. 2.

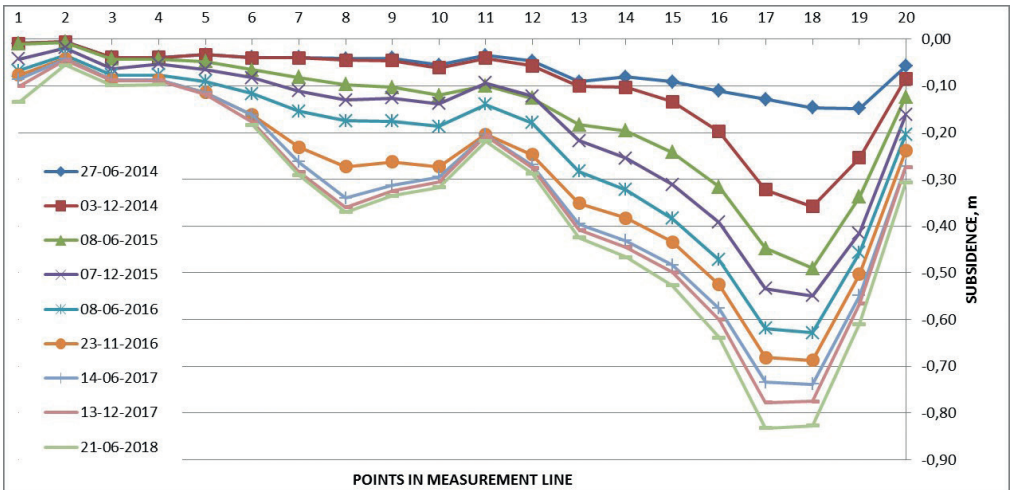
Fig. 3. Subsidence of points on the measurement line in the area of the Pszczyńska river in the period June 2005–June 2018

Altitude monitoring made it possible to interpret the process of deformation. During the period of thirteen years of measurements, the maximal surface subsidence created two subsidence troughs with maximum values of 1.79 m at point No. 8 of the measurement line and 1.79 m at point No. 18 of the line. Undoubtedly, the walls excavated directly below the measurement line exerted a crucial impact on the volume and rate of subsidence. The values of subsidence at the end points of the observation line in the western direction indicate a clearly decreased character (subsidence of only 0.23 m in point No. 1). The subsidence also decreases eastbound (0.73 m at point No. 20). In the middle of the measurement line (point No. 11), the subsidence reached the value of 0.28 m. The increase of subsidence is presented in Fig. 3.

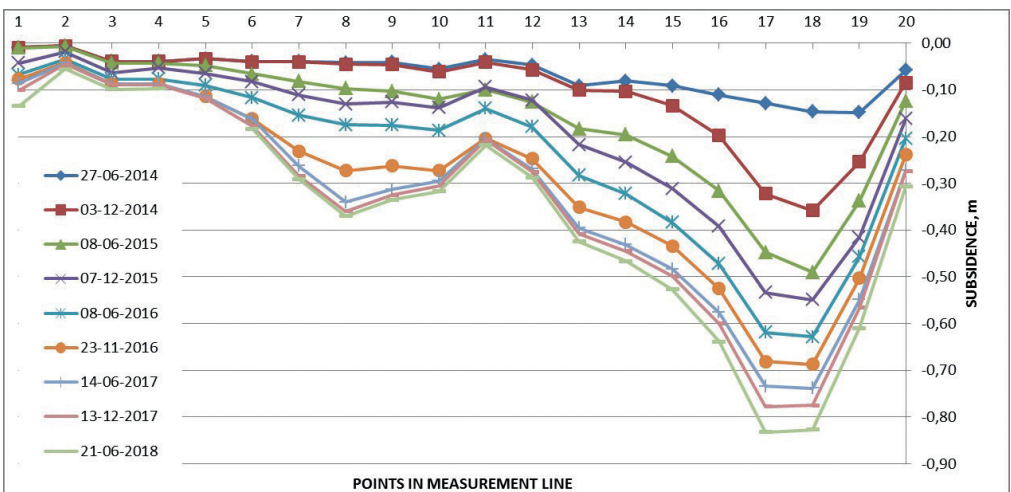
Fig. 4. Subsidence of points on the measurement line in the area of the Pszczyńska river in the period November 2013–June 2018

In the next stage of the study, a period of low exploitation intensity (November 2013–June 2018) was examined, when five longwalls in three seams (362/2, 401/1 and 404/1) were extracted. Surface subsidence reached values approaching 0.83 m at points Nos. 17 and 18, which is presented in Fig. 4. From the west, mining exploitation was also executed in walls C-4 and C-5 in seam 401/1, and in walls C-4 and C-5 in seam 404/1, which is illustrated by the subsidence at points Nos. 15–20 on the measurement line. The line remained within the exploitation area, thus it is impossible to record the entire subsidence trough. The measurement line indicates the reduction of subsidence mainly from the west side (exploitation of one wall K-1 in seam 362/1).

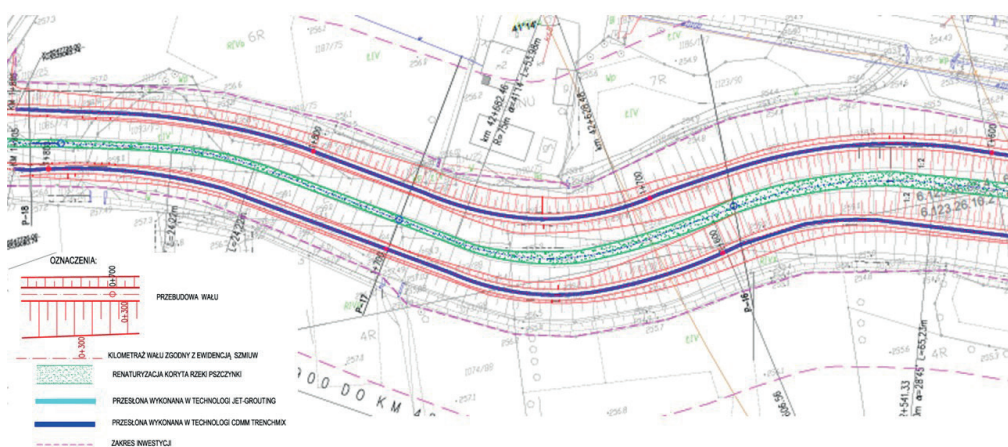
Fig. 5. Fragment of topographical map: river section with inserted design solutions

investment buildings. Therefore, particular construction works were undertaken in relation to the requirements of flood safety, proper water streaming in the riverbed and the preservation of satisfactory technical and hydraulic parameters (Fig. 5). These works involved [5]:

- ▶ repairing the existing flood protection dykes by raising the levee crowns and levee corpus development;
- ▶ raising and broadening the left and right levee corpus in the section with the largest surface subsidence;
- ▶ rebuilding perimeter drainage ditches colliding with the renovated flood protection dykes;
- ▶ rebuilding outlets of the drainage pump stations;
- ▶ rebuilding and protecting the hitherto-existing technical infrastructure intersecting with the flood protection dykes and the Pszczynka river in the discussed section.

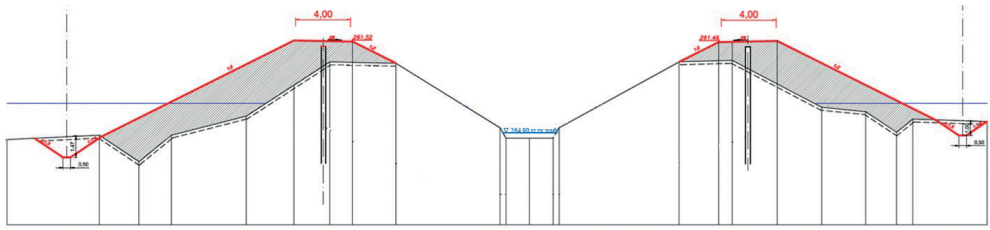
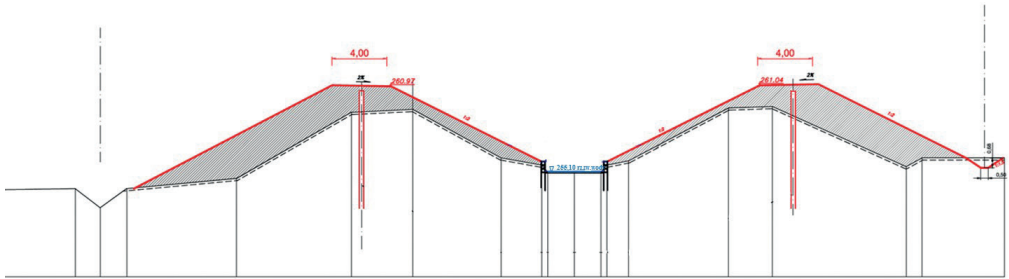
Fig. 6. Characteristic cross section of left and right embankment of the river Pszczyńska

Irregular subsidence of the riverbed of the Pszczynka causing a lack of adequate gravitation slope and serious decrease of the water flow velocity resulted in the creation of the water ponding zone. Therefore, the riverbed had to be stabilised in the section of 1 km. As part of the re-profiling process, the river bottom was reinforced with stone riprap, assuming a waterbed with a maximum bottom width of 4.0 m (Fig. 6) [5].

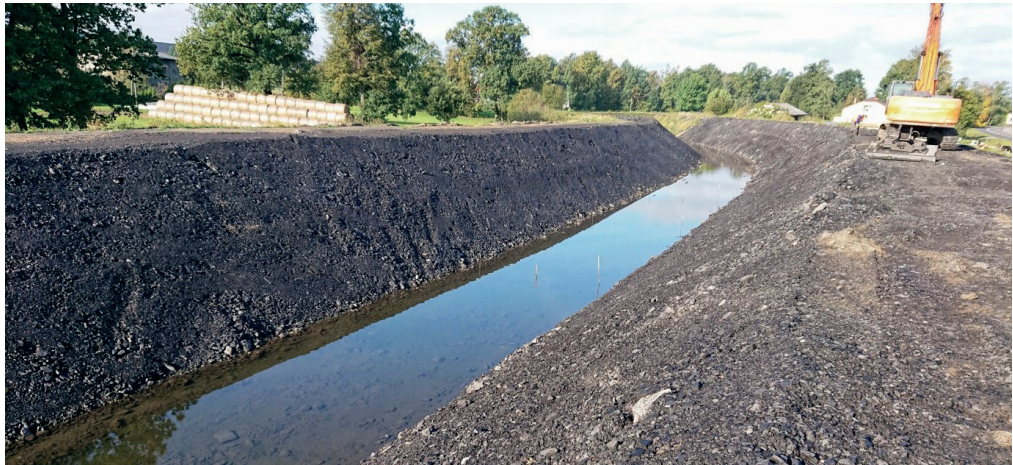
Fig. 7. Preparing riverbed for restoration

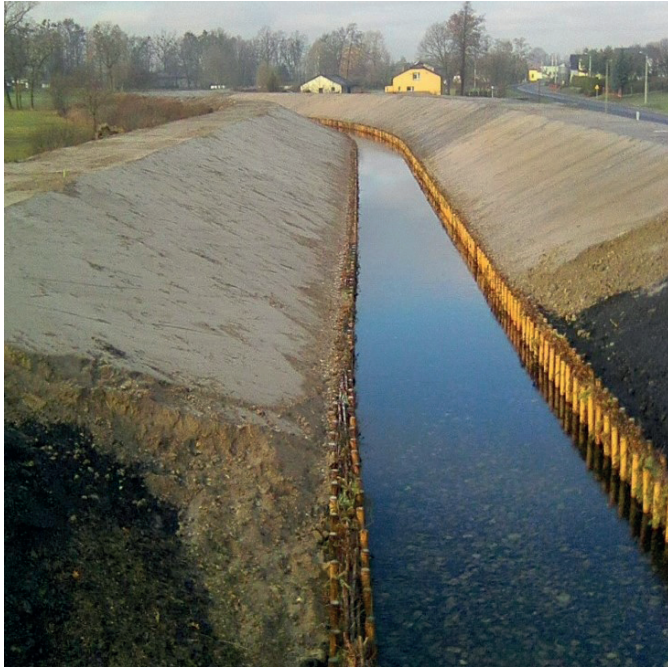
Fig. 8. Topsoiling of slopes

The restoration of the river Pszczynka will help to re-establish the original width of the riverbed from before the process of subsidence. In order to make the works in the river current possible, a special steel wall will be installed at depth of 6.0 m along the riverbed and the works will be executed on both sides of the wall interchangeably (Fig. 8).

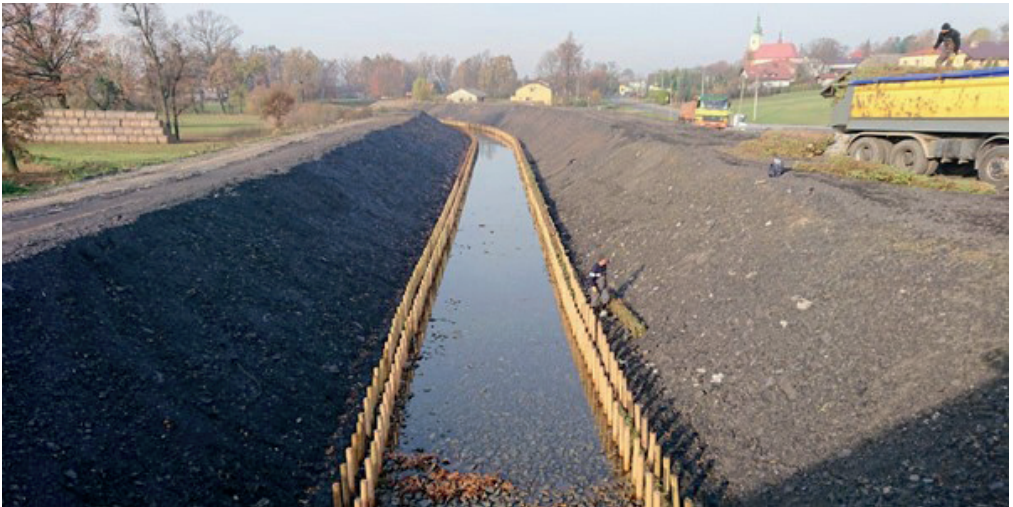
Fig. 9. Fascine construction works

As soon as the river bottom is stabilised, the Ø 25 cm fascine bands will be laid between the rows of poles in the footing of the slopes, followed by the formation of the slopes of the embankment. Most importantly, the fascine will be made after the river bottom stabilisation and before forming the embankment slopes. The total length of the fascine bands is 4 km (Fig. 9).

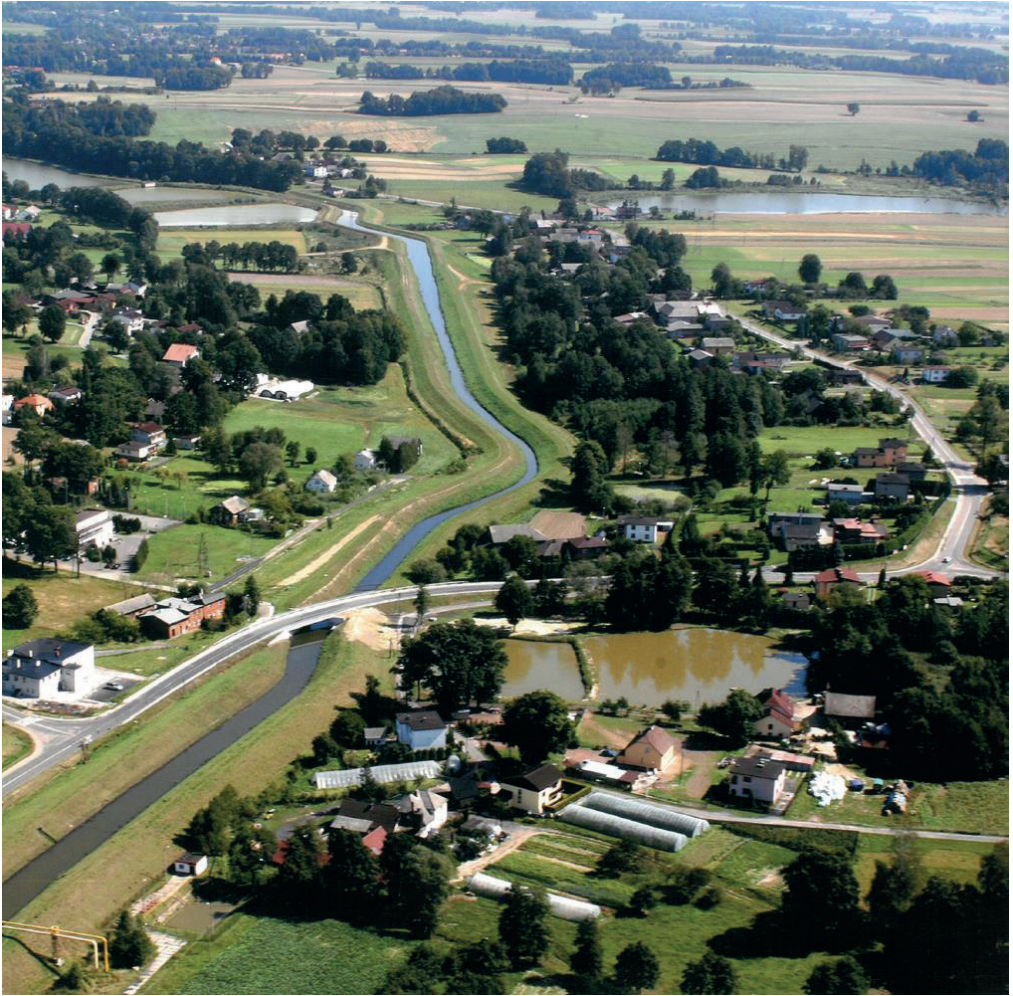
Fig. 10. Completed works after the most recent restoration

The method of restoration presented above proved most effective in the given local conditions (Fig. 10).
