# DEBRIS-FLOW (TORRENT) CONES TRIGGERED BY EXTREME RAINFALL DURING THE JUNE 2020 FLASH-FLOOD EVENT IN THE EASTERN POLISH FLYSCH CARPATHIANS

GĘBICA P., PYRC R., KOPACZKA-LEPA D., 2026. Debris-flow (torrent) cones triggered by extreme rainfall during the June 2020 flash-flood event in the Eastern Polish Flysch Carpathians. *Quaestiones Geographicae* 45(3), Bogucki Wydawnictwo Naukowe, Poznań, pp. 167–182. 9 figs, 2 tables.

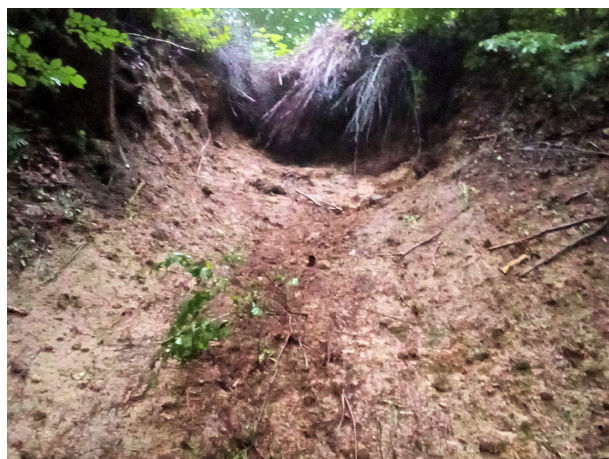
Fig. 5. Erosion in the headwater section of a dry small valley (pol. *debrza*) caused by an earth-organic debris flow following a downpour on 22 June 2020.

On a forested slope dissected by steep dry valleys, a mud-and-wood flow occurred in one of the valleys. Adjacent to a forest road, several cubic metres of soil-debris wood mass (including uprooted stumps, logs and branches – partly waste wood) detached and flowed downhill, carving out the valley floor and slopes. Vegetation growing on the valley sides and floor was eroded to a height of 2 m (Fig. 5). Over a section of several dozen metres, silty and clayey sediment (mud aggregates and cohesive clasts) and woody debris accumulated along the valley floor. In the neighbouring gullies, no similar effects were recorded on 22 June. However, the mainstream channel in the valley was deepened by approximately 1 m. Notably, during the subsequent flood on 26 June, the water level did not reach the high mark of 22 June, which remained the maximum for that particular valley.

In contrast, the effect of flow observed after the rainfall of 21–22 June in a forested ravine near Rzeszów in the Dynów Foothills (see Fig. 5) contained a high proportion of fine material mixed with wood debris. Following Van Dine's (1985) typology, the event is classified as a mudflow rather than a typical debris torrent, and it produced a smaller, less distinct depositional form.

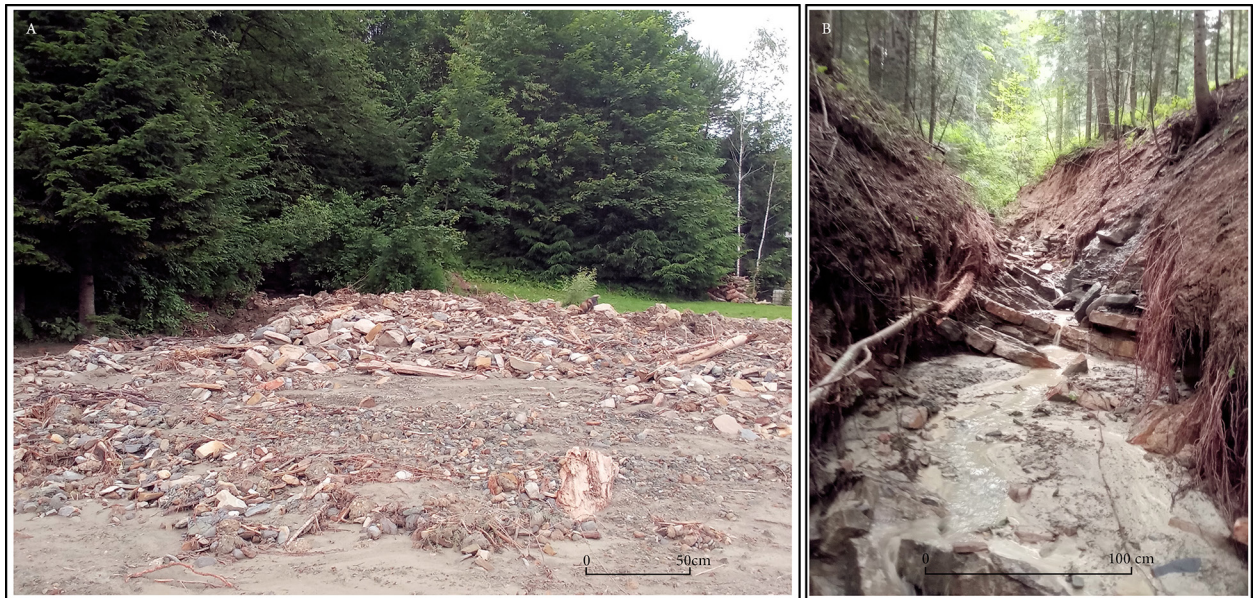
Fig. 6. A – Debris-flow (torrent) cone No. 1. The convex lobate landform of mid-fan with coarse deposition of boulders, pebbles, and wood debris. In the foreground, a clear boundary is visible between proximal-fan gravel deposition and distal-fan sand and silt deposition. B – The bedrock channel of the V-shaped valley was deepened and widened as a result of a debris-mud flow event on 26 June 2020.

The cone has a regular shape, with both flanks being similar in length (18–21 m), and a total axial length of 16 m (Table 1). The headcone (apex of cone) is convex in profile and composed of the coarsest debris (Fig. 6A). The maximum measured size of sandstone blocks (longest axis) is 75 cm (Table 2). On the cone surface, minor siltstone cobbles (ca. 13 cm in diameter) and debarked tree trunks measuring 132–160 cm in length and 13–36 cm in diameter can be observed.

Three shallow test pits were excavated on the cone. In the highest pit (to a depth of 0.2 m), coarse and medium gravel predominated, along with siltstone aggregates and clasts resting on boulders. In the second pit, situated lower on the

cone (to a depth of 0.25 m), sandy silt was found overlying coarse gravel. In the third pit, located in the lowest (distal) part of the cone, sandy-silty sediments with gravel were recorded to a depth of 0.4 m. Thus, the cone exhibits internal stratification and a fining of sediments towards its margins. Given the cone's surface area of 0.26 ha and an estimated average thickness of 0.2 m, the volume of deposited material is approximately 500 m<sup>3</sup>.

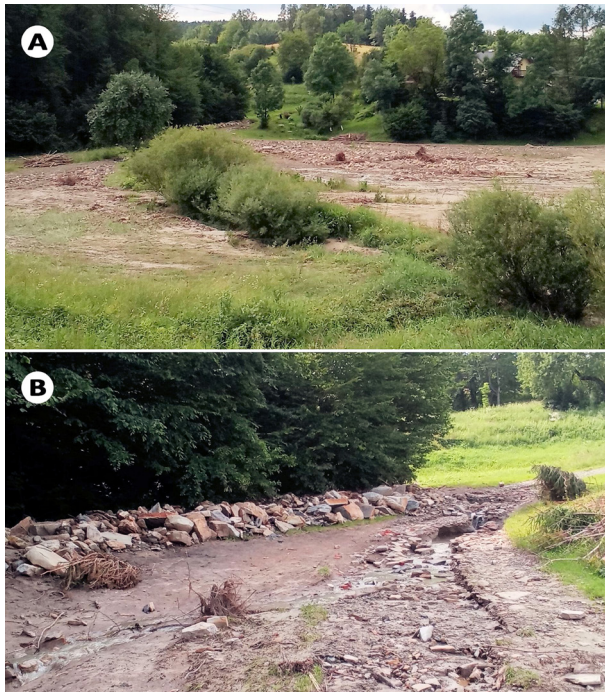
Fig. 8. A – Overview of debris-flow cone No. 2. The central (mid fan) sector of the cone shows an accumulation of coarse debris lobe, whereas the marginal zones are composed of gravelly sandy sediments. B – The apex part of debris cone No. 2 with incised channel. Sandstone blocks and boulders, up to 90 cm in diameter, accumulated at the mouth of the forested V-shaped valley.

Upstream from the rocky channel, numerous landslides were observed on the valley slopes, with colluvial deposits descending into the channel and obstructing water flow during the flood event (Fig. 8). These landslides served as a source of material transported into the channel.

In the proximal and central sections of the cone – extending over approximately 60 m – deposition was dominated by coarse-grained material (maximum diameter of sandstone blocks reached 92 cm) (Table 1, Fig. 8B). Two convex, elongated debris ridges (levees), aligned with the long axis of the cone, were observed on its surface. These were composed of sandstone blocks with maximum diameters of 87 cm.

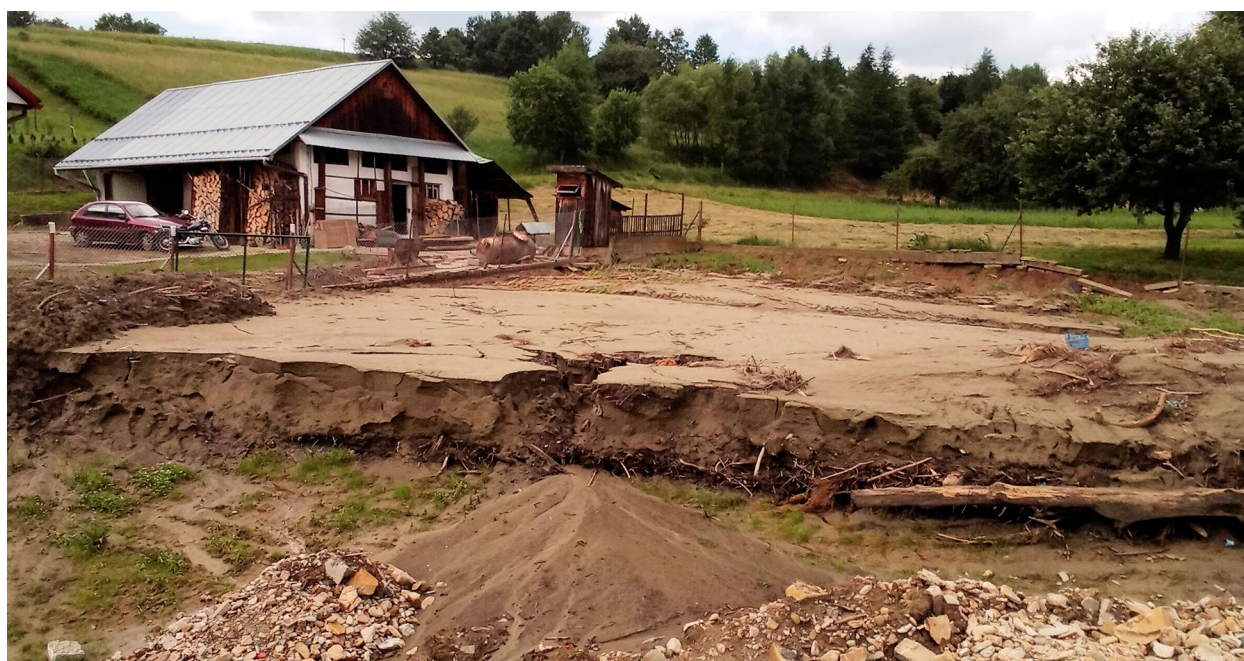
Fig. 9. Delta fan deposits, up to 1 m thick, accumulated in a small valley (a tributary of the Korzonka stream) during the peak of a flood wave backed up by a road embankment and a tree jam blocking the road culvert.

The described landform is a fan delta, formed due to the obstruction of water flow by a road embankment and the clogging of a culvert by a debris jam of trees and stones. Under these conditions, a temporary flow-through pond formed,

collecting water flowing from the upper part of the valley. As a result, water flooded buildings located downstream from the fan and partially overflowed the road embankment (294.6 m a.s.l.), which lies 4 m above the streambed. After the culvert was cleared by firefighters several hours after it had become blocked, the rapidly flowing water incised the fan, forming erosional gullies (crevasses), and at their mouths, small depositional cones (splays) developed. Water that had previously ponded, when released through the culvert, eroded the downstream channel segment with high energy (Fig. 2). The volume of material deposited within the studied portion of the fan (surface area 500 m<sup>2</sup>) is estimated at approximately 400 m<sup>3</sup>.

At the mouths of the valleys, three types of depositional landforms were observed: (1) debris cones, (2) debris-mud cones, and (3) fan deltas. The debris cones, composed of coarse-grained clastic material (blocks and boulders) and woody detritus (tree trunks, branches), had the largest surface area and thickness (see Figs 6A and 8, Tables 1 and 2). Smaller debris-mud cones were built mainly of fine-grained sediments, including mud aggregates (soil-derived sands), with a lower proportion of coarse clastic debris. The term fan delta is used here following its geomorphological definition, referring to an alluvial fan that progrades directly into a standing or slow-flowing body of water, forming a subaerial-subaqueous depositional complex (McPherson et al. 1987). The fan delta at the mouth of the tributary of the Korzonka stream, composed of sandy-muddy deposits (see Fig. 9), formed where water flow was temporarily blocked by a road embankment and a culvert clogged with vegetation. The largest debris cone covered an area of approximately 0.5 ha, with an estimated volume of 2200 m<sup>3</sup> of deposited material (see Fig. 8A, Table 1). Whereas the smallest landform – the fan delta – had a surface area of 0.05 ha and accumulated about 400 m<sup>3</sup> of material (see Fig. 9, Table 1).
