## UAV OBSERVATIONS OF CHANGES IN ROAD GEOMETRY IN A MINING AREA

**Keywords:** UAV measurements; Low-altitude photogrammetry; Road monitoring; Mining impacts.

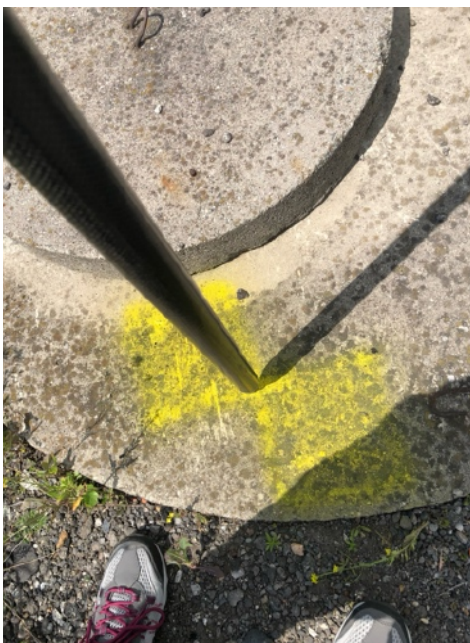
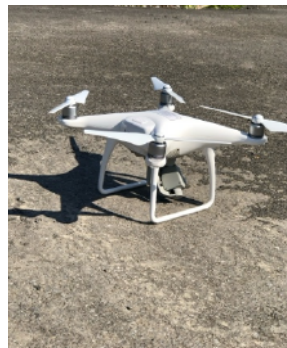
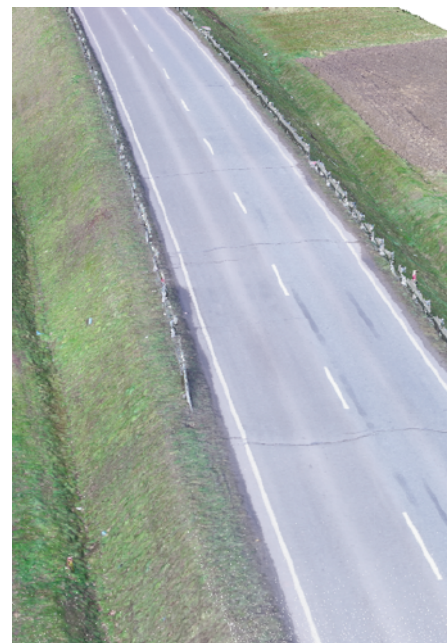
Figure 2.  
Location of road areas subject to UAV measurement

The stages of the task implementation for area 1 and area 2 are presented schematically below and in Figure 2.

1.a) Terrain vision, marking of ground reference points and their measurement using GNSS technology

1.b) Low-altitude photogrammetric measurement

1.c) Photogrammetric processing: image alignment, ground reference points identification, dense point cloud generation

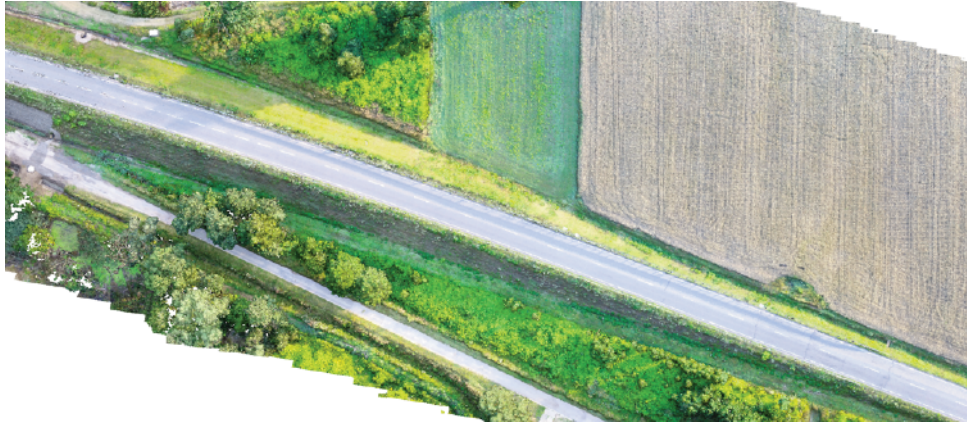
Figure 3.  
Generated dense point cloud of the research area

At the stage of photogrammetric processing, a specialist program initially aligned the photos and then indicated the ground reference points. In this way, the photogrammetric measurement was fitted into the applicable x, y, z coordinate system. Further activities came down to generating a dense point cloud, ultimately with a density of 327 points/m<sup>2</sup>. This stage allowed for reading the coordinates of the measurement points, as well as generating profiles.

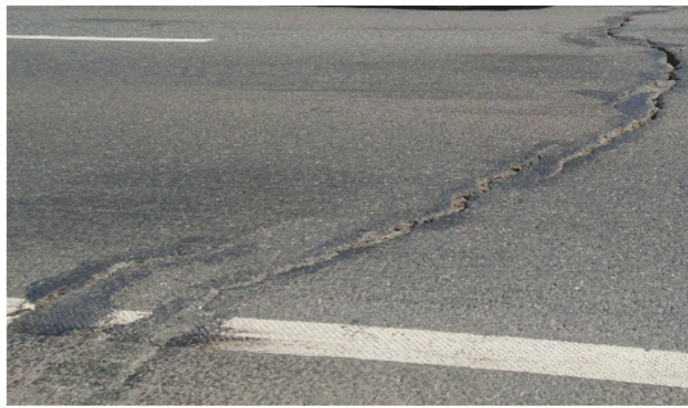
Figure 7.

An example of pavement damage revealed in the area of Linear Discontinuous Surface Deformations

In area 2, as a result of the exploitation, a zone of discontinuous deformations was created over a length of approx. 60 m. The course of these deformations was characterized by cracks with a direction close to the transverse direction to the road axis (Fig. 7). Photogrammetric measurements performed using an unmanned aerial vehicle allowed for a detailed analysis of changes in the road shape.
