BULETINUL INSTITUTULUI POLITEHNIC DIN IAȘI

Volumul 68 (72), Numărul 3, 2022

**THE QUANTITATIVE SEISMIC ANALYSIS OF A PRECAST  
REINFORCED CONCRETE FRAME HALL AND THE  
ESTABLISHMENT OF RETROFITTING SOLUTIONS. PART I –  
THE DYNAMIC ANALYSIS OF THE EXISTING STRUCTURAL  
SYSTEM**

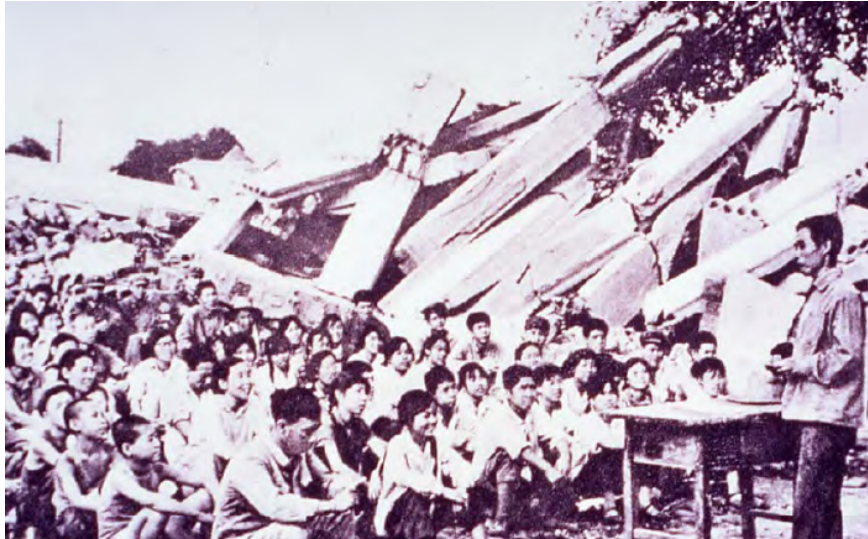
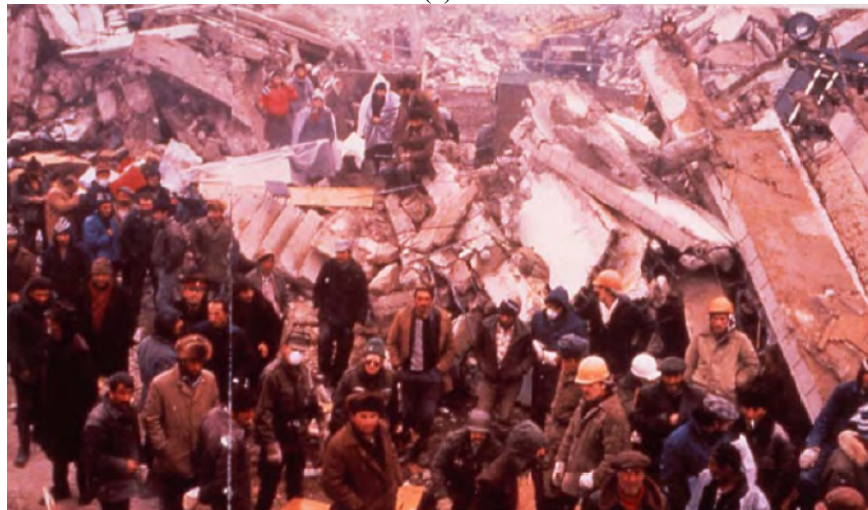
Fig. 3 – “(a) Collapse of precast buildings in Tangshan, China in 1976; (b) Collapse of precast buildings in Leninakan, Armenia in 1988” (FIB 27, 2003).

concepts. Fig. 3(a) and Fig. 3(b) show examples of major damage to precast concrete structures as a result of severe earthquakes.

Many precast concrete frame structures collapsed during the 1988 Armenian earthquake (EERI, 1989). These structures were typically nine storeys in height and contained hollow-core floor slabs. Some of the structures had some walls in one direction but these walls typically contained large openings. The beam-column connections were made by welding the beam bars to steel angles protruding from the precast columns. The floor diaphragms were poorly connected to the frame elements. Column splices were made by welding the vertical column bars. This detail resulted in significant eccentricities of the column bars at the splice location. The columns were poorly detailed with inadequate confinement and had column ties with only 90° bend hooks. These hooks were ineffective once spalling of the concrete cover occurred in the columns (FIB 27, 2003).

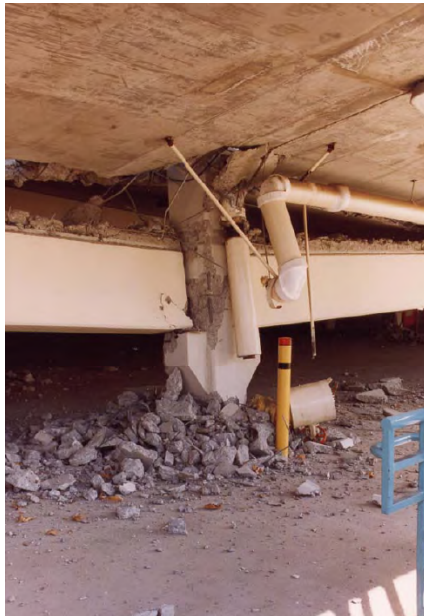
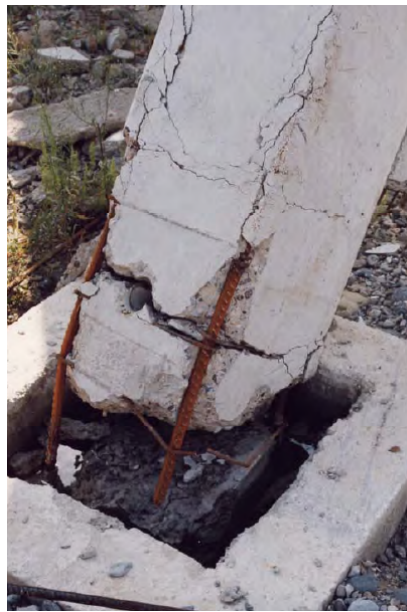
Fig. 4 – “(a) Failure of poorly detailed precast concrete column in the 1994 Northridge Earthquake; (b) Shear failure of precast concrete column at foundation socket (1999 Kocaeli Earthquake); (c) Shear failure at base of precast concrete column (1999 Kocaeli Earthquake); (d) Flexural hinging at base of precast concrete column (1999 Kocaeli Earthquake); (e) Severe distress in precast concrete column (1999 Kocaeli Earthquake); (f) Close-up of poor column details (1999 Kocaeli Earthquake)” (FIB 27, 2003).

Also, in Fig. 4 can be observed: (a) the failure of poorly detailed precast concrete column in the 1994 Northridge Earthquake; (b) the shear failure of precast concrete column at foundation socket (1999 Kocaeli Earthquake); (c) the severe distress in precast concrete column (1999 Kocaeli Earthquake); (d) the close-up of poor column details (1999 Kocaeli Earthquake). Details on the failure mechanisms can be found in the FIB Bulletin (FIB 27, 2003).

- vi. failure of poorly detailed precast concrete column (see Fig. 4);
- vii. shear failure of precast concrete column at foundation socket (see Fig. 4);

- viii. shear failure at base of precast concrete column (see Fig. 4);
- ix. collapse of precast concrete hollow core floor (see Fig. 5);
- x. failure of a poorly detailed beam-column connection (see Fig. 6);

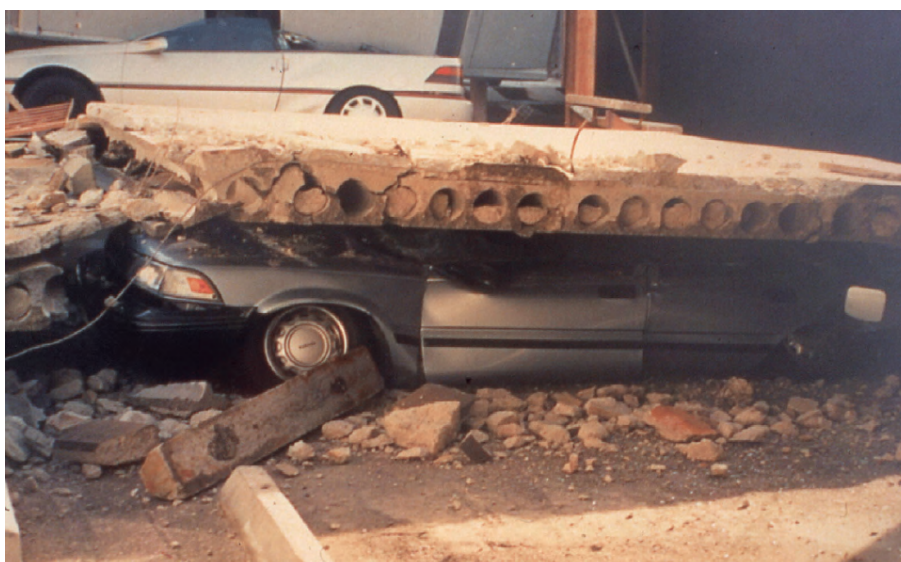
Fig. 5 – “Collapse of precast concrete hollow core floor (1994 Northridge Earthquake)” (FIB 27, 2003).

As well as carrying the gravity loads, floors need to transfer the imposed seismic forces to the supporting structure through diaphragm action. Adequate connections to transfer diaphragm forces and adequate support of precast concrete floor units are basic requirements for a safe structure. It is essential that floor systems do not collapse as the result of imposed movements caused by earthquakes which will reduce the seating area at the supports of the precast floor units. Fig. 5 shows the collapse of a precast concrete hollow core floor which became unseated during the 1994 Northridge earthquake.

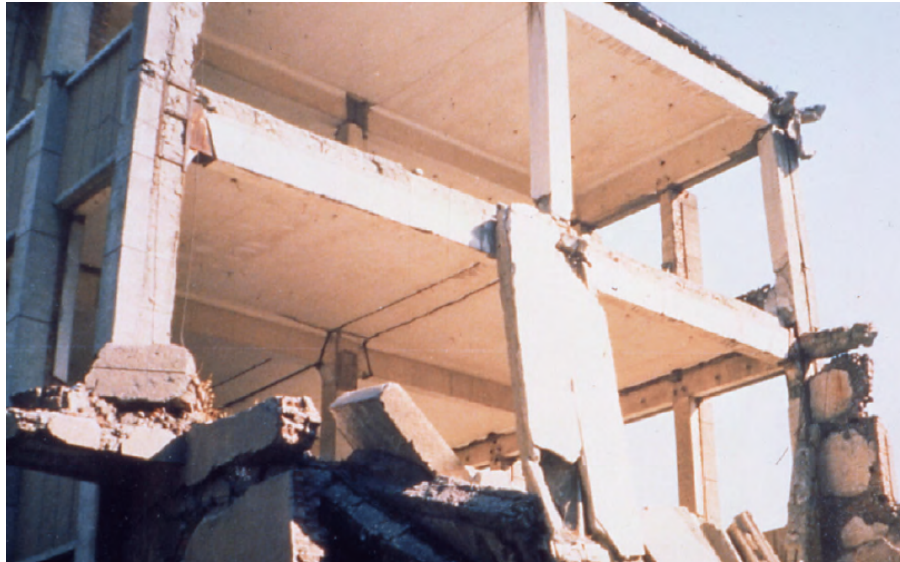
Fig. 6 – “(a) Failure of a poorly detailed beam-column connection (1976 Tangshan Earthquake, China); (b) unseating of precast concrete beams off corbels of columns” (FIB 27, 2003).

Beam-column joints of moment resisting frames incorporating precast concrete elements have often failed in earthquakes due to poor details. A significant cause of failure has been the brittle failure of reinforcing bars in the vicinity of welds. Fig. 6(a) shows the failure of a poorly detailed moment-resisting connection between beams and columns as a result of the Tangshan Earthquake in China in 1976 (FIB 27, 2003).

- xi. unseating of precast concrete beams off corbels of columns (see Fig. 6);
- xii. beam-to-column connection failure (see Fig. 7);
- xiii. brittle failure of beam-column pin connection at top of corner column (see Fig. 7) etc.

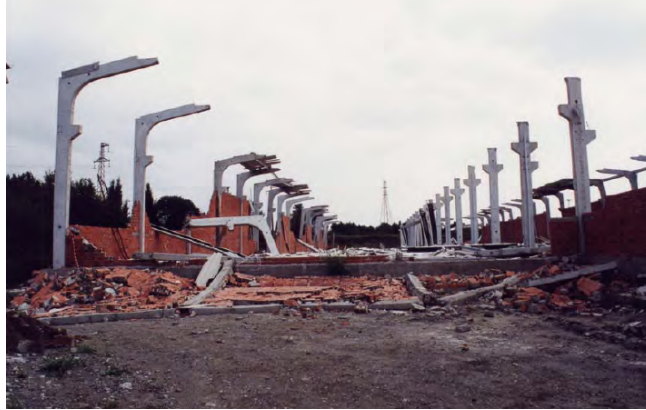
Fig. 8 – “Failure of columns due to interaction with stiff masonry infill (1999 Kocaeli Earthquake)” (FIB 27, 2003).

Fig. 8 shows the collapse of a precast concrete industrial building (Saatcioglu *et al.*, 2001). The building was under construction at the time. The presence of the stiff masonry infills that interacted with the columns resulted in column failure at the top of the partially collapsed walls where the vertical bars were spliced (FIB 27, 2003).

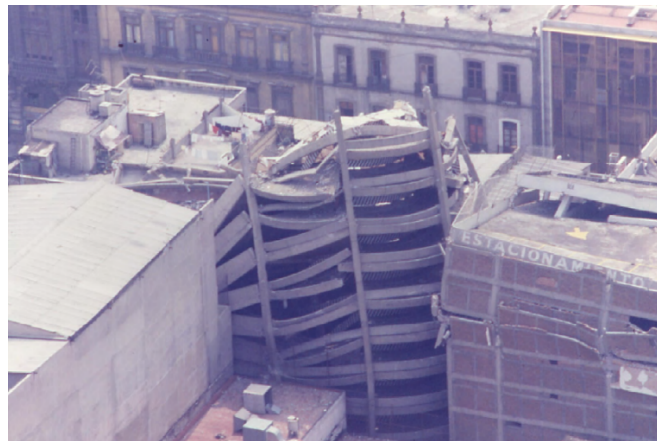
Fig. 9 – “Collapse of precast concrete parking structure due to pounding against adjacent structure in Mexico City (1985 Michoacan Earthquake)” (FIB 27, 2003).

Fig. 9 shows an overall view of a precast concrete parking structure in Mexico City that partially collapsed in the 1985 Michoacán earthquake (Mitchell *et al.*, 1986). This frame structure suffered from pounding with an adjacent parking structure due to inadequate separation between the two structures. It also experienced failures at the precast joints between the beams and the columns resulting in brittle failures and poor energy absorption. It is essential that adequate separation between structures be provided to prevent pounding between the structures during an earthquake (FIB 27, 2003).

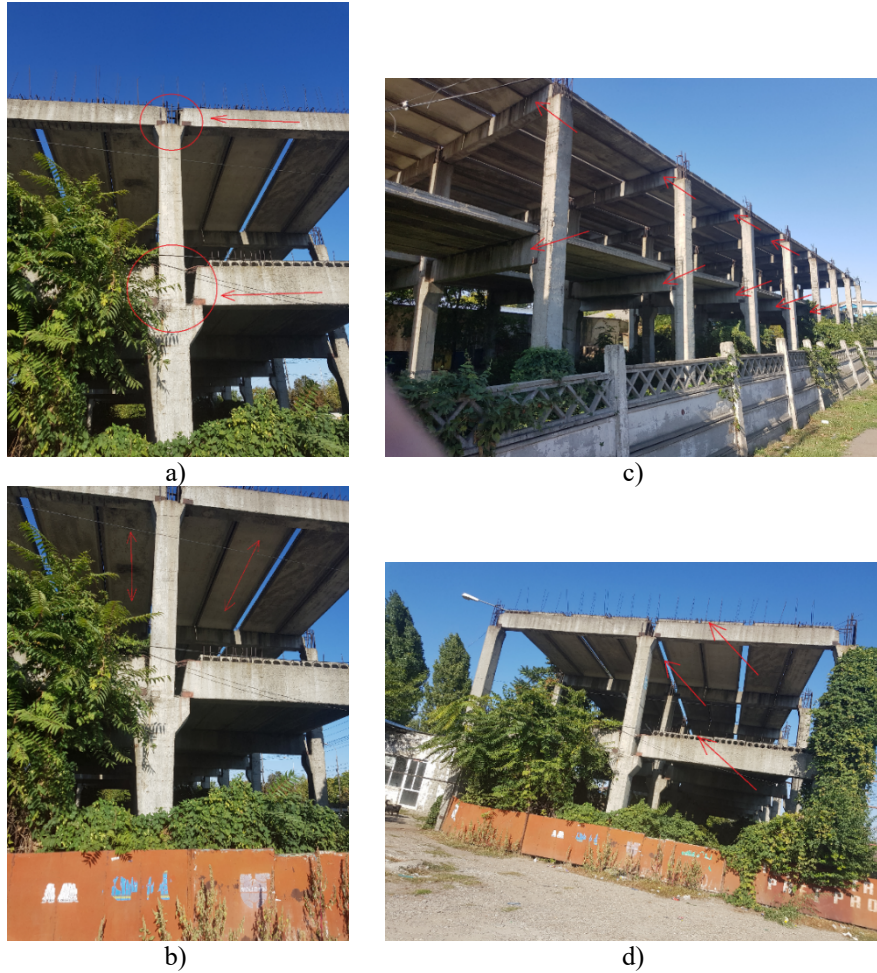
Fig. 10 – The representation of: (a) PRC beams with pin configuration in marginal areas (without any monolithic concrete); (b) the one-way pin supported mode of PHC slab strips on existing PRC beams; (c) prefabricated RC beams on a single global direction of the structural system (along the span direction); (d) the non-existence of an additional top layer of concrete on the PHC slab strips.

- i. the PRC beams exhibit a pin configuration in the marginal zones because there is no monolithic concrete and RC beam-column joints (see Fig. 10 (a));
- ii. the Precast Hollow Core (PHC) slab strips” (Liu *et al.*, 2022) are one-way pin supported on the existing beams (see Fig. 10 (b));
- iii. the existence of PRC beams on a single direction of the structural system (see Fig. 10 (c));
- iv. the non-existence of the longitudinal RC joint shear key and friction bars between PHC slab strips or the cast-in-place reinforced concrete topping. Basically, the PHC slab strips exhibit an independent, non-frictional (non-dissipative) behavior and thus do not act as a rigid diaphragm in the horizontal plane or as isolated frictional precast component (see Fig. 10 (d)).

In the current case, it was possible to observe major structural deficiencies in the areas where the PRC columns connect with PRC beams and RC beam-column joints does not exist. Further deficiencies were noted with the PHC slab strips, which require additional top concrete and concrete in splice regions.
