BULETINUL INSTITUTULUI POLITEHNIC DIN IAȘI

## PERIODIC MAINTENANCE OF ROAD BRIDGES TO ENSURE A SUSTAINABLE INFRASTRUCTURE – CASE STUDY

The case study focuses on the bridge that serves the Romanian national road DN 28 at kilometre 6+957, in Iasi country, near Șcheia, ensuring the continuity of the road when crossing the Siret River.

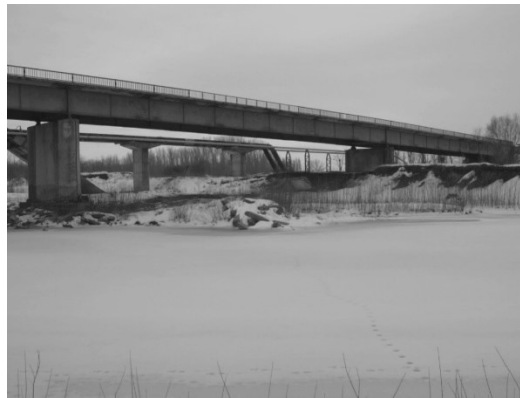
In the longitudinal section, the bridge has 4 spans of different lengths (50.35 m + 60.00 m + 60.00 m + 50.35 m), resulting in a superstructure length of 220.70 m and a total length of 236.90 m (figure 1). The static scheme of the structure is a continuous girder with 4 openings, a scheme that strongly influences its behavior in operation.

Fig. 1 – Longitudinal view of Șcheia Bridge

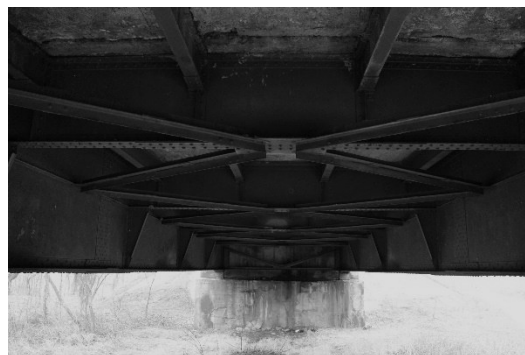
The superstructure consists of two continuous steel girders having a double T section (figure 2). The metal beam is made of laminated steel profiles, thick sheet metal and corner profiles, solidarized with rivets.

Fig. 2 – The metal bridge superstructure

The main girders have a constant height of 2.40 m, being arranged at an inter-axle distance of 7.10 m. They are solidarized in the transverse direction by means of short transvers beams resting at each end on metal reinforcements. The transverse beams are arranged at equal distances between the axes, having a constant height of 1.00 m. A riveted vertical bracing is arranged next to each support reinforcement, made of corner profiles with equal wings.

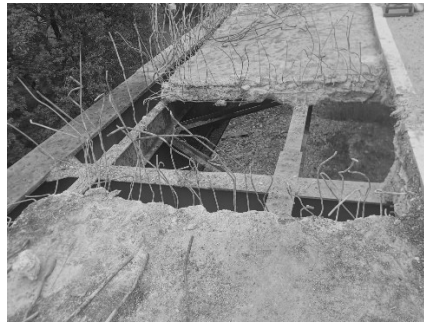
Between the main girders, in the longitudinal direction of the bridge, there are 4 metal struts with a double T section, located at a distance of 1.85 m center-to-center. The height of the stringers is lower than that of the transverse beams, having the upper soles mounted at the same level as the upper soled of the main beams (figure 3).

Fig. 3 – The “collaboration” between the metal structure and the reinforced concrete deck

The reinforced concrete pavement, having the role of supporting the carriageway and the sidewalks, rests directly on the upped soled of the main beams, the stringers and of the intermediate beams, this being the most important defect of the structure, with a repercussions on its behavior in operation (figure 3).

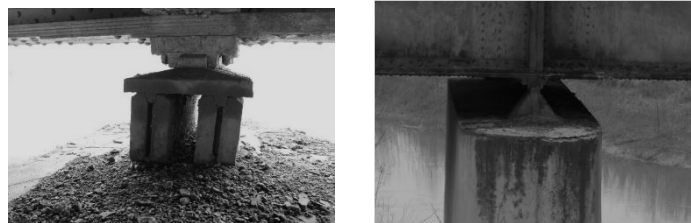
The foundations are direct, deep, made of caissons with compressed air. The support of the superstructure is done by means of mobile support devices on abutments and piers P1 and P3 and fixed on piers P2 (figure 4).

Fig. 4 – Transmission of loads from the superstructure to the infrastructures

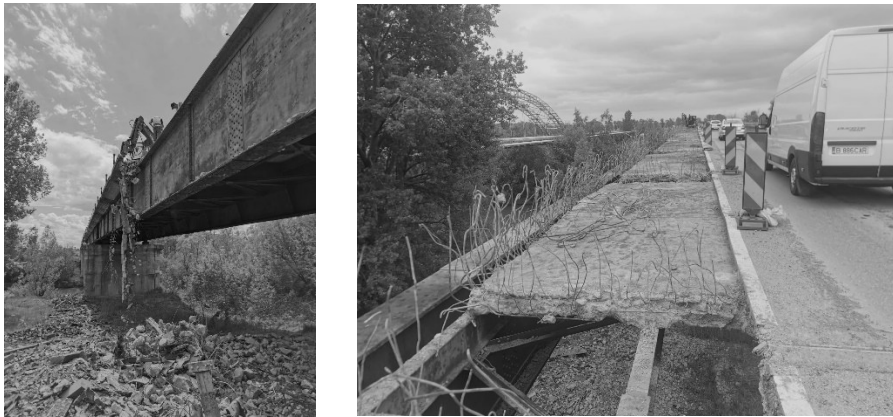
- Diverting traffic onto one lane
- Demolition of roadway layers
- Demolition of the pedestrian parapet and the sidewalk console, together with the reinforced concrete decking, including the next one to the marginal metal struts (figure 5)

Fig. 5 – Demolition of reinforced concrete decking

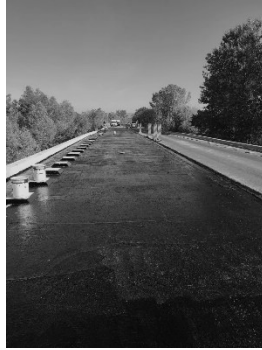
For the proper execution of the asphalt mixture layers, the base layer will be primed (figure 7).

Fig. 7 – Priming the support layer
