# Evaluation of Diagnostics and Recalculations of Several Czech Masonry Arch Railway Bridges

Civil and Environmental Engineering  
Journal of the Faculty of Civil Engineering | University of Žilina

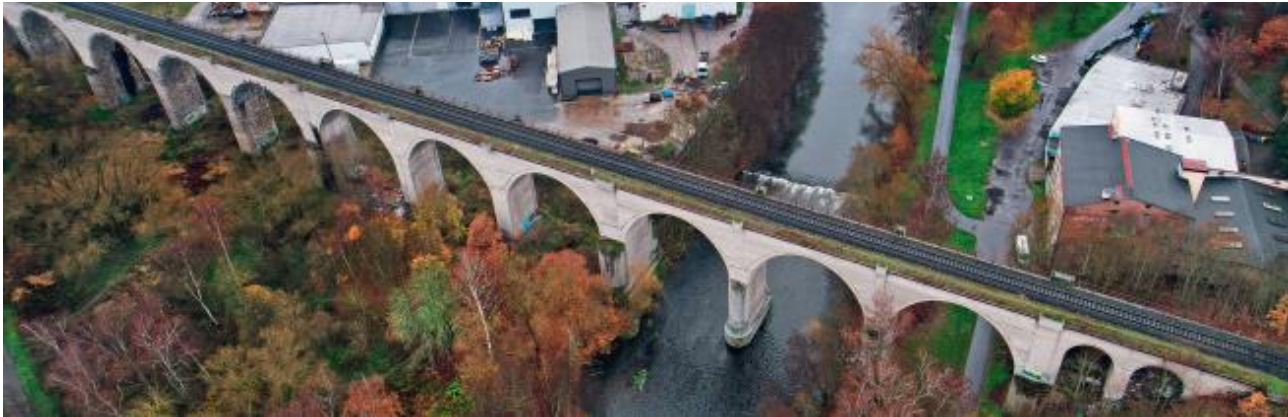
The Cheb Viaduct crosses the Ohře river with a single-track railway line. It was built in 1898 as a double-track stone viaduct with 17 spans formed by semicircular arches made of stone masonry. During World War II in 1945, the bridge was significantly damaged by bombing, and roughly half of it was destroyed. After the war, between 1945 and 1948, the remaining part was repaired, and the destroyed part was rebuilt. A total of 9 of the 17 spans were repaired, and the remaining 8 spans were rebuilt from stone to reinforced concrete arches. There are three lightening chambers above the reinforced concrete arches. Although the width of the bridge allows for a double-track railway line, only one track was finally placed on the bridge (eccentrically, with the possibility of adding a second track). The edge spans have a clearance of approx. 6.7–6.8 m, while the inner spans K03-K14 have a clearance of approx. 19.8 m. The bridge is 349 m long, 8.83 m wide, and 26.2 m high. The track on the bridge is straight, and the track grade rises at a gradient of 10.25‰. The pillars under the original arch are made of stone, while those under the reinforced concrete arch are made of reinforced concrete with plinths clad in stone masonry. The bridge structure is founded on reinforced concrete foundations set on wooden piles.

Figure 4: Cheb Viaduct – view from a drone

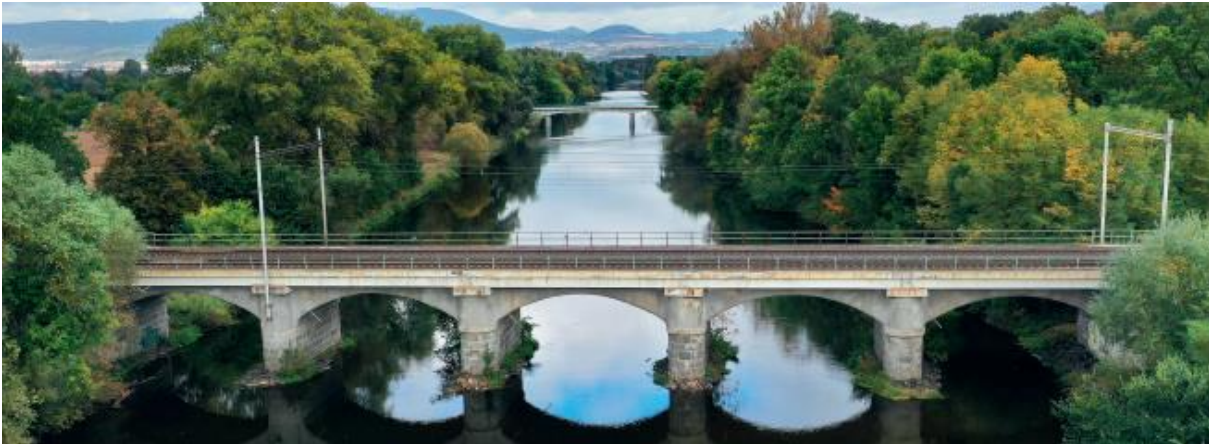
The bridge crosses the Ohře River and was built in 1853. The supporting structure consists of a stone segmental arch with nine spans. The span clearance ranges from 12.00 to 12.71 m. The width of the supporting structure is 11.57 m. The bridge is 164.7 m long, 12.83 m wide, and 8.3 m high. The first track runs straight, while the second track runs in a curve with a radius of 18 000 m. The track on the bridge is at a valley curve elevation. The track descends at a gradient of 15.63‰ in the direction of the station, and from pier P2 it descends at a gradient of 14‰. The substructure (including the wings) is made of stone, and the wings are parallel. The bridge structure is founded on a flat foundation. In 1993, reinforced concrete cornices were added and shotcrete was applied to the arches and some pillars, which was subsequently renovated in 2001. The structures are drained above the pillars.

**Figure 5:** Bridge over the Ohře River in Bohušovice – view of the bridge

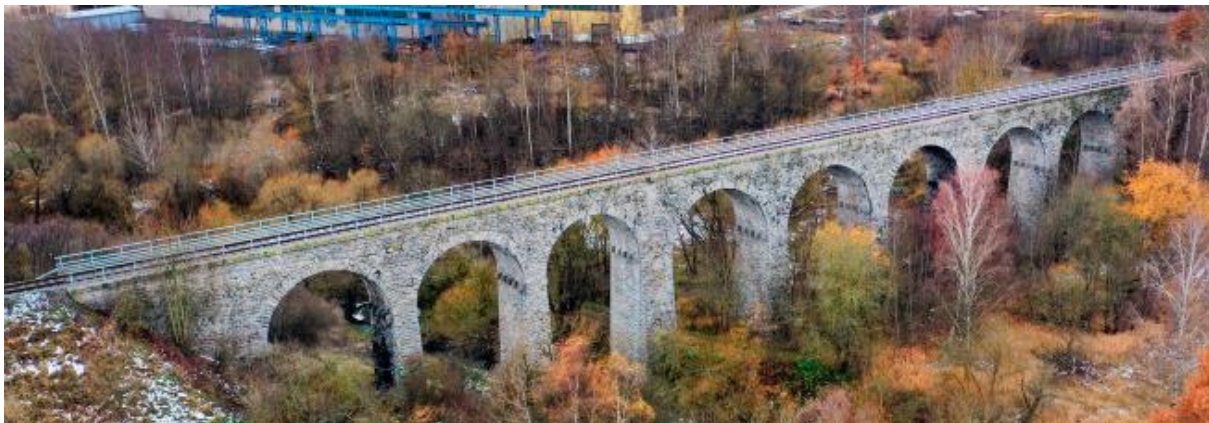
The bridge crosses a single-track railway line over the Milevský stream and a service road. The bridge was built in 1889 as a single-track stone arch bridge with nine spans. The supporting structure consists of a stone semicircular arch. The clearance of structures K01–K03 is 10.00 m, and the clearance of K04–K09 is 12.00 m. The width of the supporting structure is 4.75 m. The height of the structure is 20.65 m. The structure is drained at the tops of the arches. The track is aligned in the transition of the left arch and in a straight line. The height of the track on the bridge decreases. The bridge structure is founded on a flat foundation. In 2005 and 2006, the bridge was repaired in two phases. The repairs included grouting of the masonry of the supporting structure and substructure, waterproofing the bridge deck, installing drains, and installing new railings.

**Figure 6:** Viaduct Milevsko – view from a drone

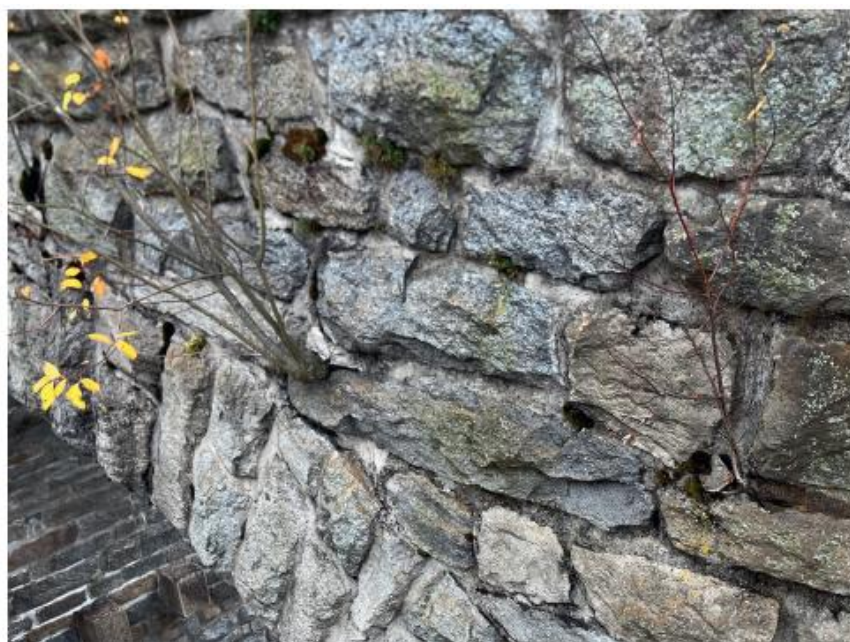
An important factor that indirectly affects the static reliability and durability of masonry arch bridges is non-functional or missing waterproofing and the associated leakage into the supporting structure. Leakage problems were diagnosed in most of the bridges investigated. Leakage causes degradation of materials, especially mortar and less resistant masonry elements such as sandstone, claystone, bricks, etc. Leakage can also result in joint failure, incrustation, and surface erosion of the structure. Increased moisture also increases the risk of vegetation growing through the structure with its roots (Fig. 9).

**Figure 9:** Milevsko Viaduct - vegetation growing through the structure

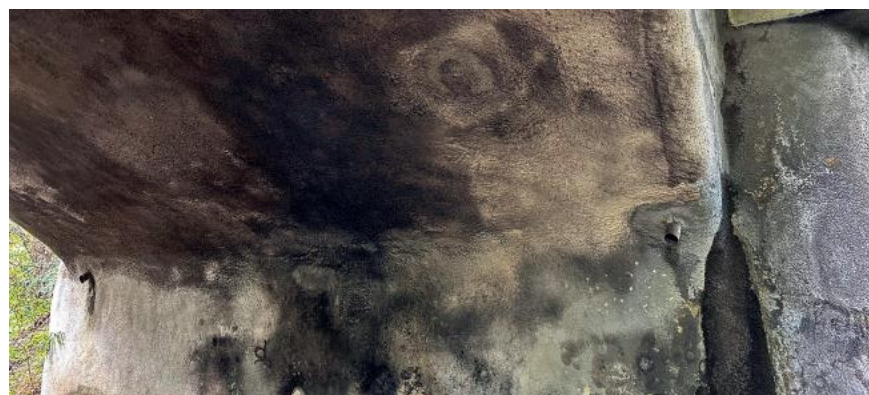
On some bridges, a layer of shotcrete was applied to the supporting structure as part of repairs to slow down degradation and strengthen the surfaces of the structure. However, it turned out that these repairs had the opposite effect. Moisture is retained under the shotcrete layer, causing the original material to degrade significantly (Niero et al., 2025; Forde, 2010; Hu et al., 2020) (Fig.10).

**Figure 10:** Bridge over the Ohře River in Bohušovice – moisture retention with shotcrete and leaks through shotcrete

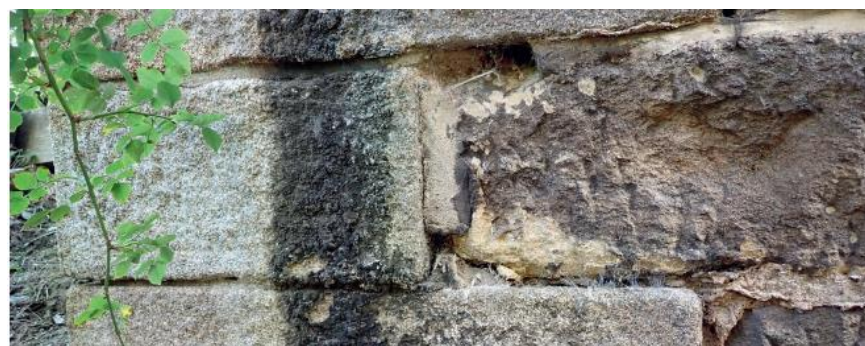
**Figure 11:** Viaduct near Ratboř – degradation of sandstone blocks and fallen jointing

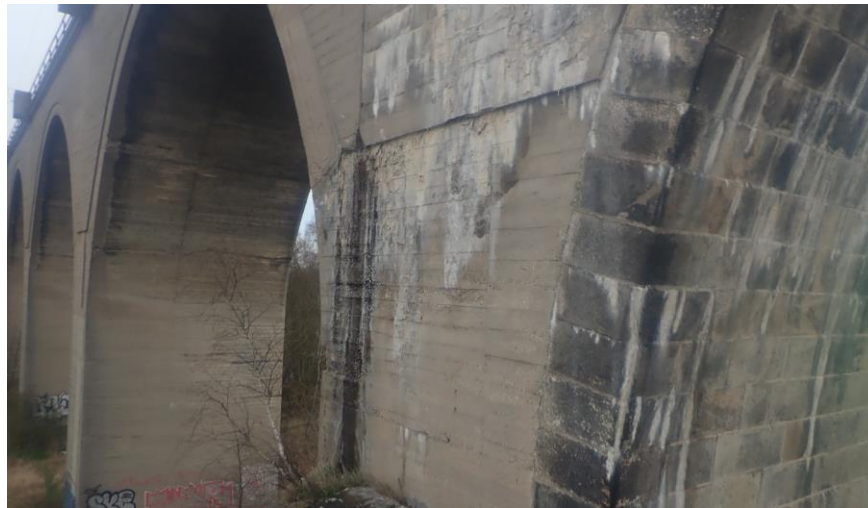
**Figure 12:** Cheb Viaduct – Degradation and leaching at the joint between the original stone structure and the newer reinforced concrete structure

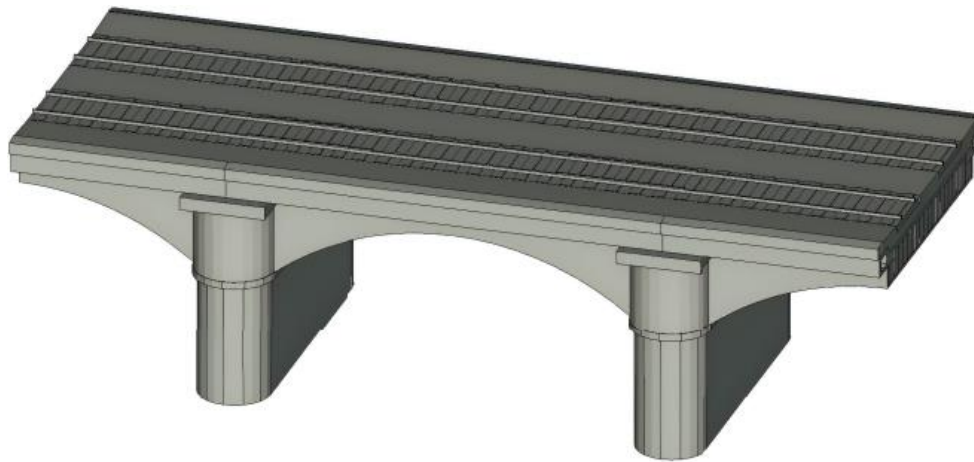
**Figure 16:** Bridge over the Ohře River in Bohušovice – Complex model in the ATENA program using volumetric discrete numerical elements

The LS RING software (LimitState Ltd, 2023) (Fig. 15), which uses the limit equity method, has proven to be a suitable tool for comparing the safety levels of arch structures in ULS. In the case of more complex structures, such as the Cheb Viaduct with reinforcement and cavities above the arch, it proved useful to supplement the complex volume models in the ATENA (Červenka Consulting, 2021) or ANSYS (ANSYS Inc., 2025) software (Fig. 16). Due to the low strength of the masonry (characteristic value 5 MPa), the volume model in the ATENA software was also used for the Bohušovice bridge. A finite element (FE) model should be applied to assess the serviceability limit states (SLS). The analysis of masonry structures is performed using a "linear calculation" for simple structures, excluding tension, and a non-linear calculation for more complex structures. Joints are modelled as elements that do not allow tensile stresses to develop. There are several calculation programs available that can be used for analysis and are commonly used in design studios.
