Post-Fire Performance Enhancement of Pre-loaded RC Short Columns Using CFRP Confinement

Journal of the Faculty of Civil Engineering | University of Žilina

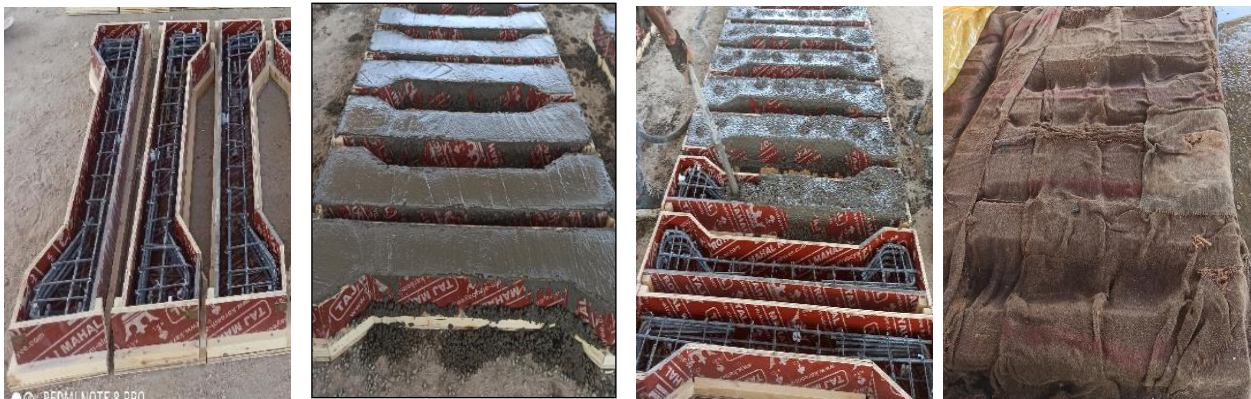
Figure 2: Casting process phases

placing each layer and rodding were strictly adhered to for proper compaction of the concrete in the molds for the cube and cylinder, as shown in Figure 2.

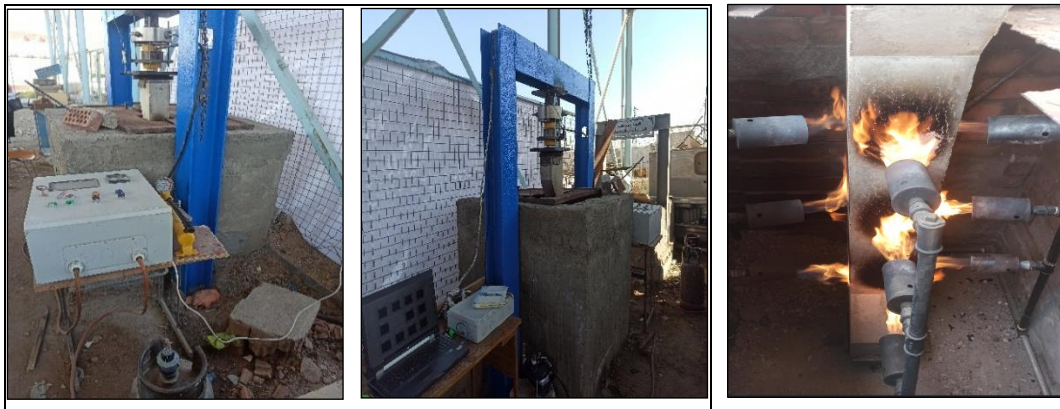
Figure 4: Specimens subjected to fire exposure under pre-loading curve

It is important to point out that all the fire-exposed columns in both groups were subjected to a constant preload of (81.5 kN), corresponding to (50%) of the ultimate load capacity of the unexposed control specimen C₁, which was (163 kN). The eccentric load was applied with a constant eccentricity of (e = 90 mm), corresponding to an eccentricity ratio of (e/h = 0.60), where (h = 150 mm) is the cross-sectional depth of the column. The eccentric load was applied in the same direction for all fire-exposed specimens.

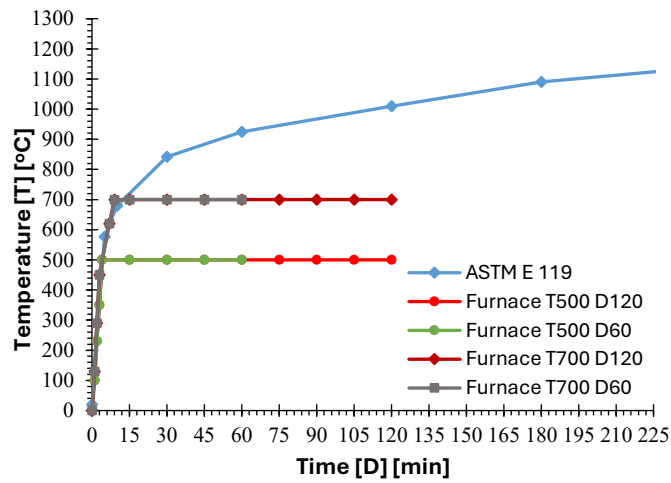
Figure 5: Measured average furnace temperature versus ASTM E119-20 time-temperature curve

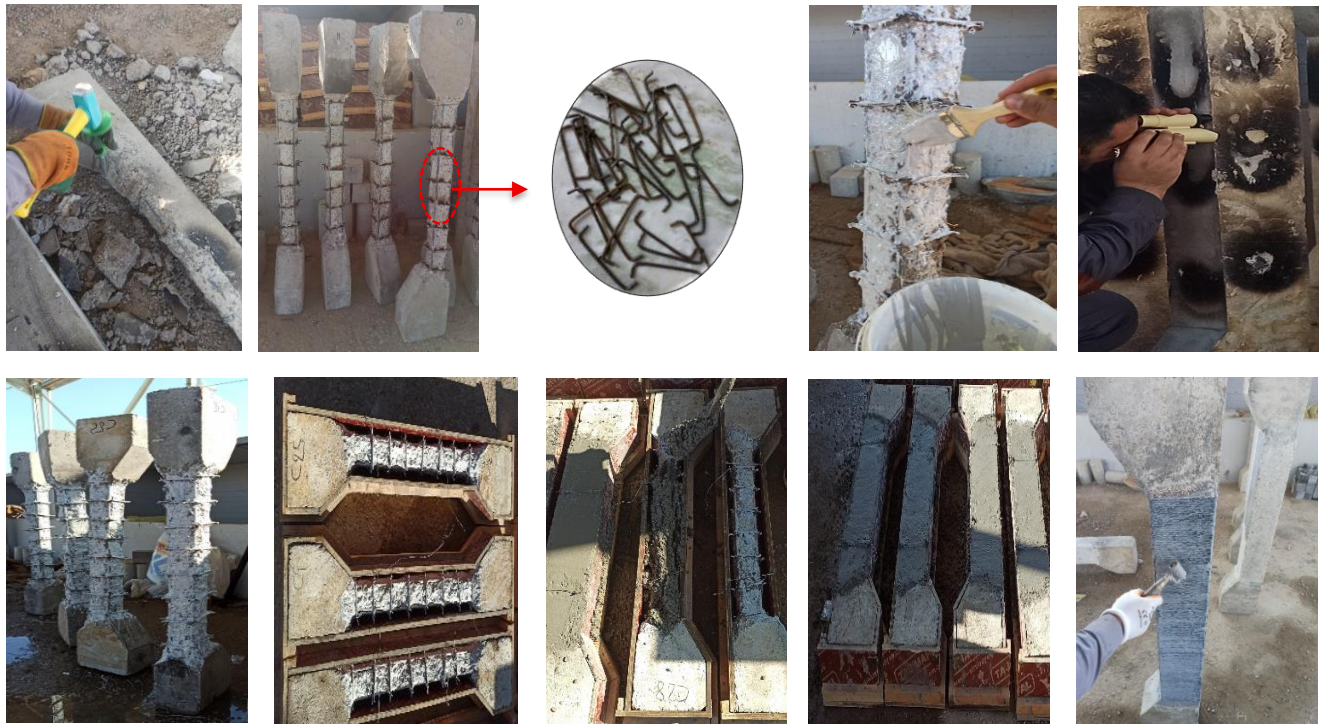
Figure 6: Sequential steps of RC column repair

- a. **Removal of Damaged Concrete:** The damaged exterior concrete layer was carefully removed manually until all longitudinal reinforcement was exposed. Mechanical methods were avoided to prevent any dynamic vibration that may affect the integrity of the column structures. The adopted removal procedure was intentionally limited to the visibly damaged exterior concrete cover in order to simulate a practical rehabilitation technique for fire-damaged columns, rather than complete removal of all concrete that may have been thermally affected by fire exposure.

- b. **Installation of Shear Connectors:** 4 mm-diameter shear connectors were horizontally installed on all sides of the stirrups to ensure a reliable bond between the original concrete core and the new layer of Normal Concrete (NC).

- c. **Epoxy Preparation and Application:** The epoxy resin (Sikadur®-32 LP) was prepared by separately stirring the base and hardener, followed by thorough mixing with a slow-speed drill for two minutes until a uniform colour was achieved. Approximately 90 minutes prior to casting the NC layer, the cleaned surface of the existing concrete was coated with epoxy to enhance adhesion between the old and new concrete layers.

- d. The new layer of Normal strength Concrete (NSC) with a compressive strength of 29.4 MPa was cast and subjected to curing for 28 days. All processes are represented in Figure 6.

3. **Epoxy Application:** The epoxy coating with a thickness of about 1.5 mm was applied to the column surface and the CFRP sheets.
 4. **CFRP Sheet Installation.** The CFRP sheets were accurately placed in their respective positions on the column surface previously coated with epoxy. A rubber roller was used to press the sheets to ensure complete adhesion to the column surface and to remove excess epoxy from both sides of the sheets. Excess epoxy was then removed from the edges of the CFRP sheets, as shown in Figure 6.

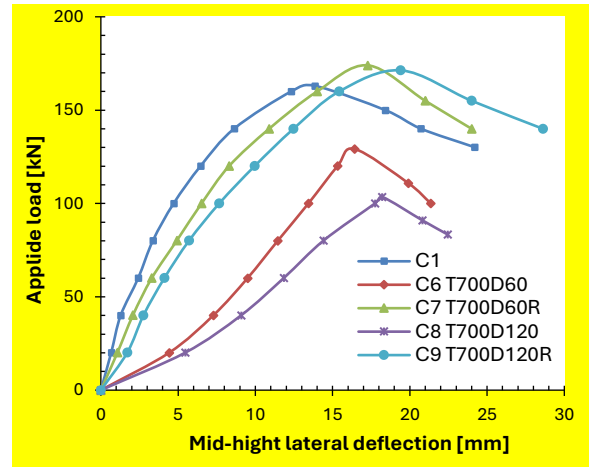
Figure 10: Load-deflection curves of group two columns

A clear convergence was observed between the lateral and axial displacement responses, both reflecting an increase in ultimate displacement with rising fire exposure temperature. The adopted rehabilitation technique based on NSC with CFRP sheets led to an improvement in the displacement response of the columns under loading. Selected load-displacement curves are illustrated in Figures (9-14). The load-deflection responses of the second group demonstrated greater sensitivity to elevated temperatures than those of the first group. Nevertheless, this rehabilitation technique did not produce any noticeable improvement in the displacement performance of the second-group specimens.

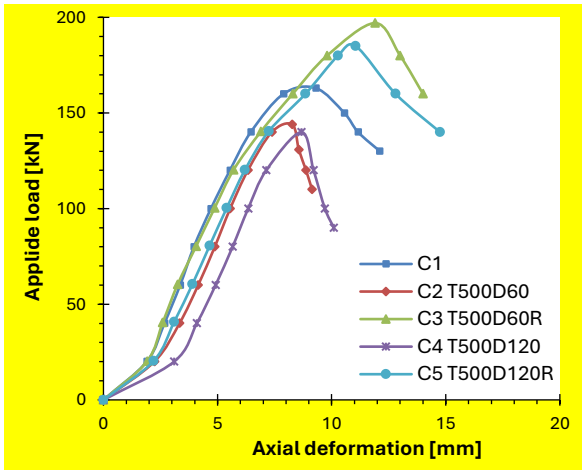
Figure 11: Load - axial deformation of group one columns

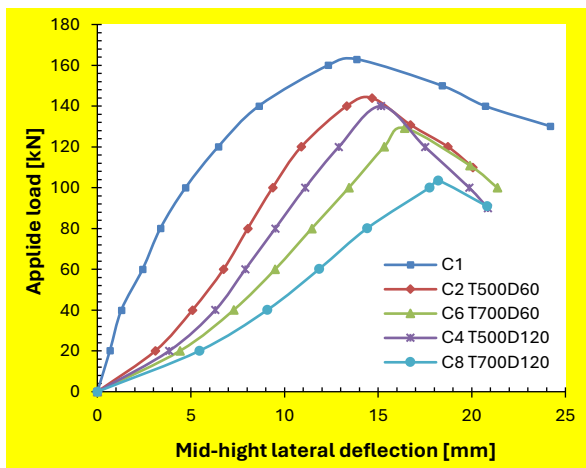
Figure 13: Load - deflection of exposed to 500°C and 700°C

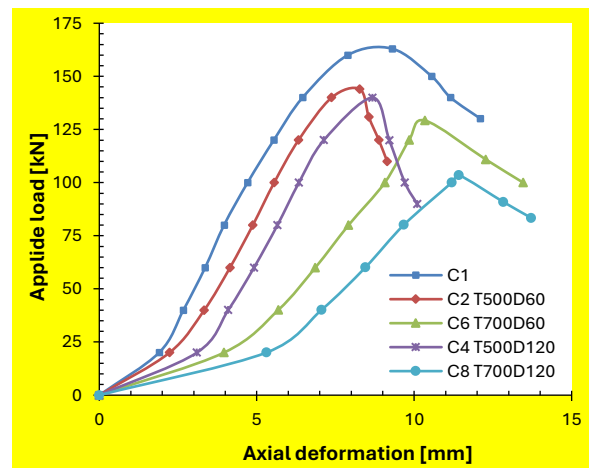
Figure 14: Load - axial deformation of exposed to 500°C and 700°C

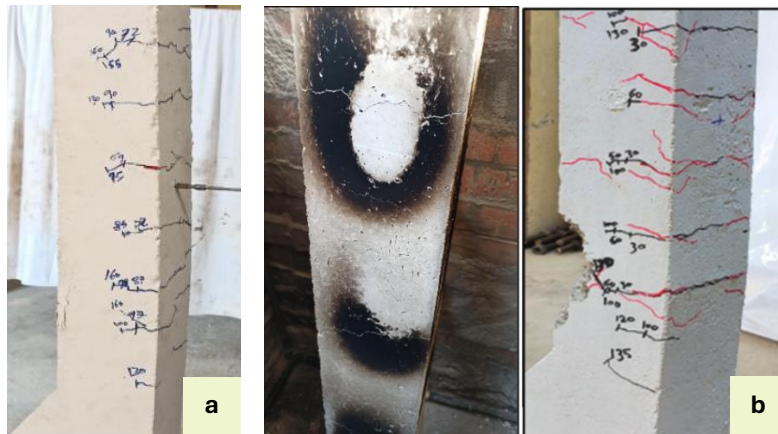
Figure 15: Spread of crack in specimens, a. Column specimens without fire, b. Column specimens with fire exposure

Crack widths were measured using a crack gauge, while the initiation of the first visible crack was identified through direct visual observation and the corresponding load was recorded. In eccentrically loaded column specimens, transverse flexural cracks typically initiate in the tension zone and propagate toward the compression zone. The black-coloured cracks were associated with the effects of eccentric loading during mechanical testing, whereas the red-coloured cracks were attributed to axial loading effects following fire exposure. Based on Table 4, the non-fire-exposed reference columns exhibited the smallest crack widths among all specimens, with an average value of (0.4 mm), as illustrated in Figure 15a. In contrast, the fire-exposed columns showed larger average crack widths ranging from (0.44 to 0.69)mm after fire exposure and subsequent mechanical testing, as presented in Figure 15b. This increase is primarily attributed to the detrimental effects of elevated temperatures on the concrete microstructure. No visible external cracks were observed on the rehabilitated columns after repair, since their surfaces were fully wrapped with CFRP sheets. Therefore, direct observation of surface crack development was visually restricted by the external confinement layer.

In general, all the column specimens were subjected to a constant eccentricity of $e = 90$ mm. The columns exposed to this type of loading condition have mainly exhibited compression-controlled failure. The failure mechanism was progressive in nature, starting from the tension face of the column and then progressing toward the compression face. In the unexposed reference column, crack initiation and growth were relatively slow and limited in extent when compared with the fire-exposed specimens. Conversely, columns subjected to fire exposure contained pre-existing microcracks induced by thermal degradation, which significantly accelerated crack initiation, propagation, and widening at relatively lower load levels, as illustrated in Figures 16 (a to i). An extended period of fire exposure enabled the development of cracks. Concrete specimens exposed to fire for 120 minutes showed wider and more extensive cracks compared to specimens exposed to fire for 60 minutes under the same temperature condition. Failure always resulted in spalling of the concrete cover in the compression zone in the middle third of the column. Subsequent crushing of the concrete cover started from the middle height and progressed to longitudinal and transverse cracking before finally detaching from the column, as depicted in Figures 15 and 16 (a to i).

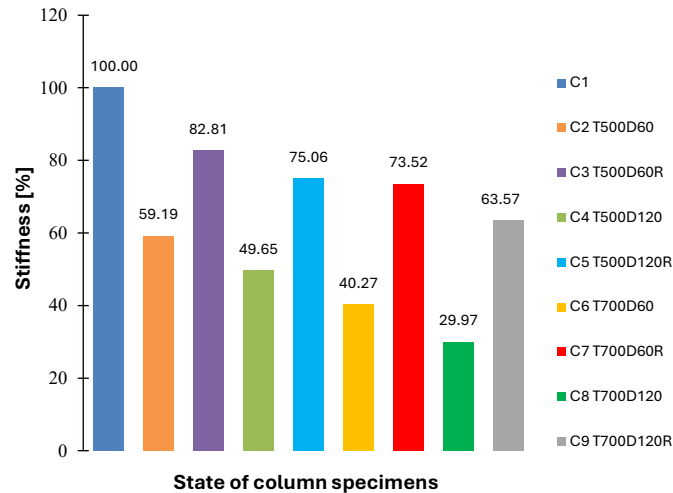
Figure 18: Stiffness of specimens

In the context of structural mechanics, the definition of stiffness is given by the magnitude of the load required to cause unit deformation in the structural member. The commonly used technique to measure the stiffness is the secant slope technique, where the stiffness is determined by the slope of the curve at 75% of the ultimate load, as proposed by (Lan et al., 2025; Muthuswamy & Thirugnanam, 2014). In the present study, this parameter was adopted as a consistent comparative stiffness index for all tested specimens. As illustrated in Figure 18, the stiffness of the columns is determined, followed by the comparison with the reference specimen. From the results, it is evident that the stiffness is reduced with the increase in fire exposure temperature and duration. The reduction is significant at 700 °C, where the stiffness is reduced by 70.03%, along with the reduction in the load-carrying capacity.

On the other hand, when the adopted rehabilitation technique based on damaged concrete cover replacement with NSC and external confinement using CFRP sheets was applied, no significant improvement in stiffness was observed. In fact, a reduction in stiffness was recorded by (21.06%) for columns exposed to 500 °C after rehabilitation and by (31.45%) for those exposed to 700 °C. This limited stiffness response may be attributed not only to the characteristics of the CFRP sheets, which mainly enhance confinement and tensile resistance rather than the initial axial stiffness of the section, but also to the influence of pre-existing fire-induced damage, the properties of the recast NSC layer, and the interaction between the original concrete core and the repaired outer layer. As mentioned in the literature, CFRP has high tensile strength but negligible compressive strength, especially when used in thin sheets. Accordingly, the initial stiffness of the rehabilitated columns remained governed mainly by the concrete core and internal steel reinforcement, while the confinement effect of CFRP sheets became more relevant after the development of lateral dilation. Thus, the adopted rehabilitation technique showed negligible effectiveness in improving the initial stiffness of fire-damaged RC columns.
