# Reconstruction of Pustý Kostol (Deserted Church) Ruin in Veľká Čalomija

Civil and Environmental Engineering  
Journal of the Faculty of Civil Engineering | University of Žilina

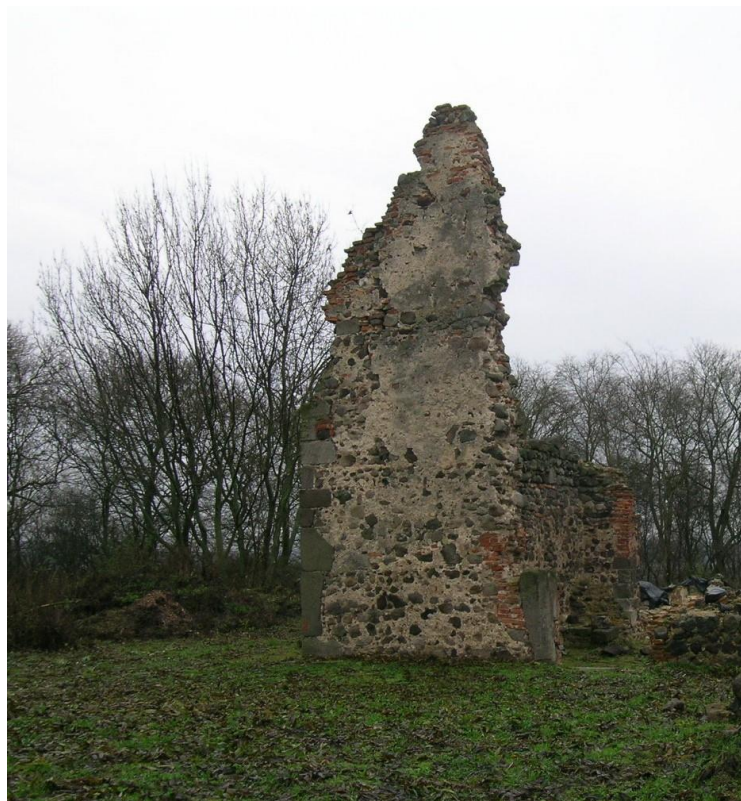
**Figure 1:** Church in ruins from west, year 2009. Photo: B. Polomová

The church that lies on an elevation over the village was left abandoned and gradually dilapidated (Figure 1,2). In 1879 F. Kubinyi presented report on wreck state of the building to the Hungarian temporary monument commission. Another visitation was made in 1879 by architect I. Steindl who elaborated for monument commission detailed report on the state of the church (Steidl, 1879), (Figure 3). Material Could be found in Archive of Monuments Board of the Slovak Republic. E. Križanová in 1960 elaborated basic conservation survey of the village (Križanová, 1960) and she included also ruin of Pustý kostol. Architect M. Križan has made on the location basic pinpoint of church nave, at that time western façade and side walls were still standing (Križan, 1960). Eastern part of disposition – presbytery chevet – was under ruins of debris and so he drew it with polygonal closing supposing that church has its origin in the 14th century. This information was also taken over by the Register of historic monuments in Slovakia III (Collective, 1969, p. 367). In further years no one dealt with dilapidating ruin in a professional way.

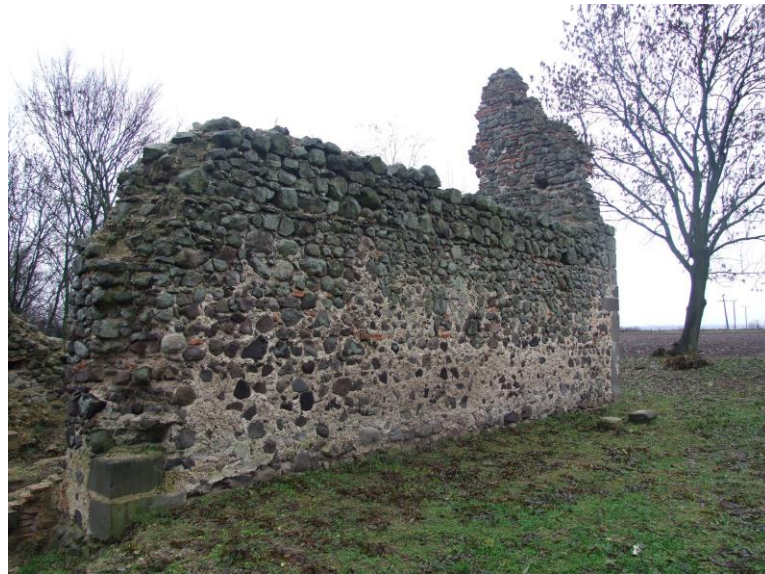
**Figure 2:** Church in ruins from north, year 2009. Photo: B. Polomová

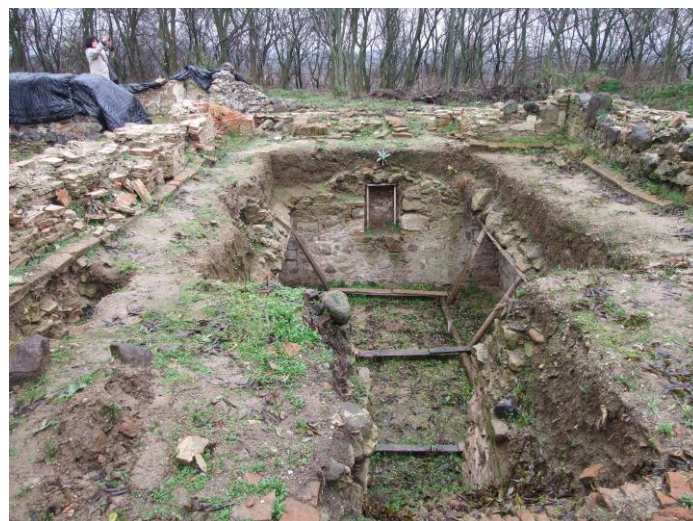
**Figure 7:** Finding of the tomb in the nave, 2009. Photo: P. Pauliny

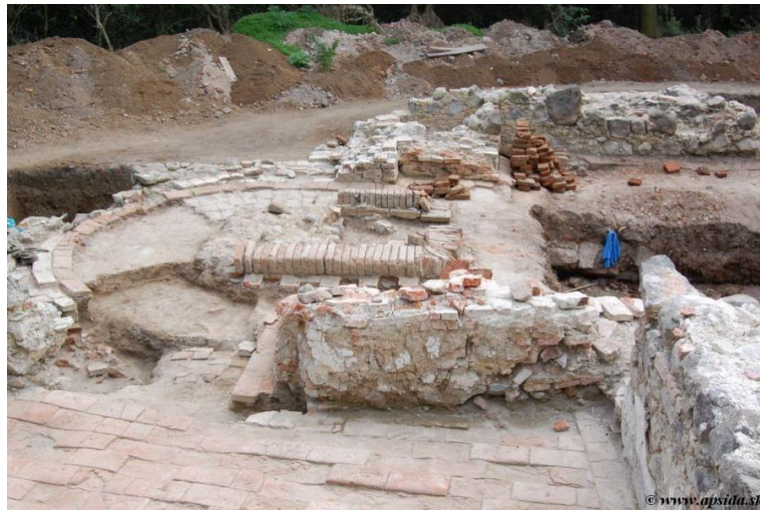
**Figure 8:** Finding of the aps with remains of altar table, 2009. Source: <https://apsida.sk/c/578/velka-calomija>

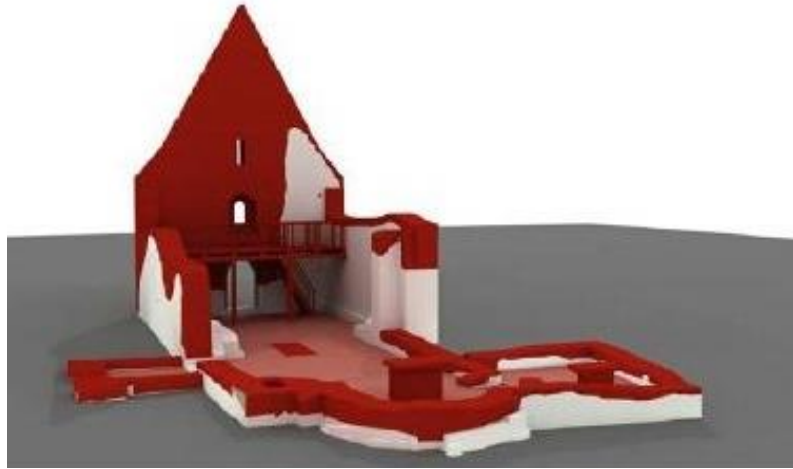
**Figure 12:** Design of construction modifications. Red – added masonry. Source: Botek, Pauliny, Polomová, 2010a, drawing A 04, detail. Drawn by P. Pauliny, T. Sabin

**Selected method of reconstruction.** According to thorough analysis of potential of respective area and church ruin as well as limiting factors of reconstruction plan, authors of architectonic study decided for method – ruin reconstruction with prevailing use of conservation of preserved masonry and their necessary addition and addition of selected perished elements through form of stylized trace (Figure 12, 13). Similar models of rehabilitation of destroyed sacral architecture can be seen in several medieval ruined churches in Hungary. The example of the church in Ecsér - Kővágóörs by Lake Balaton has a repaired western facade and an indicated architectural shape of the fallen tower and roof. The work was preceded by professional archival research. (Figure 13, Balays, 2022). The emphasis on the western wall, perceived as an architectural element, can also be seen in the restoration of the ruin, today called Pusztatemplom, in the extinct village of Somogyvámos (Figure 14, Joó, 2024, Farkas, 2024). For newly walled constructions were used original bricks and original stone from the object that were put aside during surveys on a disposal site about 10 m from the object. Fragments of architectonic elements that were not used for anastylosis, were after realization put into crypt. It was considered that a new floor of interior would be of bricks but because of financial reasons it was done only as compacted ceramic broken parts of brick colour. In principle it could be stated that ruin reconstruction with partial addition and possibility of limited function is not reconstruction of object that exists independently on surroundings and natural context but it is by its way exhibit in nature. In such sense its reconstruction is close to type of “museums under open air” (Tišliar et al., 2025). Much help was done by 3D modeling, as it will be usually used by planning of reconstructions of ruins (Česnek et al., 2022).

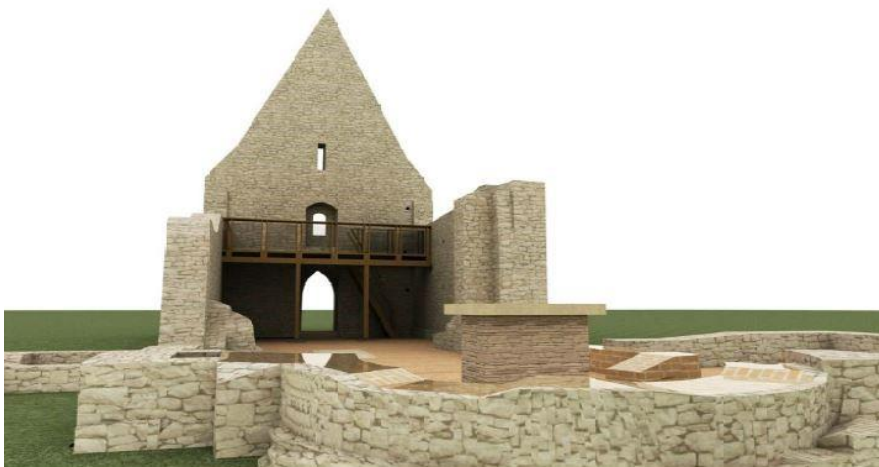
Figure 15: Visualization from east. Source: Botek, Pauliny, Polomová, 2010a, drawing A 08, det2010bl. Drawn by P. Pauliny, T. Sabin

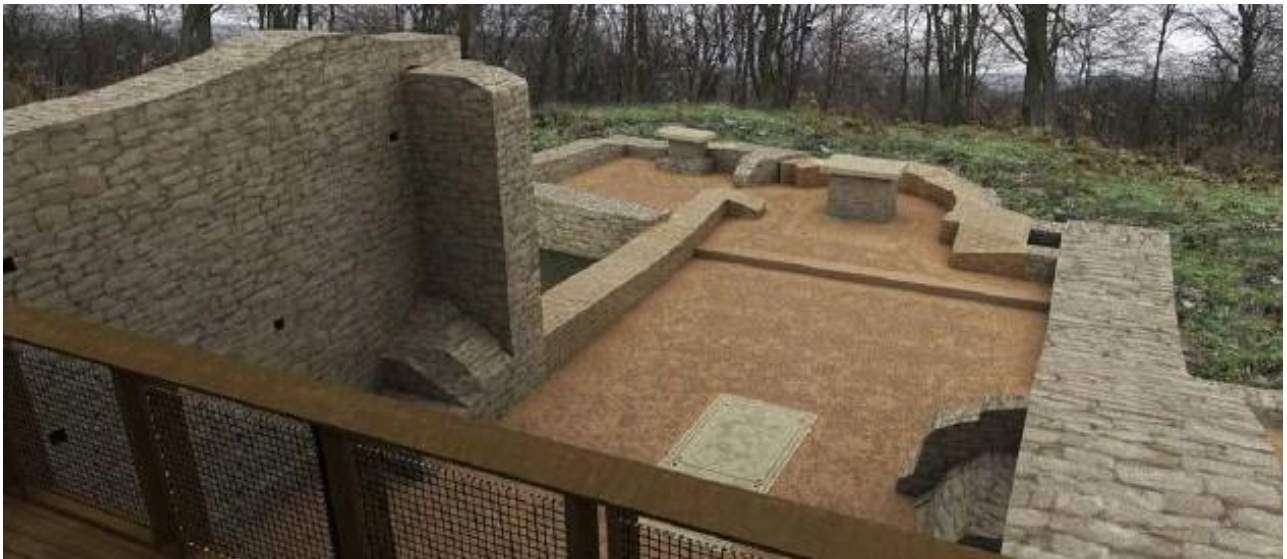
**Figure 17:** Vizualisation - view from gallery. Source: Botek, Pauliny, Polomová, 2010a, drawing A 09, detail. Drawn by P. Pauliny, T. Sabin

**2<sup>nd</sup> above ground floor:** for more active presentation of the object (view from above to the nave and presbytery, Figure 17) it was proposed wood gallery by method of indication that was from point of construction and size determined by existing niches in preserved walls (from them it was derived also height of gallery) and foundations openings in floor.

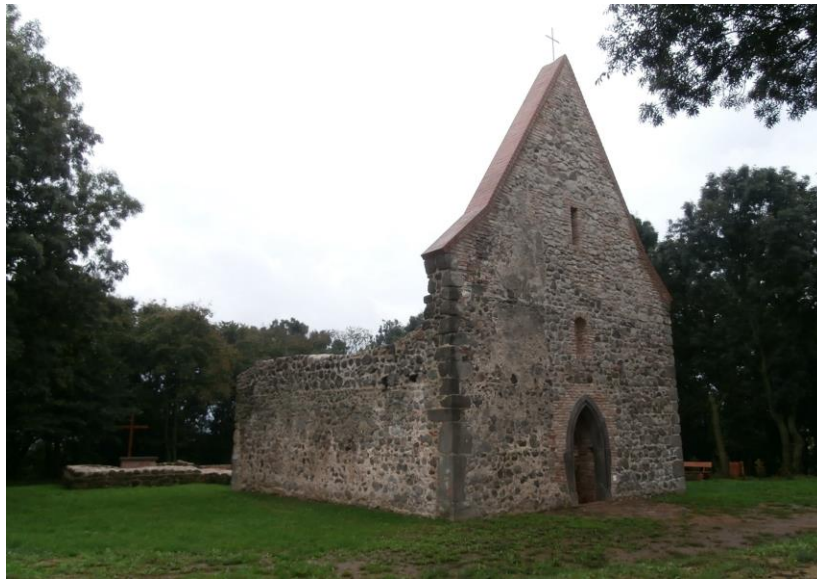
**Figure 18:** Main view of church after renovation, 2014. Photo: B. Polomová

**Consolidation and filling of constructions.** Projected reconstruction with filling of western gable facade wall to its look from 30ies (Figure 18). It is a reconstruction of form with indication of original materials and composition of walls as well as surface of top (blended wall with dominance of stone, brick work in upper part and flatly laid brick top of wall that is hydrophobized). Recommended way of lying is artistic and handmade attitude. Stone portal was proposed to be renewed by anastylosis method (repeated building of fallen elements) with maximal use of found fragments what demanded conservation attitude. Tops of existing stone masonry were added (about 1 to 2 lines) on lime mortar - with protection cover about 1.5 year because of maturing filling mortar. Height of top is filled in minimal rate; from southern side it should not exceed level of windows' sills as their shape and height were not known at the time of project. In part of apse it reaches height about 45 cm above proposed floor. In sacristy part it keeps preserved heights. Consolidation of Romanesque brick wall demanded individual attitude. In the project we mentioned unambiguous reconstruction by professional conservation in artistic and handmade attitude. We recommend to verify technology before realization because of similar experience if these latitudes.

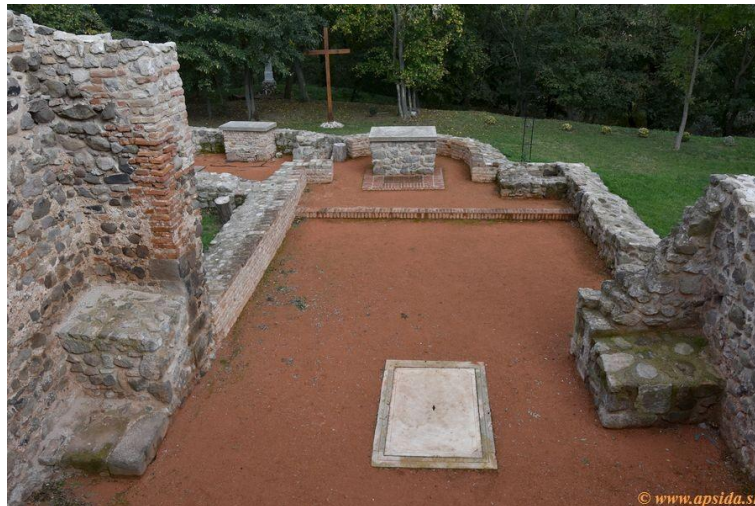
**Figure 19:** Interior floor with stone covered entrance to the tomb. Source: <https://apsida.sk/c/578/velka-calomija>

- b) unified interior floor with trace of original colors that defines and simultaneously distinguishes sacral interior from sacral exterior, in our case low grass in area of refugium (Figure 19).

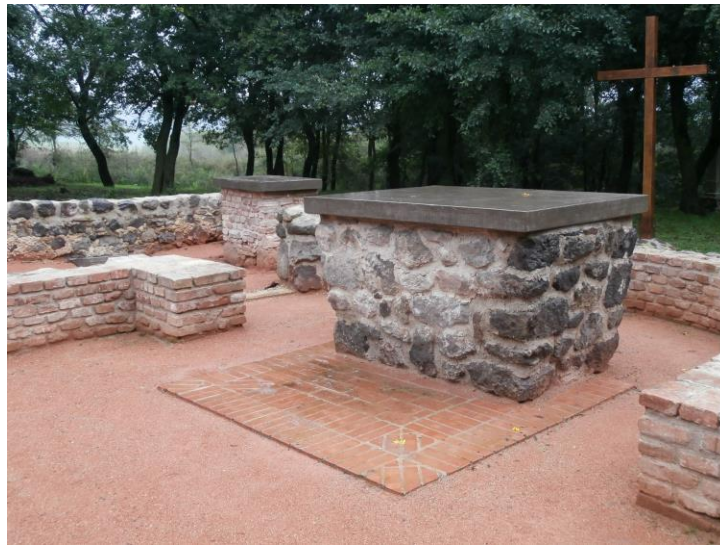
**Figure 21:** Realized altar, 2014. Photo: B. Polomová

In sanctuary there is basis of original altar. To emphasize main altar situation we proposed directly at its place and on original space new substance understood as trace reconstruction. It is full cube of podium on which it is placed stone altar plate with ochre grey color and resistant against meteorological conditions (Figure 20, 21). We proposed the plate originally in the full substance in several variants. Use of quarry stone from original masonry of object, without plastering – this variant was realized - or technique of gabion baskets (stones laid evenly in a dry way in rod metal construction) or by making a podium and plate from stone block (blocks). Every of abovementioned variants would enable artistic elaboration as well as composition of artistic accent with sacral themes. Side altar is situated in adjoining space of sacristy near wall. It was preserved of masonry in shape of moderate trapezoid with inner hole. It was selected trace reconstruction of original substance: podium in size of preserved hole is narrower as original dimension. Altar plate corresponds with extent of preserved podium. Through height it is expressed hierarchic position against main altar – upper plate is laid lower that plate of main altar. Plate of a crypt is laid into level of a new floor. Around it was lined up stone frame from original preserved artefacts. It is tuff frame with groove to mount a plate. Plate consists of two pieces that are not of the same length because of better entry into crypt. In corners they have circle openings for inserting rod for lifting.

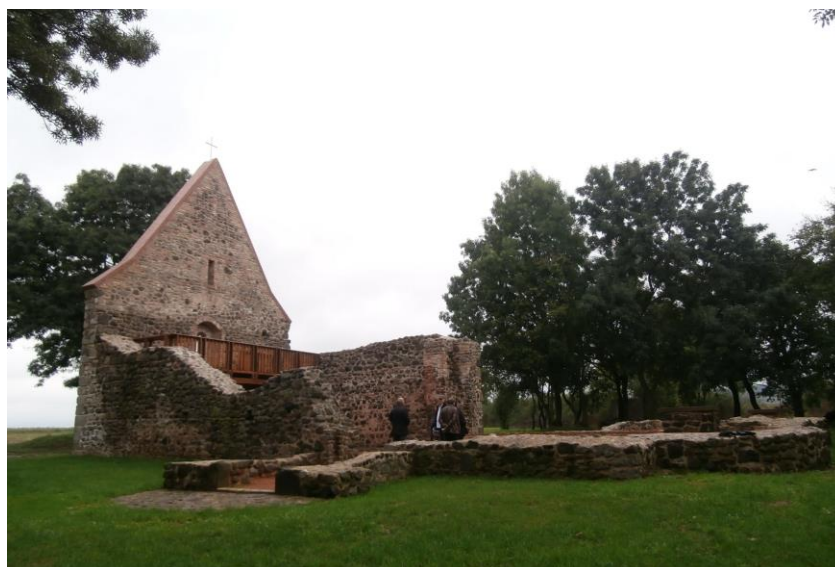
**Figure 22:** Realized renovation of the church from south, 2014. Photo: B. Polomová

Execution project according to preceding documentation degree elaborated by Ing. arch. J. Sálus. Reconstruction works on renewal of church ruin began in 2012 while at first static stabilization and conservation of existing over-ground masonry was realized and extension of western church gable was finished. In second phase in 2013 it was renewed vault of baroque crypt, access stairway and covering plate together with newly projected floor layers that overlaid originally conserved brick grooves. In the last phase in 2014 it was realized trace reconstruction of perished wooden gallery, main altar and sacristy space. Final realization diverted from execution project only a little, especially in conservation of torso of Romanesque brickwork. Problem of preservation and selection of way how to present original is illustrated especially by Romanesque brickwork, preserved as torso of static failures (Kohút 2009). Because of that the project for building permission referred only to technological and artistic-historic conservation techniques with the goal to present original as preserved masonry without plaster. Result of intervention does not meet proposed stabilization (even though technologically demanding), probably of financial reasons. Result visually prefers tracing of brickwork also by brickwork, that overlays original of Romanesque wall construction left in depth (Figure 22).
