# ASSESSING MORTAR MIXES FOR RETROFITTING DAMAGED RC COLUMNS

**KEY WORDS:** Retrofit, RC columns, mortar, rehabilitation.

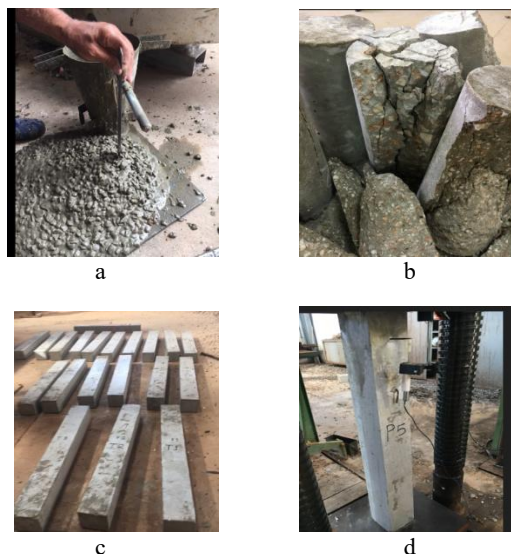
Figure 6.a) Concrete of Testing Columns, b) Cylindrical Specimens Post-testing, c) Column Samples under Curing, and d) Typical Column under Testing

In the first phase, concrete columns were vertically cast using a mix with a cement, sand, and coarse aggregate ratio of 1:1.852:3.086 (Figure 6a). The materials - ordinary Portland cement, beach sand as fine aggregate, and crushed gravel as coarse aggregate - were chosen for consistency. A water-cement ratio of 0.7 was maintained. Alongside the columns, 150 mm cylindrical samples were cast for compressive strength testing after 28 days to establish a reference baseline (Figure 6b). The concrete was poured into wooden molds, compacted using a rubber tube vibrator to eliminate voids, and cured under laboratory conditions. To retain moisture and ensure proper hardening, columns were coated with Sika Antisol WB curing compound. After 24 hours, the molds were removed, and the top surface was smoothed using a rubber plate. The specimens were then cured for 28 days to achieve full strength before testing (Figure 6c). During testing, a 300-ton capacity machine applied uniaxial compression (Figure 6d). The first set of columns (Series T – Total Failure) was loaded continuously until structural collapse establishing baseline failure capacity. The second set (Series P – Partial Failure) was loaded only until initial cracking appeared, marking the onset of structural distress. The loading rate was manually controlled for uniform application across all specimens.

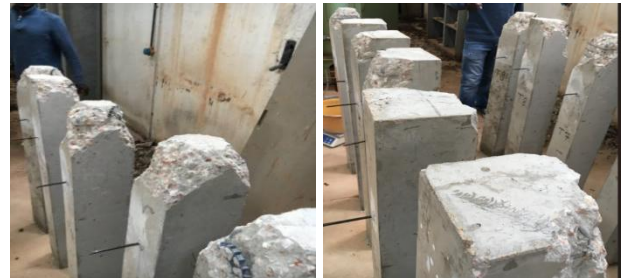
Figure 7. Column Samples after Failure

In Phase II, all damaged columns were repaired using different mortar Mixes to restore or enhance their structural integrity. The repaired columns were then re-tested under axial compression to assess improvements in load-bearing capacity and deformability. Proper preparation of the damaged concrete surfaces was essential to ensure effective repairs. All unsound or contaminated concrete, along with any external concrete cover outside the reinforcement cage, was carefully removed using hammer and chisel to expose rough, sound surfaces. Final cleaning involved washing the surfaces to remove dust and loose particles, followed by drying. Sika Bond was then applied to form a strong adhesive layer between the old concrete and the new repair materials. Figure 7 illustrates the specimens at the final stage of preparation, showing surfaces after chipping, cleaning, and the application of the bonding agent. New wooden molds were custom-built to match the exact dimensions of the damaged areas on each column, ensuring a snug fit and uniform repair coverage. The columns were then cast in a vertical orientation.

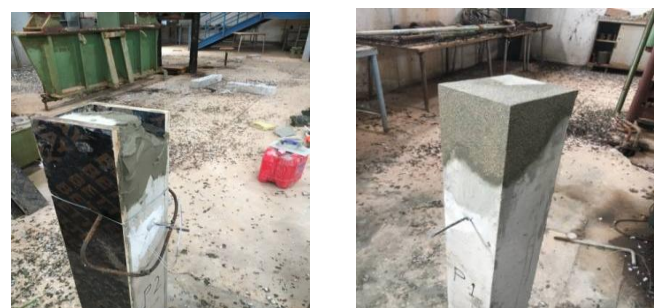
Figure 8. Smoothing and Finishing of Tested Column surfaces

After casting, the fresh repair specimens were left to set for approximately 4 to 6 hours, allowing the repair materials to reach initial hardening. Once this phase was complete, the wooden molds were carefully removed, and the column surfaces were smoothed and finished, as shown in Figure 8.

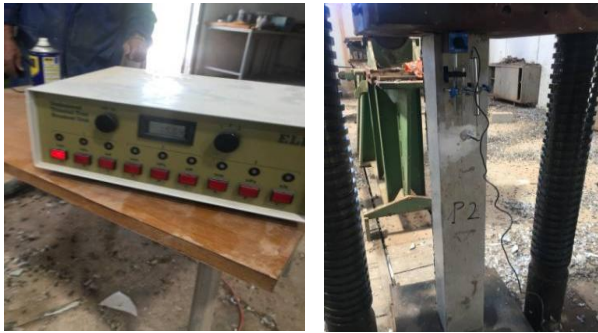
Figure 9. Connection of Digital Strain Measurements

To monitor deformation characteristics during loading, a digital strain gauge was installed 300 mm from the top of each column. This gauge measured vertical displacement and strain in real time. By tracking displacement variations, the system helped detect early signs of structural cracking or yielding, providing critical insights into column stability and failure mechanisms. The experimental setup, illustrated in Figure 9, shows the placement of the strain gauge and its connection for continuous monitoring.
