# Impact of river engineering on Vistula river channel morphometry near Warsaw (Poland): a 172-year perspective

This study investigates the impact of river engineering on the morphometry of the Vistula River channel near Warsaw, Poland, over a 172-year period. This research focuses on the examination of modifications in the Vistula channel between 1843 and 2015 that were associated with regulation, and evaluated their immediate and indirect consequences by analyzing parameters such as channel width, length, sinuosity, presence, and number of channel bars and islands. This study used historical topographic maps and contemporary aerial laser-scanning data to verify changes in the Vistula riverbed in the Warsaw region. Research has found that human-induced transformations directly affect erosion and accumulation, as well as material transport, and that changes in the river channels are most apparent in their cross-section and size of mesoforms.

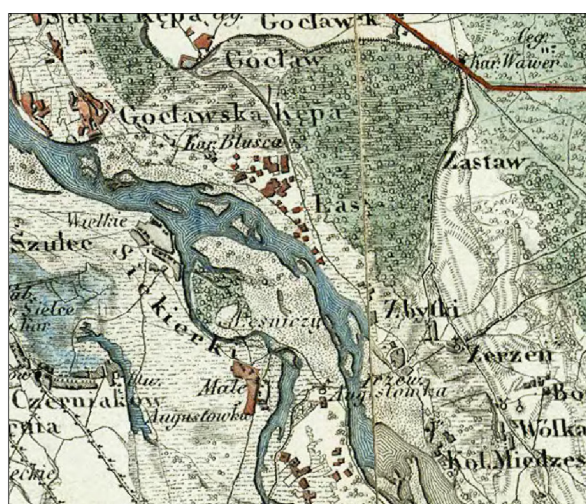
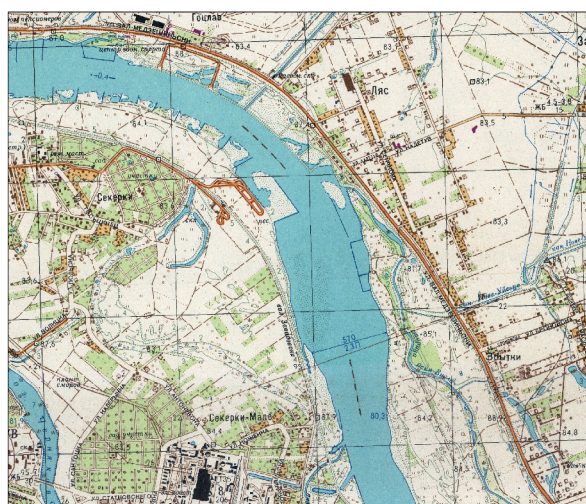
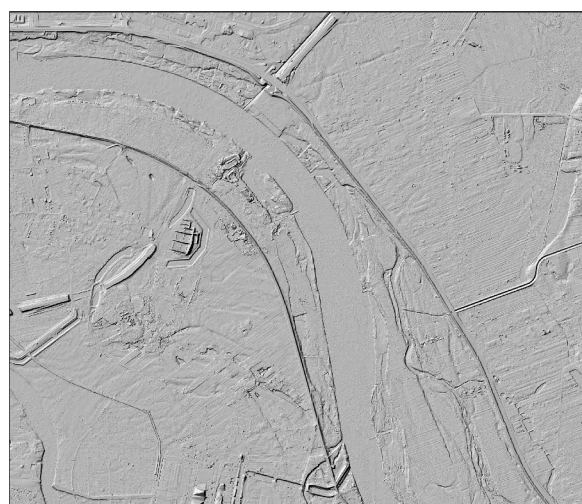
Figure 2. Cartographic overview of the Vistula River  
Source: Mapster (2024)

"Topograficzna Karta Królestwa Polskiego", 1843  
Kol. IV. Sek. III.; Kol. IV. Sek. IV.  
1: 126 000

"Karte des Westlichen Russlands", 1915  
Warszawa-Nord; Warschau-Sued  
1: 100 000

"Varšava/Варшава", 1980  
Варшава (лист 1); Варшава (лист 2); Варшава (лист 4)  
1: 25 000

Digital elevation model (DEM), 2015  
Spatial resolution 1 m

According to the methodology used in fluvial geomorphology (Gurnell et al. 2003; Trimble 2008; Grabowski and Gurnell 2016; Mandarino et al. 2021), a comparison of archival maps (Fig. 2, Table 1), DEMs, and orthophotomaps were used to verify the changes in the Vistula riverbed in the Warsaw region. To facilitate comparison between the historical maps, they were first registered in QGIS software, then rectified using the Georeferencer tool to align them with Poland's CS92 coordinate system. This process is in accordance with the recommended methodology for preparing archival maps for spatial analysis (e.g., Brovelli & Minghini 2012; Lorek 2017). According to Lorek (2017), having too few points can lead to inaccurate results and position errors. To ensure optimal correction, 30–50 control points were implemented per sheet. The geometric accuracy of rectification (RMS error) ranged between 18 m and 33 m. The pixel size of the maps from 1843 and 1915 was 1 m, while that of the map from 1980 was 1.5 m.
