# Cyclic loading test for brick masonry walls strengthened by steel mesh-ECC layers

Research Article

**Abstract:** To evaluate the seismic performance of masonry walls strengthened with a steel mesh-sprayed Engineered cementitious composite (ECC) layer, low reversed cyclic loading tests were conducted on walls strengthened with steel mesh-ECC and steel mesh-mortar overlays and compared with an unstrengthened specimen. Considering the superior mechanical properties of ECC and the importance of the wall-overlay bond, a novel strengthening method is proposed in which a steel mesh is embedded in the ECC layer and anchored to the wall through tie bars to enhance interfacial bonding and ensure composite action under lateral loading. The study focused on the shear load-bearing capacity, ductility, energy dissipation capacity, and failure patterns of the walls. The results indicated that the failure pattern of the unstrengthened masonry wall was shear failure, accompanied by diagonal cracks. The masonry wall strengthened by steel mesh-ECC layer underwent bending failure. Compared with the unstrengthened specimen, the peak load, ductility coefficient, and yield load of specimen strengthen

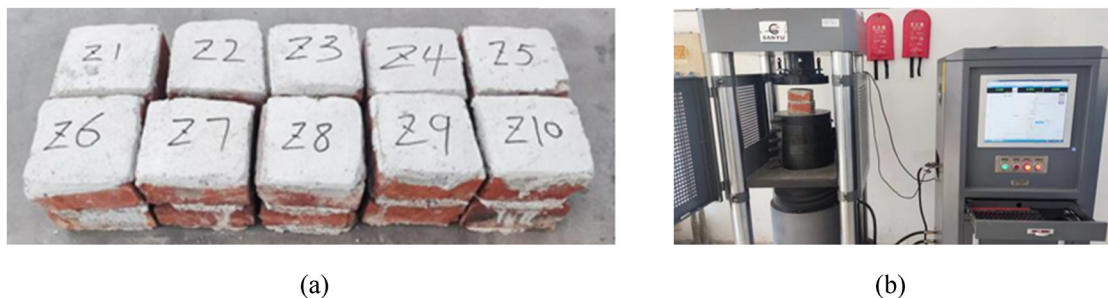
**Figure 7.** Compressive strength test of a single brick. (a) Brick specimens. (b) Testing apparatus.

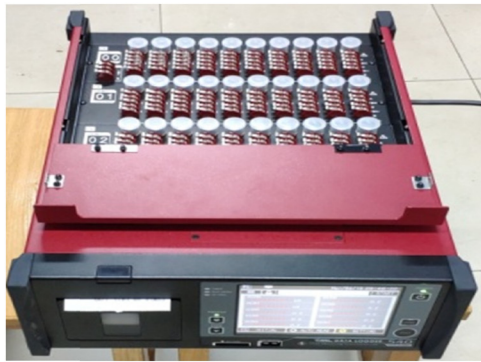
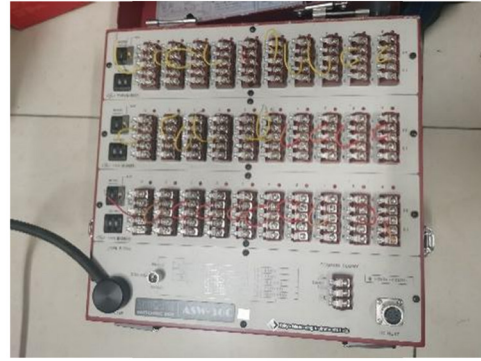
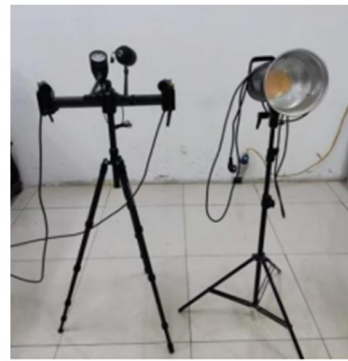
**Figure 13.** Main instruments. (a) TDS-540 static resistance strain acquisition system. (b) Extension unit. (c) Displacement gauges. (d) DIC device.

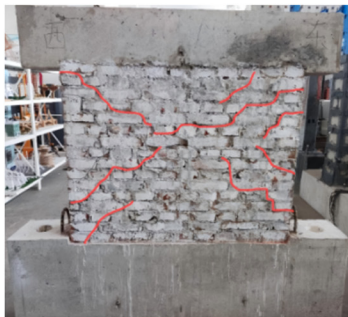
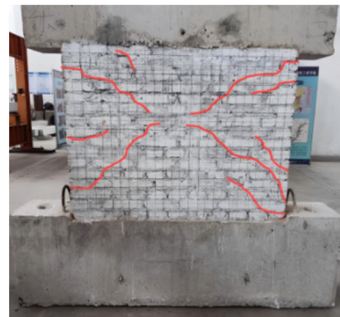
**Figure 14.** Failure pattern of specimen S1. (a) The south side of the specimen. (b) The north side of the specimen.

For specimen S1, no visible crack was observed in the wall after the application of vertical loads. When the lateral load reached  $F = +75.34$  kN with a displacement of  $\Delta = +1.60$  mm (positive for actuator pushing, negative for pulling), three minor diagonal cracks along the mortar joints appeared on the first, third, and sixth layers of

bricks at the bottom west side of the wall, and two minor downward diagonal cracks were observed on the first and third layers at the upper east side. When the lateral load increased to  $F = -69.40$  kN with a displacement of  $\Delta = -2.00$  mm, two minor upward diagonal cracks along the mortar joints developed on the third and seventh layers of bricks at the bottom east side, and two minor downward diagonal cracks appeared on the second and fourth layers at the upper east side. When the lateral load reached  $F = +97.32$  kN with a displacement of  $\Delta = +2.00$  mm, the diagonal crack on the west side of the wall continued to propagate along a 45 degree angle. As the load reversed to  $F = 82.39$  kN with  $\Delta = -2.40$  mm, a similar diagonal crack on the east side extended along the same angle. When the displacement reached  $\Delta = \pm 4.00$  mm, the primary diagonal cracks on both the east and west sides further propagated, and the peak load-bearing capacity dropped below 85%. The test was subsequently terminated, and the failure pattern of specimen S1 is shown in Figure 14.

The initiation and propagation of diagonal cracks along mortar joints indicate that the shear resistance of the unreinforced masonry governed the failure process. Owing to the absence of any strengthening measures, the masonry shear capacity was exhausted prior to the development of flexural deformation, resulting in a typical diagonal shear failure mode. The test was subsequently terminated, and the failure pattern of specimen S1 is shown in Figure 14.

In summary, specimen S1, representing the unstrengthened wall, exhibited a typical diagonal shear failure pattern characterized by intersecting cracks across the wall. Consistent with previous studies on URM under cyclic loading [35], such diagonal cracking led to rapid degradation of load-bearing capacity due to the brittle nature of masonry. Specimen S2, strengthened with a 30 mm thick ECC overlay and steel mesh on both sides, demonstrated significantly altered failure behavior. The high tensile strain capacity and crack-control properties of ECC effectively delayed crack initiation and propagation, leading to an increased cracking load and enhanced lateral stiffness compared with specimen S1. Specimen S3 strengthened with a 30 mm thick mortar layer and steel
