| <p>Nordic Concrete Research</p> | |

## Photocatalysis and Blue Light in Swimming Pools Delay Corrosion in Concrete and Metal Parts and Improve Indoor Air Quality

Västertorpsbadet aquatic center in Stockholm, Sweden, opened in 1967, had its original hypochlorite-based water treatment system combined with a photocatalysis treatment for the water and blue light in the pool hall. This case study follows up the outcome of these installations. When chlorine was reduced from 0.8 to 0.4 mg Cl<sub>2</sub>/l levels of culturable bacteria did not raise, and also all other indicators remained well within the Public Health Agency of Sweden's guideline values. In addition, air quality in the pool hall was much improved because concentration of trichloramine in the air was reduced. When chlorine and chloride in the pool

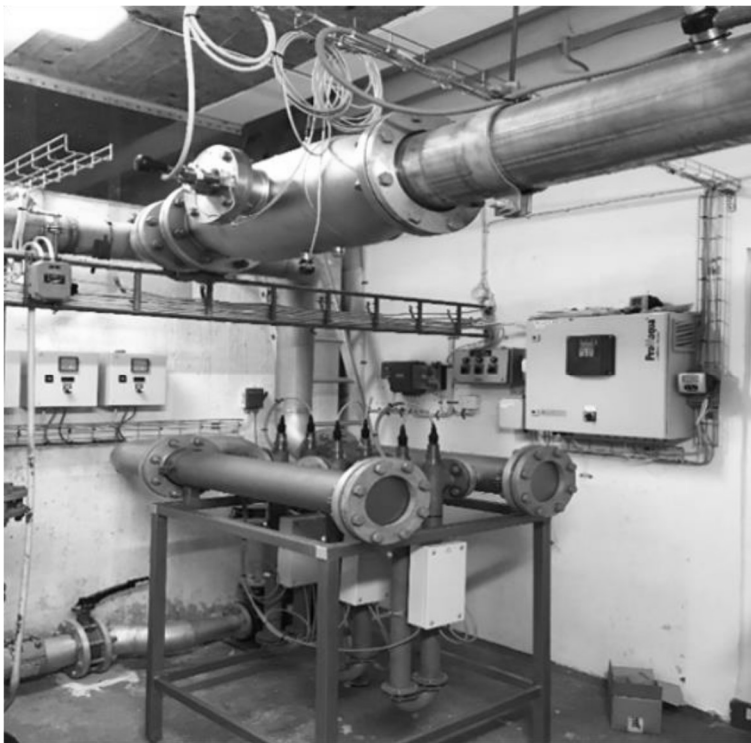
Figure 2 – This picture shows the AOT devices for photocatalysis installed in the treatment plant of Västertorp aquatic center.

example, residues from skin care products. The AOT device is placed after the sand filters in the treatment plant, as indicated in the process scheme, Figure 1. Figure 2 is a photo of the equipment. For each circulation about 50% of the water flow passes the photocatalysis equipment, so in the long turn all the water will be treated. This type of photocatalysis was formerly tested in Sundbyberg aquatic centre in 2005, the outcome was said to be good [26], but no description or follow up was published.

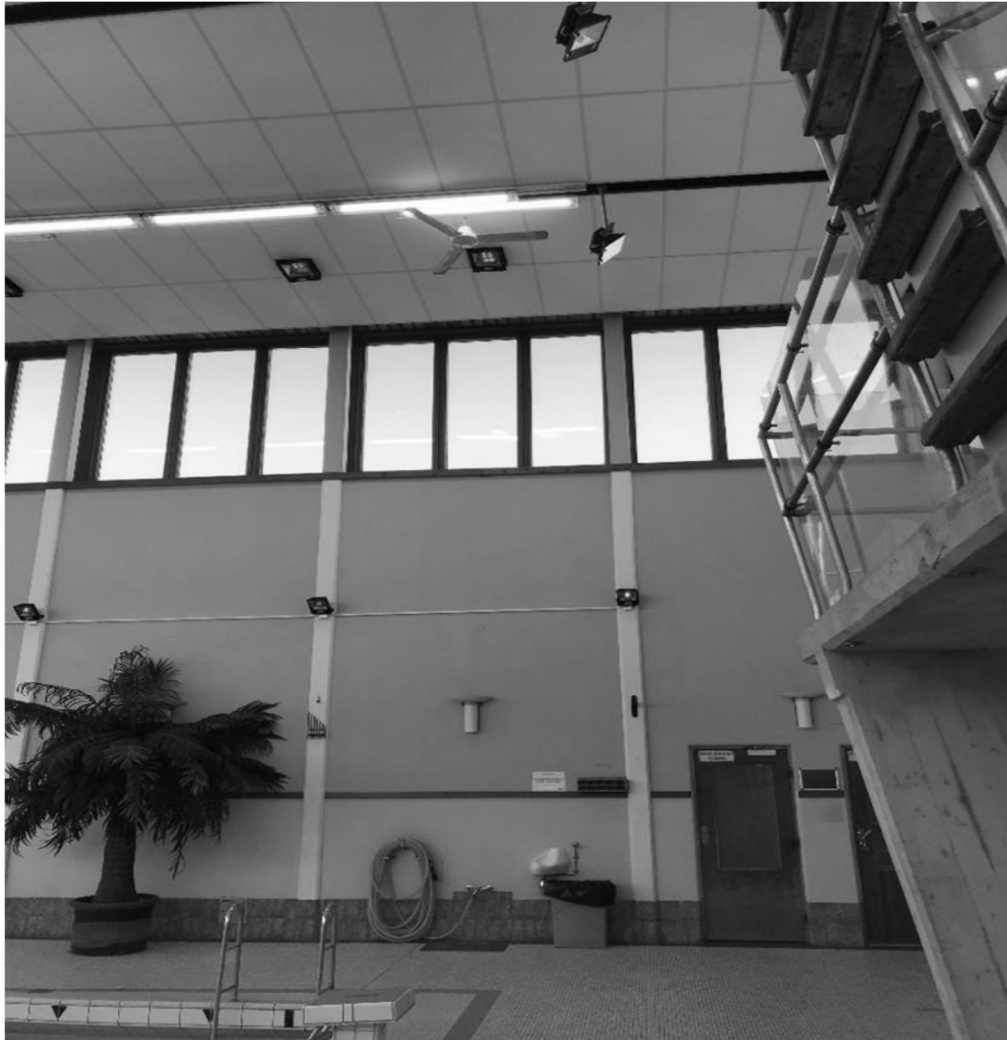
*Figure 4 – The photo shows blue light lamps in the bigger pool hall.*

no lenses. All the fixtures shine towards different parts of the swimming pool and floor surfaces. The total floor and pool surfaces are approximately 550 square meters. Total illumination intensity for the blue light (optical power) is 2.1 kW, which in turn means 3.8 W/m<sup>2</sup>. A timer supplements the installation, so the blue light is automatically turned off during daytime when bathers and personnel are in the premises. Figure 4 shows lamps in the hall.
