## **DYNAMIC RESPONSE OF A GUARDRAIL SYSTEM BASED ON PRESTRESSED CABLES**

This paper studies the possibility of adopting an innovative safety barrier solution based on modern, more efficient materials such as prestressed high-strength steel reinforcement. Scaled model of 1:20 tests and numerical simulations are presented for a guardrail system made up of high strength cables and plastic hinge supports.

In the next chapters, this paper will study a novel guardrail system made up of high strength cables and plastic hinge supports. Scaled model of 1:20 tests and numerical simulations are presented.

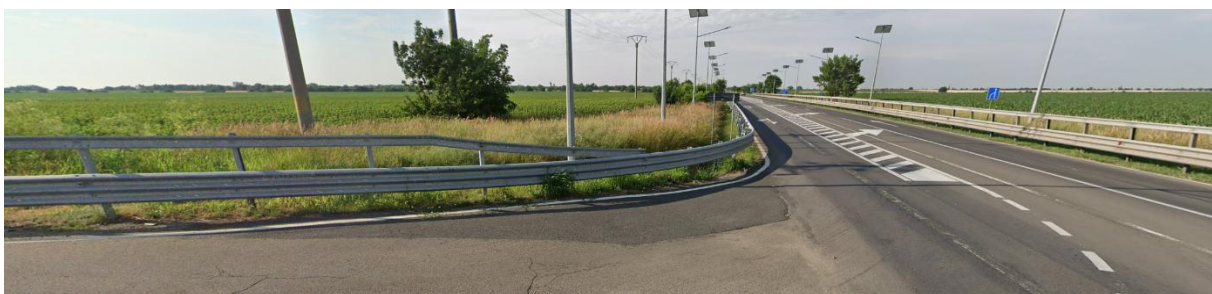
A typical "T" intersection between a secondary road and a very busy road, where there was no way to ensure both optimal visibility and safety conditions for drivers. A compromise had to be made by locally reducing the level of protection provided by the guardrail from H3 to H2, in order to increase visibility.

**Figure 1.** Low impact level guardrail in the intersection between National Road DN2 and county road DJ 203C

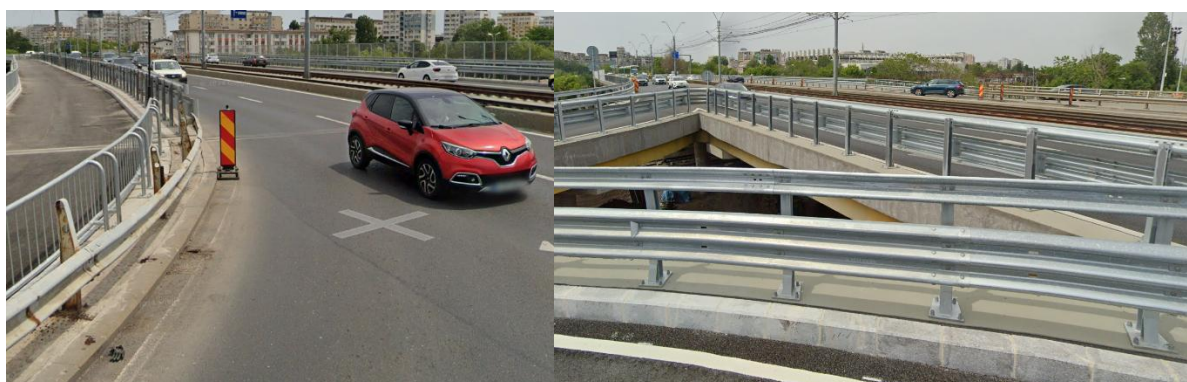
The Grant Bridge recently underwent a series of retrofitting procedures. During the latest interventions on the structure, high impact resistant H4b guardrails were installed, replacing the older, less resilient model, in accordance with the regulations in force. The large dimensions of the guardrail, corroborated with the lack of acceleration/deceleration lanes and the curvature of the bridge in plan view, make entering the flow from the side shoulders very difficult and dangerous. This situation existed before, but the much smaller guardrail reduced the magnitude of the phenomenon. Since reopening to traffic in march 2024, there have been numerous incidents of light accidents on the bridge.

**Figure 2.** Grant Bridge Shoulder view when entering the traffic flow

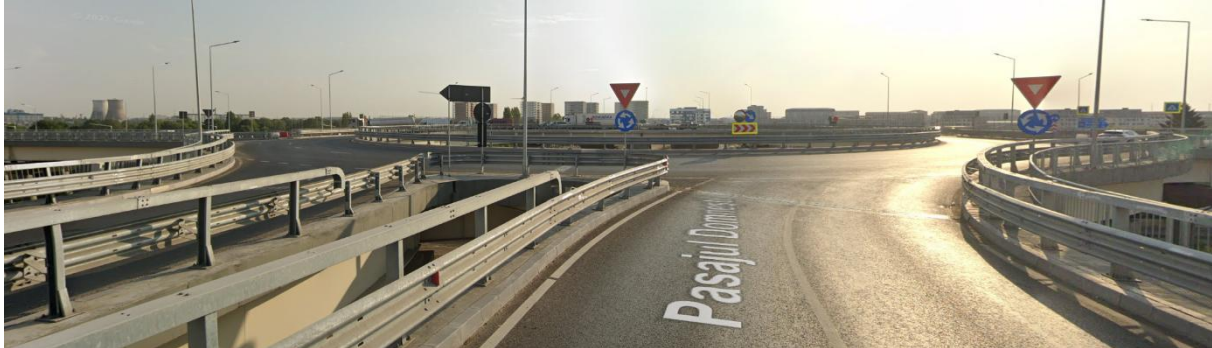
The atypical shape of the passage supporting a roundabout makes it very difficult to ensure visibility conditions at the entry into the flow, while also ensuring a very high level of impact protection, in accordance with all regulations. The solution adopted was to ensure satisfactory visibility conditions by locally reducing the level of protection of the safety barriers from H4b to H3.

**Figure 3.** Domneşti bridge local guardrail impact level decrease

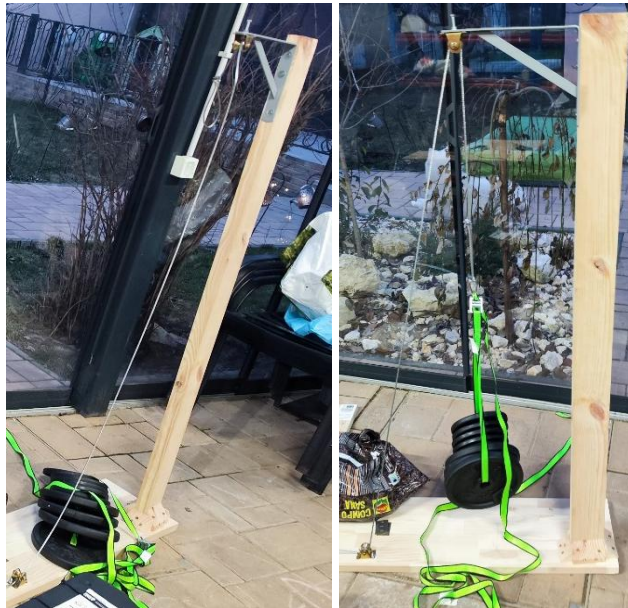
The pole was created from a 5x15cm section, 1.50m long wooden bar. This also has wooden reinforcements installed on all sides at the base level and a 30cm long steel cantilever attached at the top.

**Figure 16.** Installed stilps and anchorage on the wooden base plate

After installing the pole on a separate base plate, pulleys and the cable were also attached. A textile strap and a hook were used to attach the 50kg weights and prestress the system cables of the system. Bags of earth and bolts fixed to the ground were added as a precaution for general stability of the test frame.

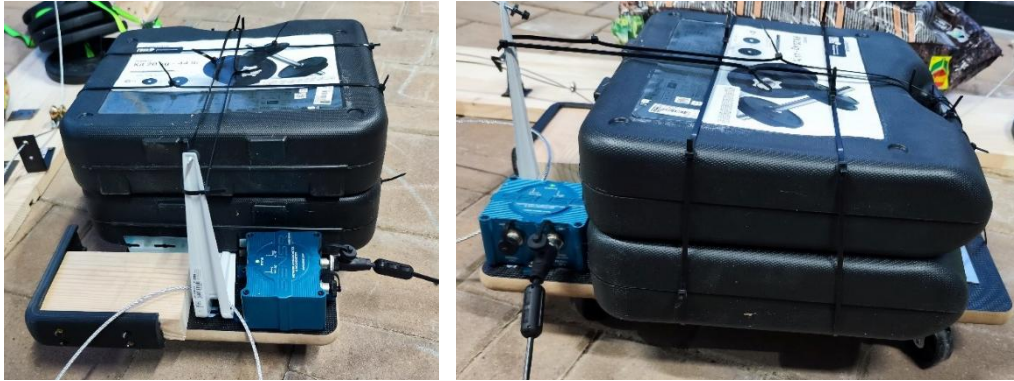
The impact vehicle is composed of a 60x40cm wooden plate with 4 wheels attached at the bottom. The following components were added on the plate, in order to facilitate better impact conditions and measurements:

- a steel hook was added at the front in order to pull the cart to the desired speed
- a three directional accelerometer was mounted for test results
- two 25kg weights were added to simulate the scaled mass
- a plastic bumper bar to simulate damage and deformation of the vehicle chassis
- wooden wedges and plastic strips were added to fix all components on the plate

Figure 17. Scaled vehicle

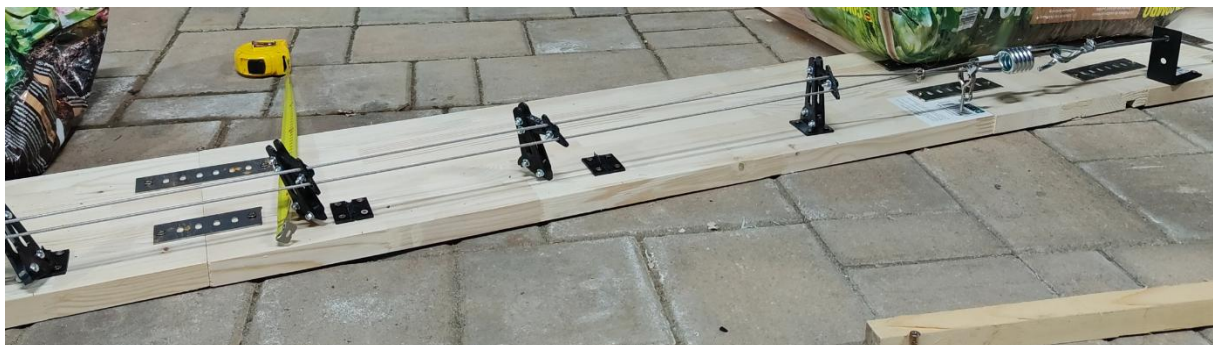
Although some damage to the stilps occurred, the test can be considered a success. It took about 1.10m of impact length for the cart to come to a complete stop, with a maximum transverse displacement of about 8cm. The transverse displacement matches a W4 working width class, which is higher than anticipated but still within acceptable limits according to the norm.

**Figure 19.** Scaled guardrail after crash test

During the test, two of the stilps actually broke at the level of the base plate piece. Upon closer inspection, it was found that the rupture mechanism was of share force, basically tearing apart two adjacent layers of filament. It is highly

improbable for this to happen in real life if the stilps would have been made of steel. The rupture mechanism is related to the limits of 3d filament prints that are known to have poor layer adhesion. Aside from this, there was minimal to no damage on the cables, anchorages, or on the cart itself.
