# Compressive Strength Assessment of 60–70-Year-Old Bridge Concrete in Eastern Slovakia: Compliance with Historical Standards vs. Current Eurocode Requirements

This article focuses on the evaluation of concrete substructures of 10 road bridges in eastern Slovakia, built between 1960 and 1970, based on core sampling and compressive strength testing performed in accordance with current European procedures for in-situ strength assessment. The results confirm that the concrete was predominantly site-batched, characterized by a large aggregate size and significant strength variability. Although all tested specimens meet the design requirements valid at the time of construction, only about half of the bridges achieve the prescribed characteristic strength when assessed according to present-day European standards. Despite their age of 60–70 years, the substructures (abutments and piers) remain in very good condition. In contrast, the superstructures show extensive deterioration, dominated by reinforcement corrosion and alkali–silica reaction, which will require costly rehabilitation or replacement in the near future.

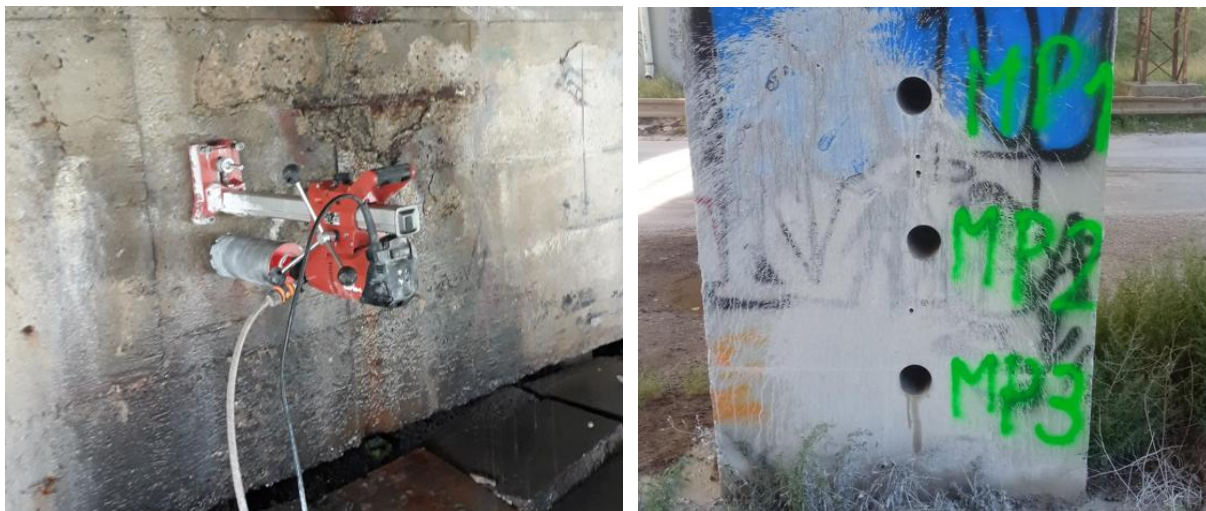
Figure 1: The process of core drilling the and a view of the holes after the drill bits have been removed

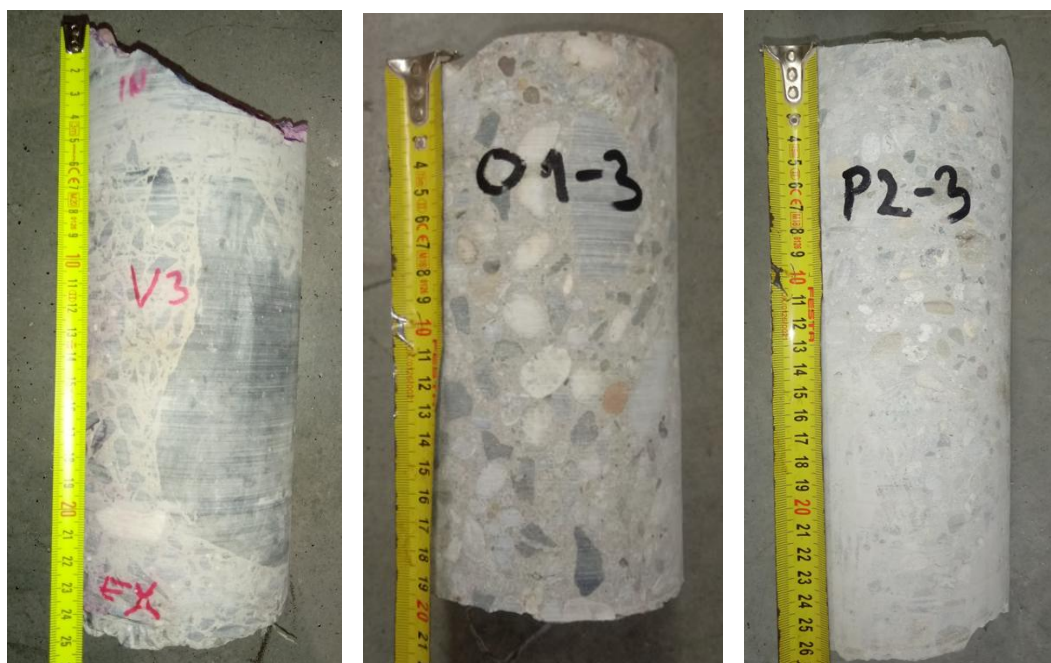
Figure 2: The Core drills with different aggregate sizes, from left: large, medium and small grains

The maximum aggregate size determined from the cores ranged from 20 to 72 mm (Tables 1–3). Such values clearly indicate that the concrete was predominantly site-batched. Aggregate sizes exceeding 32 mm are considered high by today's standards, and when pumpability is required, current European recommendations [3,4] limit the maximum size to 40 mm. Nevertheless, with an appropriate grading curve and well-designed mix, large aggregate can

still yield the required compressive strength, as confirmed by the test results. From a practical perspective, however, placing such mixes was extremely demanding. Interestingly, significantly larger aggregate particles were more frequently observed in bridges located farther from Košice. In those regions distant from ready-mix concrete facilities, local quarry stone was favoured, and concrete was generally made on site.

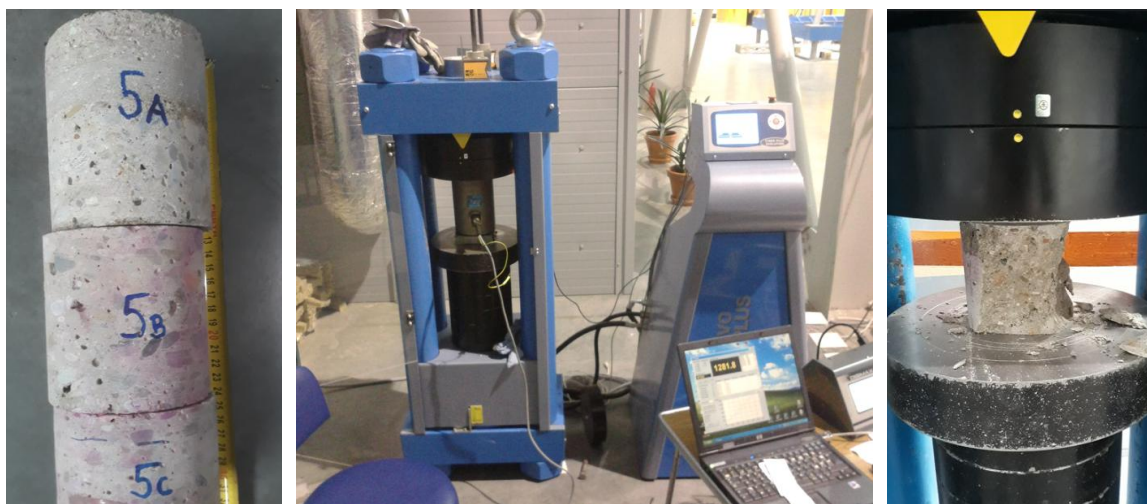
Figure 3: Left - prepared samples, middle - Matest press machine, right - damaged sample after testing

surfaces ground to produce cylindrical test specimens. Each prepared specimen was weighed and measured to determine its bulk density. Following the compressive strength test in a laboratory testing machine (Figure 3), the maximum aggregate size was visually determined on the fractured surfaces. A summary of the measured compressive strength values, bulk densities, and maximum aggregate sizes is presented in Table 1.
