# Structural performance of repaired reinforced concrete beams with damaged compression zones: an experimental study using digital image correlation

## Abstract

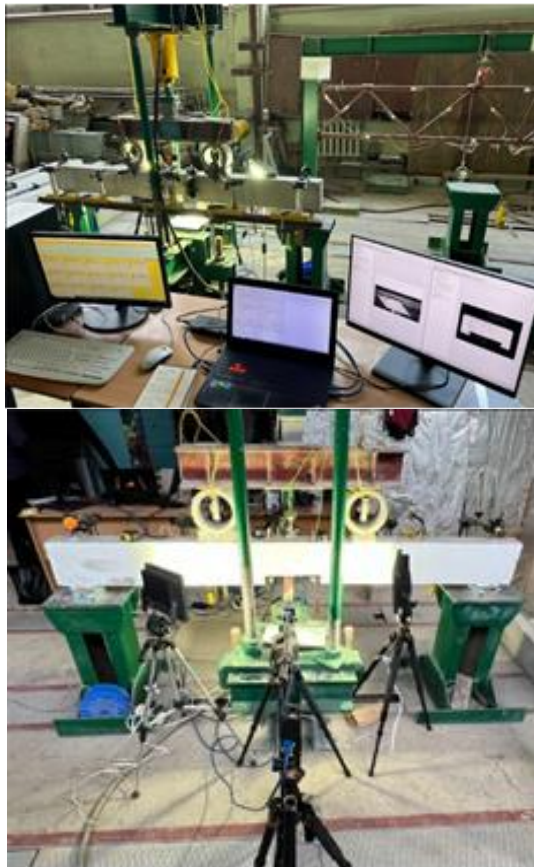
**Fig. 3.** Overall view of the experimental testing stand

Experimental investigations were conducted employing both strain gauges and digital image correlation (DIC) to minimize measurement errors and validate the research methodology. Submicron, non-contact strain gauges were affixed to one surface of the beam, whereas the opposite surface was dedicated to DIC implementation (see Fig. 3). This configuration ensured reliable and complementary application of both measurement techniques.

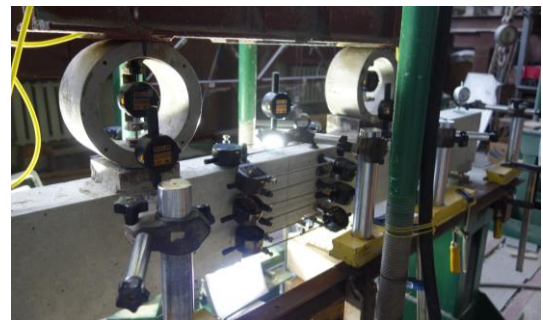
**Fig. 4.** Microtech measuring gauges were applied in the course of the experimental research

Experimental methodology for RC beam measurements. High-precision, submicron non-contact sensors were employed to ensure accurate assessment of strain and stress. In the present study, Micro-tech sensors with a resolution of  $1 \times 10^{-4}$  mm and a measurement error below  $13 \mu\text{m}$  were utilized (see Fig. 4). The acquired data were transmitted to a computer via Bluetooth, enabling continuous monitoring of the specimen up to ultimate failure. Measurements were recorded at 1-second intervals. Two submicron sensors were dedicated to capturing the deformation of the most compressed concrete fibers, while steel reinforcement strains were monitored using conventional strain gauges mounted on mechanical holders. Along the beam height, five sensors were strategically positioned, with the first sensor located 20 mm from the top edge and the remaining four installed at 30 mm intervals. Beam deflections were monitored using five additional submicron sensors: one at midspan, two at the locations of applied loads, and two directly above the supports.

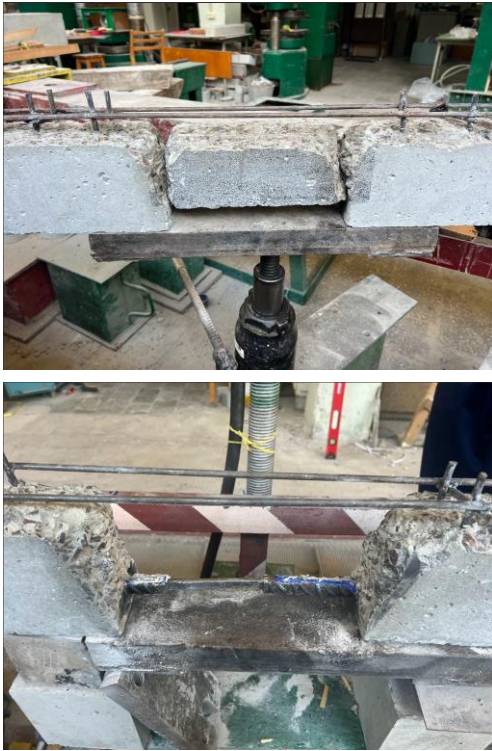
**Fig. 5.** Overview of the damaged region of the RC beam

During the experimental investigation, two full-height cracks developed along the beam, enabling the extraction of a concrete fragment measuring  $300 \times 100 \times 100$  mm that was

no longer structurally connected to the main body of the specimen (see Fig. 5).

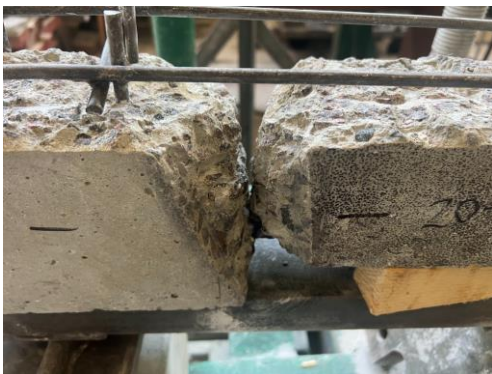
**Fig. 6.** Surface preparation and gap for restoration work

The first step in the preparation for bonding involved creating a gap of 5-10 mm between the concrete insert and the body of the beam, followed by cleaning the surfaces of dust and weak concrete residues (see Fig. 6).

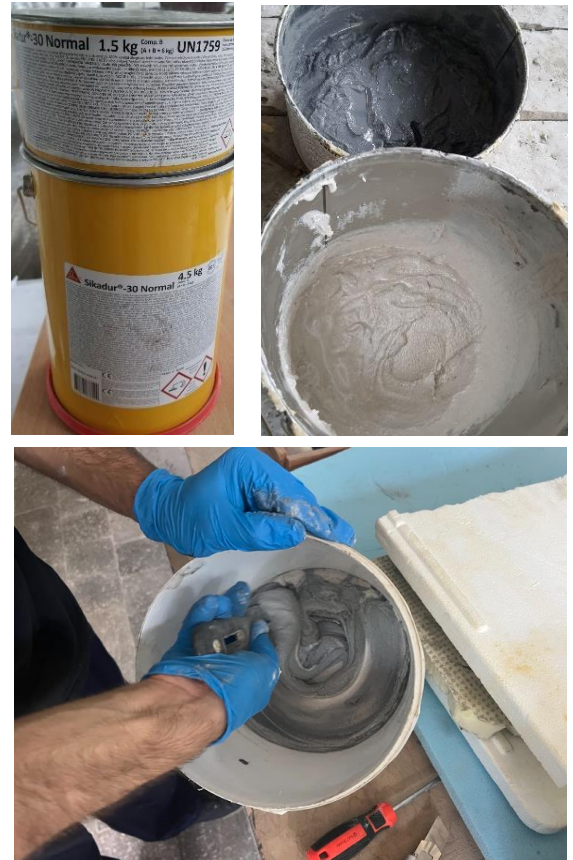
**Fig. 7.** View of the damaged area of the RC beam

For the bonding procedure, Sikadur-30 epoxy adhesive was employed. Sikadur-30 (Sikadur®-30) is a thixotropic, two-component epoxy-based adhesive specifically formulated for the bonding of construction materials. It possesses high mechanical strength and is used for repairing chips and damage to concrete structures (see Fig. 7).

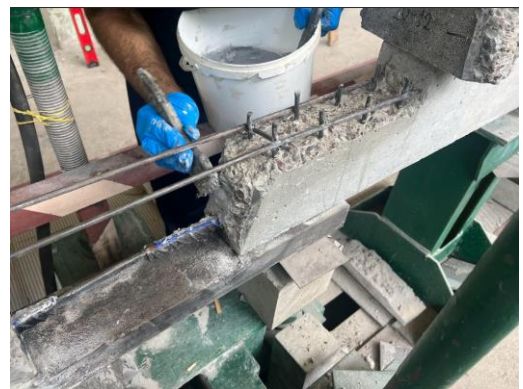
**Fig. 8.** Priming the surface with epoxy adhesive

The main physical and mechanical properties of Sikadur-30 epoxy adhesive are provided in the documentation. After preparing the surfaces, the Sikadur-30 epoxy adhesive was prepared by mixing components A and B for 3 minutes to achieve a homogeneous mass. The finished adhesive was applied to the concrete surface in a thin layer (see Fig. 8), and then quartz sand was sprinkled on top (see Fig. 9) to ensure mechanical bonding, thus creating a priming layer between the surfaces. This work was performed on all surfaces that needed to come into contact.

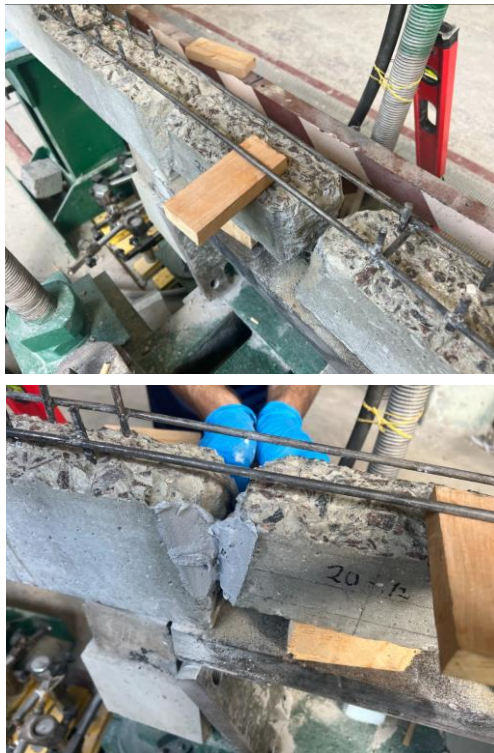
**Fig. 10.** Positioning the insert in the designed position and securing it

The next step involved applying a thicker layer of Sikadur-30 over the primed surface and positioning the concrete piece that needed to be bonded in its designed position (see Fig. 10).

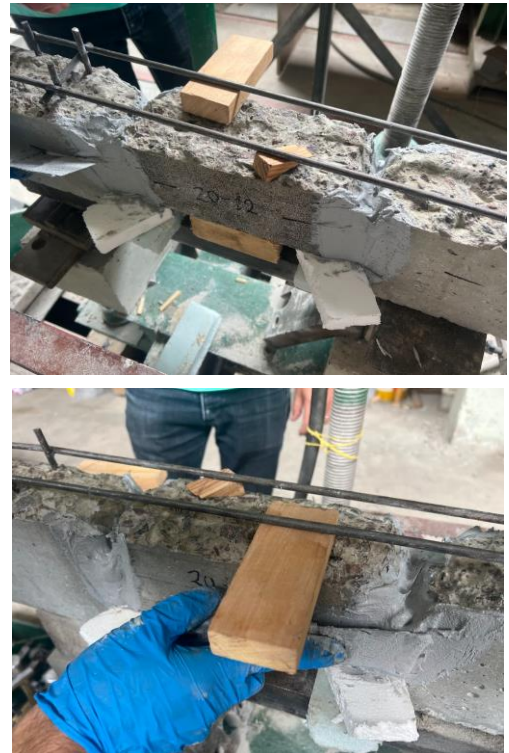
**Fig. 11.** Pressing in the epoxy adhesive and allowing it to cure

After aligning and securing the concrete insert, Sikadur-30 epoxy adhesive was used to fill all gaps, forcing it into the bonding areas (see Fig. 11).
