## Wear Mechanisms and Service Life of PVD-Coated Collar Dies in Coin Minting

Coin minting;  
 Collar dies,  
 PVD coatings,  
 Wear mechanisms,  
 Economic evaluation.

DOI: 10.30657/pea.2026.32.4

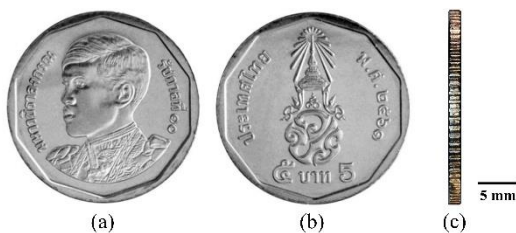
**Fig. 2.** The 5-baht coin issued since 2018: (a) obverse, (b) reverse, and (c) reeded edge

weighing 6 g and 24 mm in diameter, with a reeded edge of 78 serrations (Fig. 1 and 2). During minting, blanks are struck between upper and lower dies within a collar die, which forms the edge serrations (Fig. 3). The high-speed press (650–850 strokes/min) delivers rapid production, with regular quality checks monitoring for defects such as misaligned patterns, excessive rims, or collapsed edges. Among these, wearing collar die's reeded grooves is the most frequent cause of failure mode, resulting in defective coin edges (Fig. 4). At the Royal Thai Mint, uncoated hardened DIN 2379 collar dies typically last ~700,000 coins before replacement, thereby increasing production costs through frequent downtime.

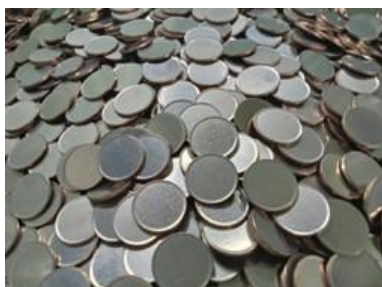
Fig. 6. Cupronickel-clad copper planchets prepared for minting trials

The coin blanks (planchets) were standard Thai 5-baht cupronickel-clad copper, consisting of outer layers of 75 % Cu – 25 % Ni bonded to a 99.5 % Cu core. Each weighed 6.0 g, measured 24 mm in diameter, and featured 78 serrations in accordance with Treasury Department specifications. Representative planchets used in the trials are shown in
