# Static and Fatigue Performance of Repaired Reinforced Concrete Beams

H.P Sooriyaarachchi

**Abstract:** Deteriorated concrete structures due to corrosion cracks and with fallen concrete cover are often repaired by removing the cracked concrete around the corroded reinforcement and replacing it with new concrete or with special repair mortar. This process is often referred to as “Mechanical Repair” and is widely used for repairing deteriorated reinforced concrete members. Mechanical repair leads to the formation of an ‘interface’ between the ‘parent concrete’ and repaired material. The structural behaviour of the repaired members is critically depended on the performance of the interface. This paper reports the results of static and fatigue tests performed on a total of 21 beams, cast in two stages to resemble the mechanical repair. Location and dimensions of the repair and the repair material are taken as variables in the study. Results of the static tests on repaired beams reveal that static performance can be restored by the mechanical repair. Compressive face repair can even improve the performance depending on the properties of repair material and the performance of the bond

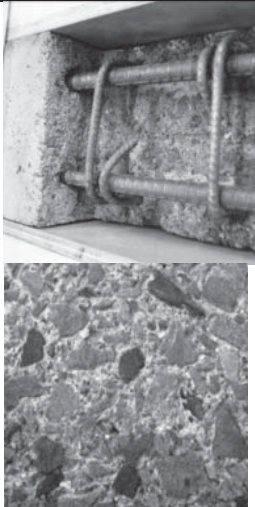
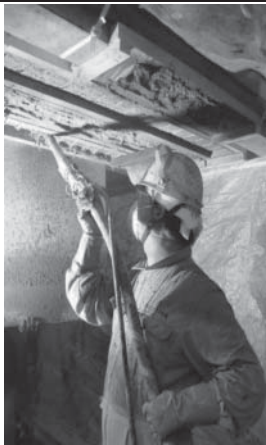
| 4(a) Provision for the required repair dimension attached to the reinforcement skeleton | 4(b) Reinforcement Skelton lowered to the mould | 4(c) Cast concrete | 4(d) Strip off the packing material and expose the repair cavity |
| 4(e) Preparing repair surfaces using water blasting | 4(f) Complete the required shuttering work for the repair | 4(g) Application of primer to the prepared surface before being repaired | 4(h) Shotcrete the repair mortar to the cavity |

**Figure 4 - Various steps involved in the preparation of the repaired beams**

First the packing material was attached to the reinforcement skeleton as shown in the Fig. 4(a). Then the skeleton was lowered into the mould and concrete was cast (see Fig. 4(b) and 4(c)). After curing the beams for 28 days packing material was stripped off exposing the repair cavities (see Fig. 4(d)). Repair surfaces were then water blasted to create the required roughness for better bond between the repair material and parent concrete (Fig. 4(e)). Thereafter, appropriate shuttering work was done to cast the repair mortar to the required dimension (see Fig. 4(f)). Primer was then applied on the prepared surfaces (see Fig. 4(g)) before they are stacked in the correct

orientation and shot-created with the appropriate repair mortar (see Fig 4(h)).
