# Comprehensive Structural Assessment of Old School Buildings in Sri Lanka

**Abstract:** The deterioration of old school buildings has become a significant challenge to the Sri Lankan Government and the educational system. This study investigated a total of twelve old school buildings, distributed across six distinct schools in Sri Lanka, all of which were constructed in the 1980s and 1990s. Visual inspection was carried out to detect the common defects of the structural elements. Non-Destructive Testing (NDT) and Destructive Testing (DT) methods were performed to determine the existing material properties of the identified deteriorated structural elements. Utilizing the SAP2000 software, a Finite Element (FE) model was developed to simulate a representative school building, considering the architectural and structural similarities shared with the examined old school buildings. Structural analysis was carried out for the typical concrete structural elements and their capacities were closely investigated based on variables such as concrete cover, effective steel area, and grade of the concrete. According to the FE modelling results and the capacity assessment, possible retrofitting

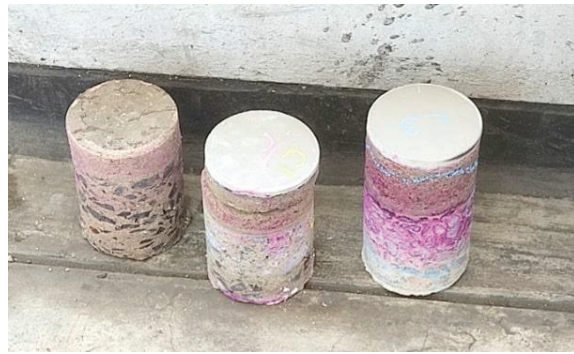
The core test is the only destructive test that was conducted in this study, and it was used to determine the in-situ compressive strength of extracted concrete core samples from concrete slabs in each school building. The test was conducted as per BS EN 12504-1: 2009 [7] and BS 6089:2010 standards. Core samples of 100mm diameter were extracted using a diamond drilling bit (Figure 2). The compressive strength was determined using the compressive test by applying corrections to the length-to-diameter ratio, the effect of reinforcement present perpendicular to the axis of the core, and excessive voidage. The average compressive strength value of three core samples was considered for each floor in the building.

Figure 2 - Extracted Concrete Core Samples

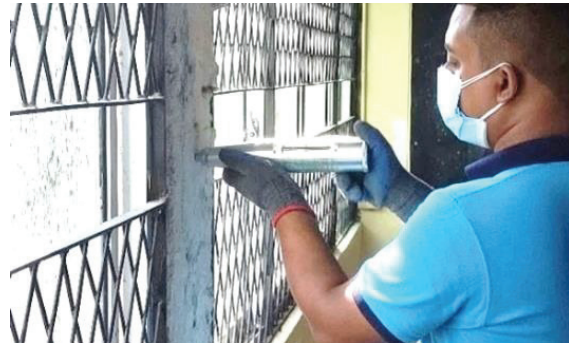
The rebound hammer test was the other testing method that was used to obtain the in-situ compressive strength, based on the surface hardness of the concrete in each selected structural element in old school buildings. The test was performed as per BS EN 12504-2: 2001 standard. To determine an accurate rebound number for each selected 300mm x 300mm test area, a minimum of nine observations were taken. The result was recorded as an average value of all observations, which were corrected by considering the orientation of the rebound hammer according to the manufacturer's instructions. Figure 3 illustrates the rebound hammer test on an RC column.

Figure 3 - Rebound Hammer Test on a Reinforced Concrete Column

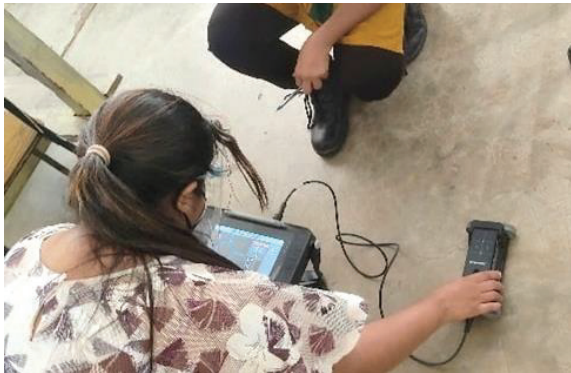
**Figure 4 - Cover Meter Test on a Reinforced Concrete Slab**

The cover meter test was used to determine the locations, arrangements, and spacing of reinforcements when the drawings were not available for old school buildings. The test was conducted according to BS 1881-204: 1988 and Profometer 5+ was used to conduct the test.

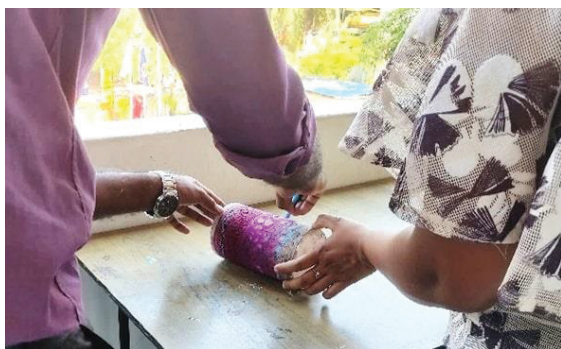
This test was used to determine the carbonated depth of the extracted core samples, the carbonation depth of the beams and columns, and the internal voids of the core samples. A phenolphthalein solution was sprayed on the freshly extracted concrete core samples and the carbonated depth (uncoloured area) was measured four to eight points from the external concrete surface, and the median was recorded. Figure 5 shows the carbonated depth marking on an extracted concrete sample.

**Figure 5 - Marking the Carbonated Area on an Extracted Core Sample**

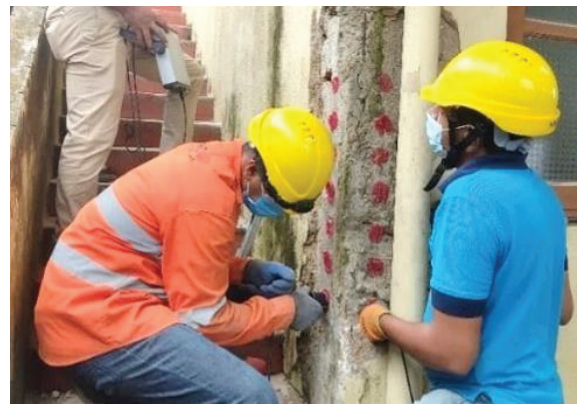
The UPV test is a wave propagation test that was used to determine the uniformity of concrete components of the examined school buildings. In this test, the time taken for an ultrasonic pulse to pass through the concrete was measured. The test results show higher velocity if the concrete has good quality, density, homogeneity, and uniformity. UPV test was conducted as per BS EN 12504-4: 2004 and before starting the test, the surface was prepared properly. UPV test on a concrete column is shown below in Figure 6.

**Figure 6 - UPV Test on a Reinforced Concrete Column**

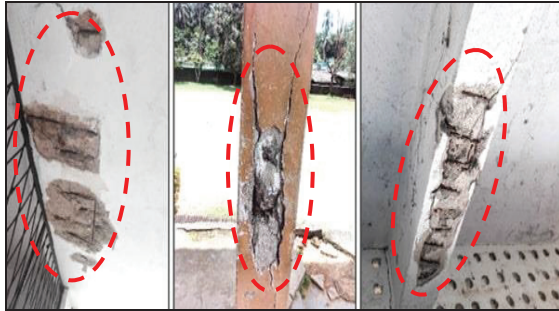
Based on the visual inspection data, the cracking of concrete elements and spall-off concrete (Figure 10) due to the corrosion effect were identified as the most common defects in these studied school buildings.

Figure 10 – Defective Structural Elements in an Old School Building

For the identified minor defects on the structural elements during the visual inspection, repairing methods such as the patch repair method and epoxy injection method were suggested.
