# Road Safety Risk Assessment on Partially Completed Road Work Zones in Sri Lanka

**Abstract:** Road safety issues in Low to Middle-Income Countries and the key causal factors are well documented in the literature. However, an issue that is often overlooked is the safety hazards posed by road work zones or partially completed road segments that have not followed adequate safety measures to safeguard the road users. The stoppage of road works occurs due to various issues, with financial reasons being the primary cause in developing countries. These sites are left unattended for months, exposing road users to numerous hazards that may result in road crashes. Considering road agencies face major budget constraints, it is unlikely that all road segments can be completed within a short time. Therefore, there needs to be a process to expedite the evaluation of these road segments to prioritize mitigation measures to reduce the safety risk. This research aims to provide a framework for assessing the risks associated with partially completed roads. First, the key safety issues were identified through a comprehensive road safety inspection across several types of sites where partially comp

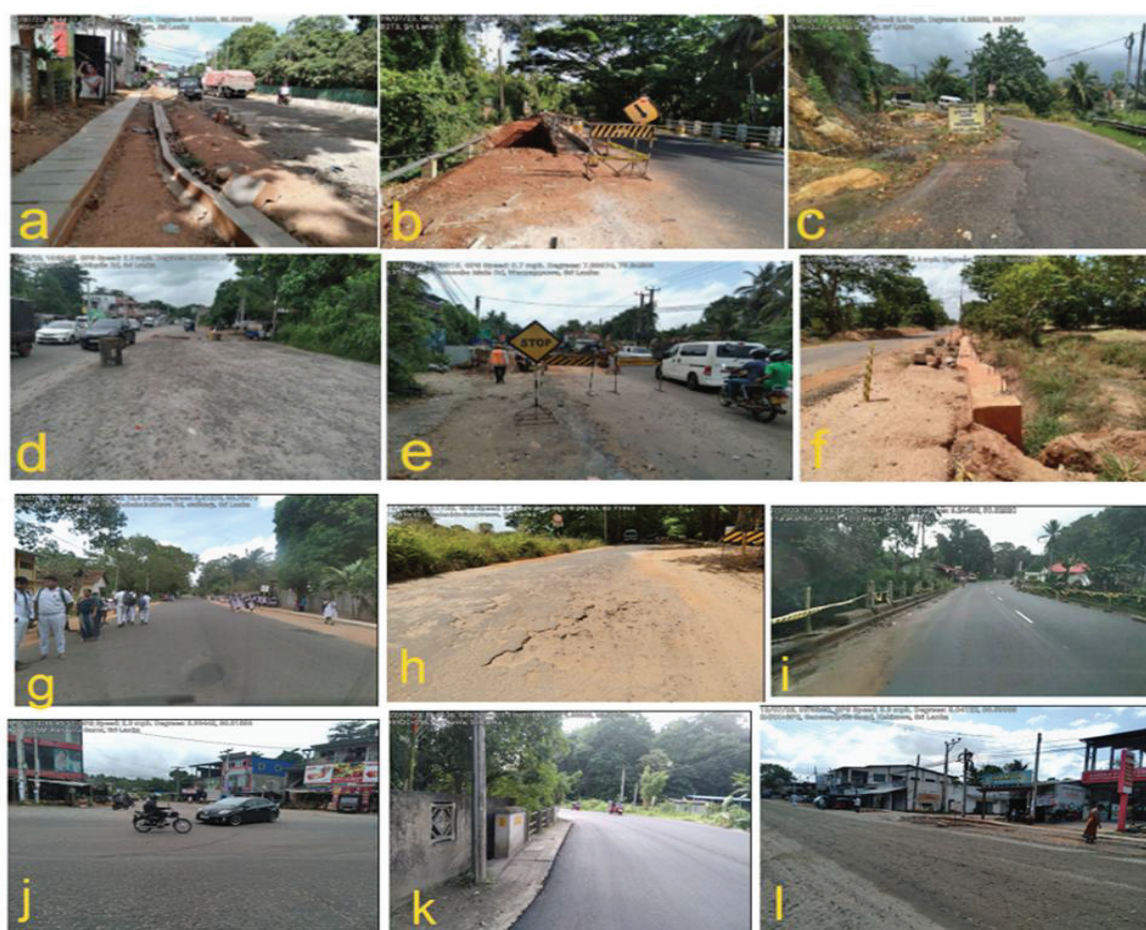
**Figure 1 – Sample photographs of audited road sections**

The information available in the checklist and the onsite observations are used to identify the key safety issues at each location. In summary, the common issues that were identified along with sample images, are shown in Figure 1. The

field survey identified several recurring safety deficiencies on partially completed roads, which are summarized in Table 4. Key issues included nonstandard work-zone demarcation, absence of pedestrian facilities, lack of protective barriers at bridges and steep embankments, incomplete or deteriorated pavement surfaces, and inadequate signage or delineation. Among these, the most frequent concern stemmed from suspended road upgrading projects, where work zones were not demarcated in accordance with established guidelines. At several locations, residual construction debris, incomplete culverts, and unfinished bridge structures created substantial roadside hazards, particularly for motorcyclists and pedestrians. Furthermore, the lack of adequate warning signs exacerbated these risks by failing to alert road users to the presence of hazardous conditions. The road safety risk assessment confirmed that these deficiencies were consistently associated with high-risk ratings, underscoring their potential contribution to increased crash likelihood.

**Table 4 – Common safety issues that were identified during the safety audit with the location**

| No | Issue | Image | Example location |
|---|---|---|---|
| 1 | Nonstandard work zone demarcation practices for incomplete road segments | a | B212 Road, Kekirawa |
| | | b | B213 Road (Kekirawa to Thalawa) |
| | | c | B429 Road, Panagala West |
| | | d | B124, Udupila Junction, |
| | | e | A3 Road, Wennapuwa, |
| | | f | B133 Road, Yakalla, |
| 2 | Lack of pedestrian infrastructure along both main roads and local roads or presence of open drains on local narrow roads/ low roadside space posing a major risk to pedestrians | g | B133 Road, Ganewelpola |
| 3 | Lack of barriers at bridges/culverts or road segments with steep vertical drops | i | B429 Road, Ehalakanda |
| 4 | Partially completed roads with base layer, unpaved sections or incomplete road sections with severe deteriorations | h | B133, Galenbindunuwewa |
| | | l | B212, Kekirawa |
| 5 | Lack of road signs and markings, poor delineation on most road segments that have been recently paved. | j | B124, Udupila Junction |
| | | k | A8, Ketetanna |

For the roads that had been paved, the lack of pavement markings and road signs caused delineation issues for road users. The smooth road surface profile of the newly paved segments would encourage speeding, but the lack of safety measures would not create a safe environment for road users.

Adequate emphasis is not given to improving pedestrian infrastructure in the road upgrading work. Even in the road segments that have been paved, pedestrian infrastructure is in an unsatisfactory condition, especially in town areas and near schools, where pedestrian activity is expected to be high.
